Condition Report

Greys Auction Perth
WD600-6 | 55016

General Information		Customer Details	
Case Number	AD61161741060937	Customer Name	Greys Auction Perth
Date	04/03/2025	Customer No.	
Equipment	Wheel Dozer	Location	Jandakot
Model	WD600-6	Contact Name	Taine Yates
Serial No.	55016	Contact No	0452482963
S.M.R	23127	Contact Email	
Engine Serial No.	512384	Service Details	
Technician	Ruby Livingstone		
Supervisor	Kieron Hinsley		
Case Description	Condition Report on a used WD600-6		
Report Completed By	Ruby Livingstone	Component Report Recommended	
		Delivery Name

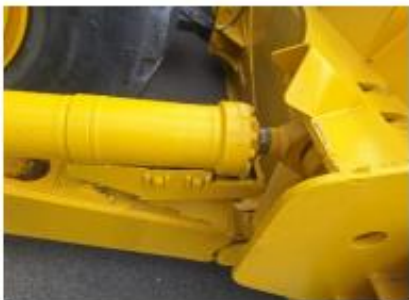
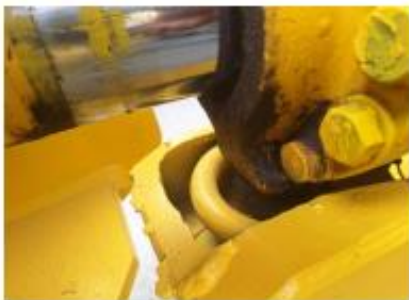
Component:
Hydraulic cylinders

Comments
blade tilt cylinder in good condition

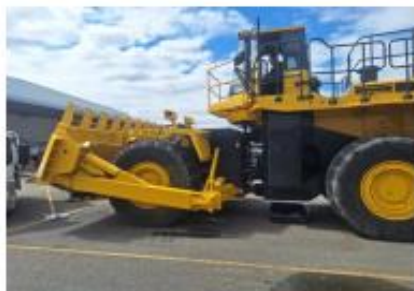
Component:
Tyres and rims

Comments:
All tyres in used condition, few minor
defects in tyres

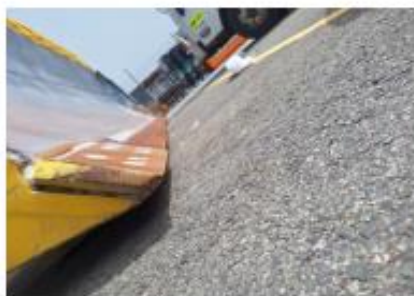
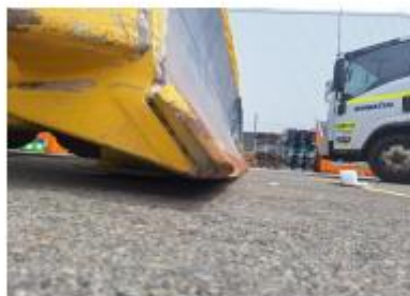
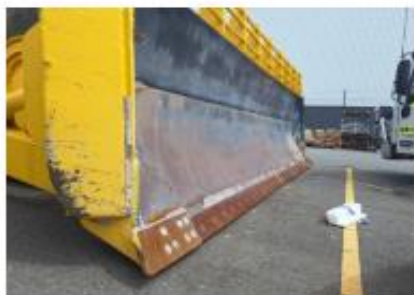
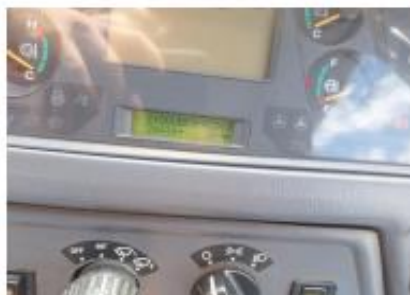
Component
Blade, Bucket, Ripper and GET

Comments:
Blade, Bucket, Ripper and GET in good condition

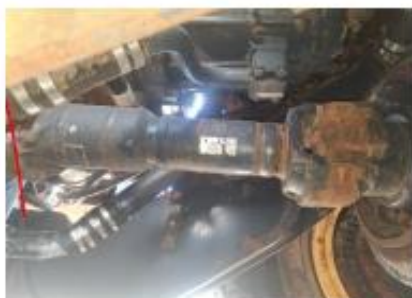
Component:
Drive shafts

Comments:
Drive shafts have usual wear and tear

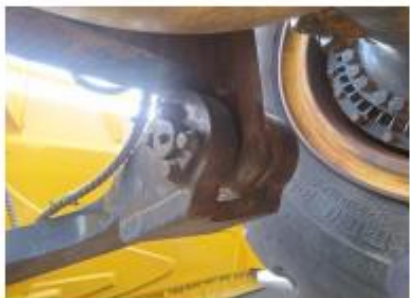
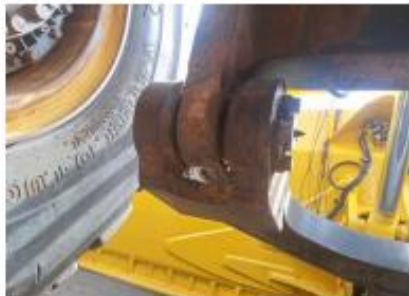
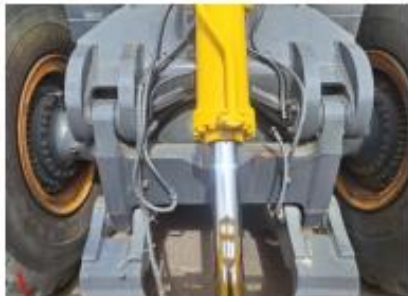
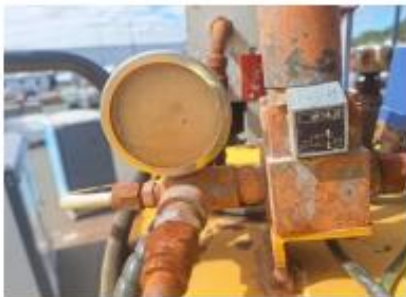
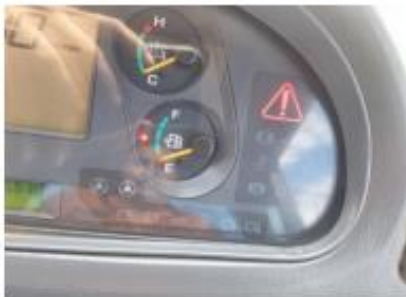
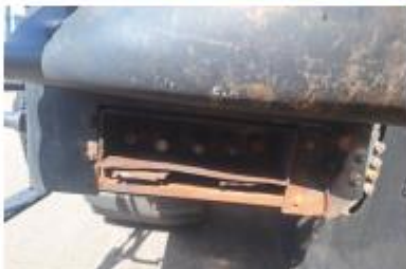
Component:
Work equipment

Comments:
Grease lines and injector in good order

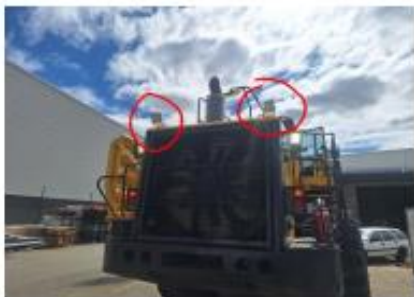
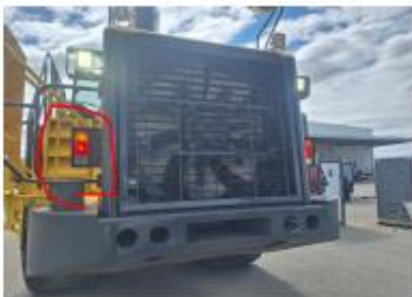
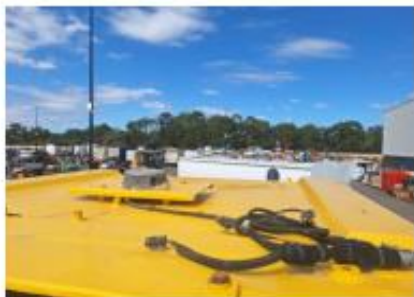
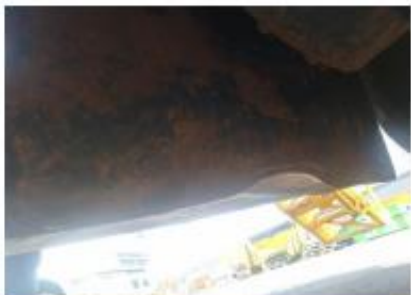
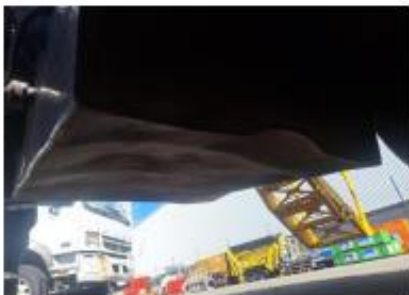
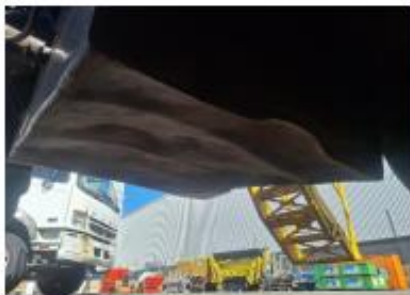
Component:
Lights, beacon and instruments

Comments:
In good condition

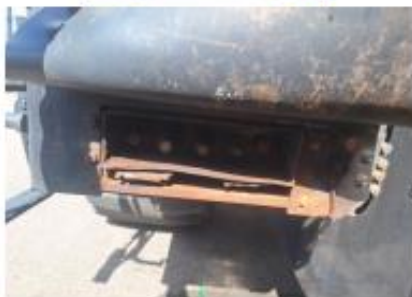
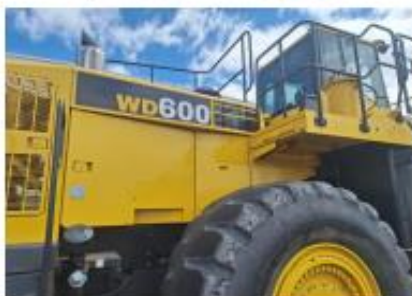
Component:
Outer body panels and paint

Comments:
Paint and body panel in good order-
normal amount of wear around machine

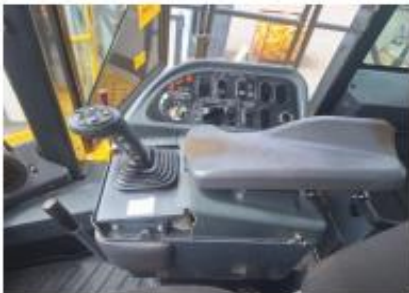
Component:
Monitor panel

Component:
Dash upholstery appear in good condition
