# REDLINE CRANES

## MOBILE CRANE MAJOR INSPECTION AND MECHANICAL REPAIRS

**CRANE TYPE: Franna AT20 SN 3569**

**MAJOR INSPECTION CERTIFICATE # AC A179781-13**

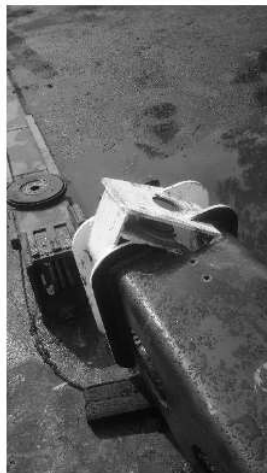
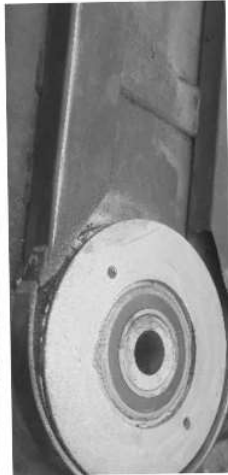
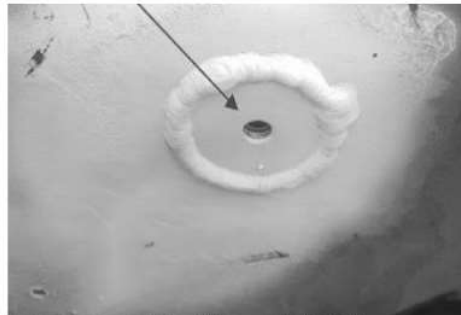
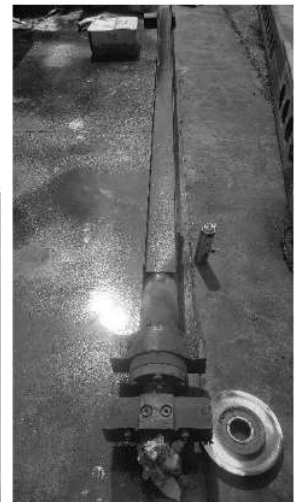
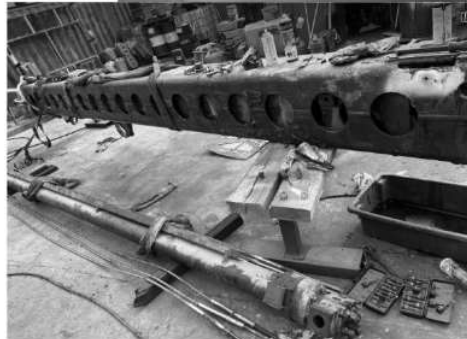
**BOOM:**

From Mechanical Inspection of the Boom, it was identified that the boom is in good condition, no cracks were found. We needed to carry out wear pad adjustments to adjust alignment and any worn wear pads replaced. All extension and retract ropes were inspected and found in good condition.

Full inspection was carried out on boom sections for straightness and distortion. All sections had a string line run across them and all measurements were recorded all boom sections were determined to be within OEM Franna specifications and limits. Base section no distortion, 1<sup>st</sup> section 3mm vertical and no lateral distortion, 2<sup>nd</sup> section 4.5mm vertical 1mm lateral 3<sup>rd</sup> section 4.5mm vertical no lateral.

Boom was considered satisfactory for continued use with fatigue checks at a minimal allowing for an additional 10 years before major reassessment is required. Regular routine servicing and annual checks should still be considered in accordance with AS2550. Inspection of critical welds on the boom section was undertaken with full ultrasonic testing being carried out on welds and pins. Please refer to NDT inspection report by independent AMAP Engineering on report #23PE174ET01, 23PE174MT01, 23PE174UT01. Results indicated satisfactory from this report.

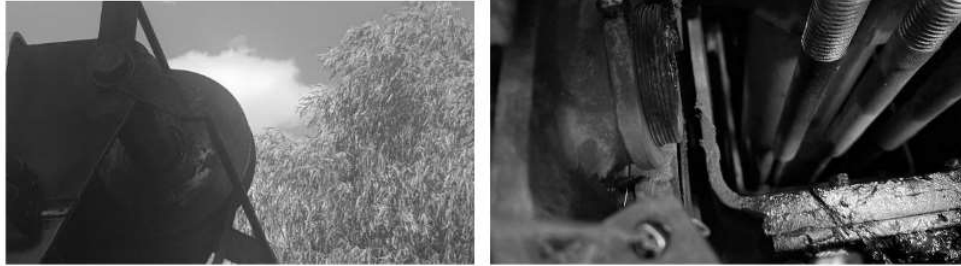
## WIRE ROPES:

Main winch rope was inspected and found to be in good condition, reinstalled during reassembly of the boom.

Retract rope was inspected and found in good condition. The 3 extension ropes were also inspected and found in good condition. These Ropes were Originally fitted in 2021 so therefore not required at the time.

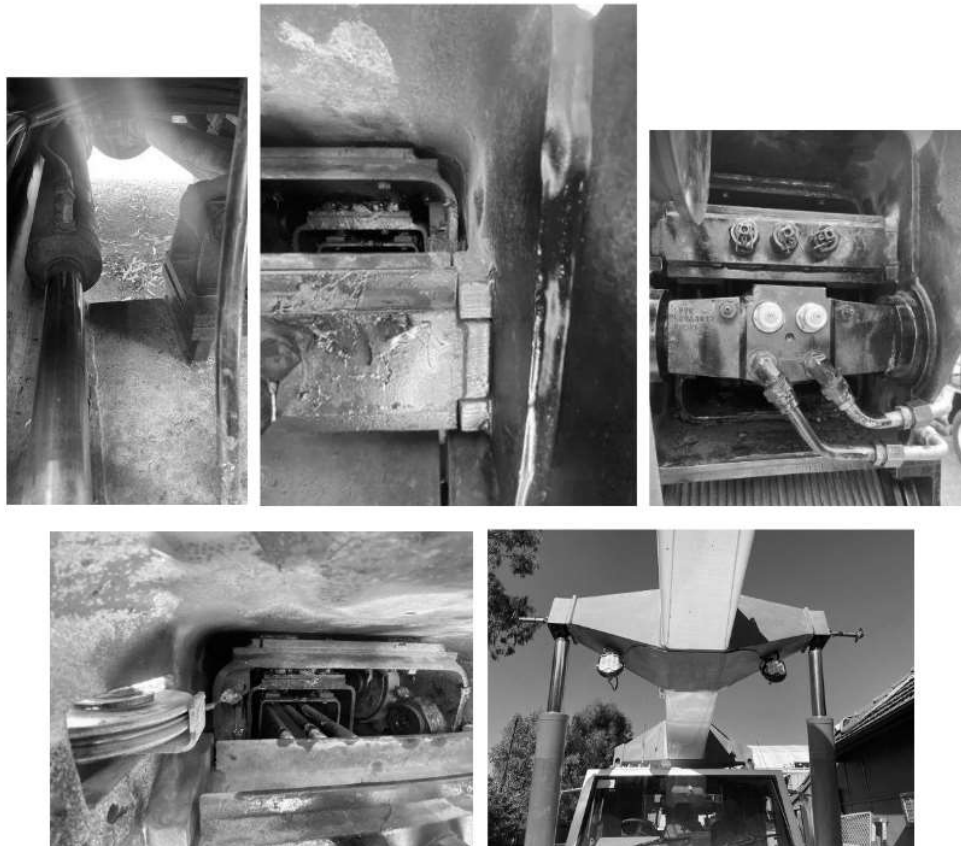
## HYDRAULIC SYSTEM:

Hydraulic hoses were inspected for damage and wear, any brittle hoses, were found and replaced.

**Steering Crossover** hoses were replaced. **Winch hoses** and **Extension Cylinder hoses** were also replaced.

**Luff Cylinders were replaced, and Steering cylinders** were pressure tested and Chrome inspected and found to be in satisfactory condition.

All function pressures were checked, and counterbalance valves tested and replaced tellie C/B valves.

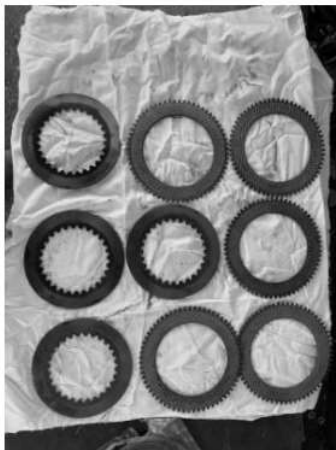
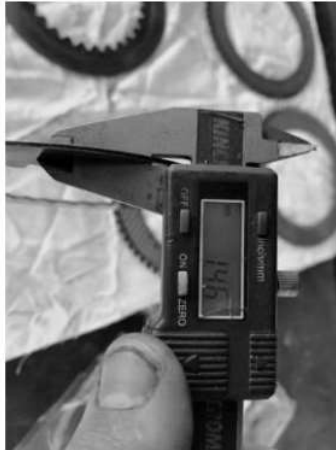
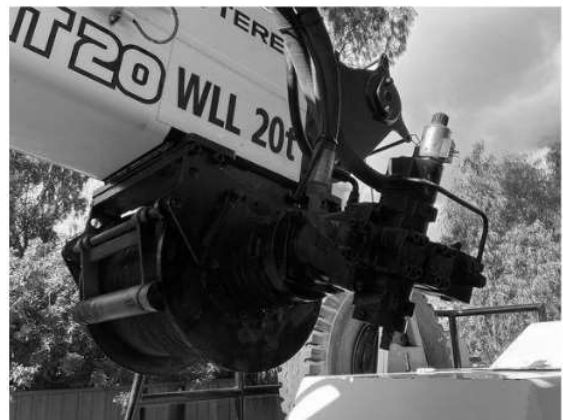
**WINCH:**

A line pull test at 110% of rated capacity was conducted winch. Load was suspended for 10 minutes and checked for any visual signs of creeping or stress.

Main winch line pull, 4200Kg. Test load @ 110% = 4620 KG Result: Comply

The main winch is an internal friction disc type braking system. The winch was assessed and was upgraded to a 2600 series Brevini Winch with Drive Motor being replaced; all components were inspected as per Australian standards AS2550.5.

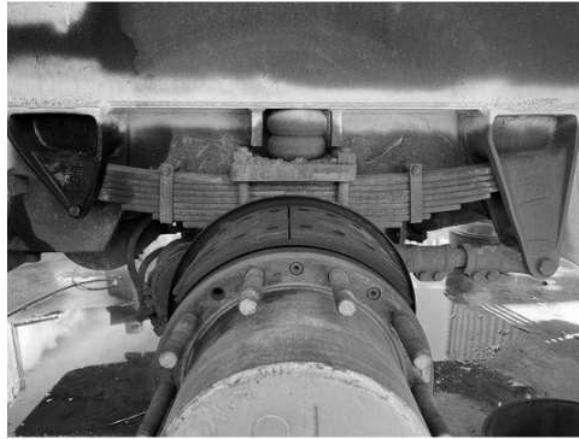
### **UNDERCARRIAGE SYSTEMS:**

Drivelines were inspected, with Universal and Centre Bearing Replaced, All Brake Shoes and Brakes Drums were inspected, found to be above the minimum standard. Brake Chambers and hoses were inspected, and diaphragms replaced, Dump Valves replaced and entire Air System Lubricated.

Inspection of Suspension was undertaken Front and Rear Springs were in good condition with no visible cracks and maintenance of Brakes, boosters and air valves carried out.

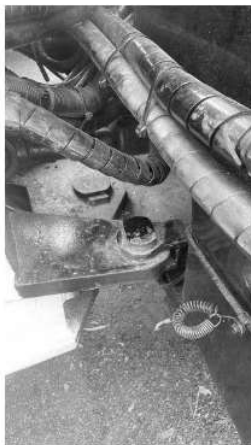
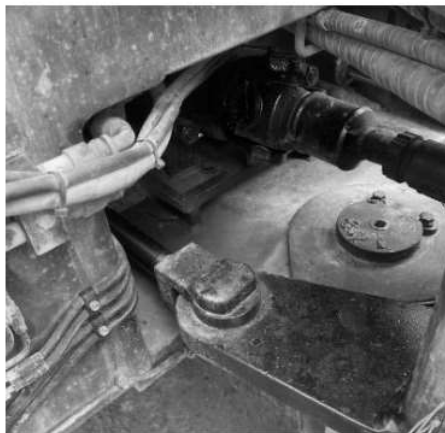
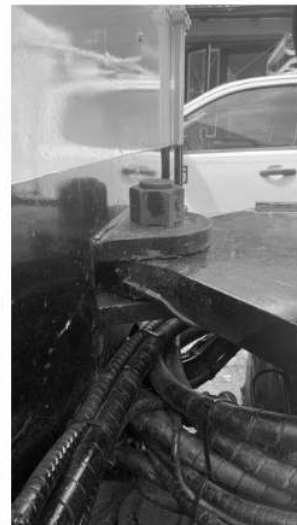
### **STEERING SYSTEMS:**

Centre Artic Joint wear was checked by Training & Inspection Services AC A 179781-13 via and adjusted to meet OEM specifications. Centre Artic welds were inspected by AMAP Engineering on Report #22PE017ET01 2PE017UT01 22PE017MT01.

All Tyres across Front were replaced with new Westlake tyres. Rear tyres found in good condition.

Steering cross over hoses were replaced, all steering bosses were inspected for wear, all welds were inspected and tested via NDT Testing, see individual report AMAP Engineering on report #22PE017ET01, 22P017MT01 22P017UT01.
