# BUILDING AND PEST INSPECTION REPORT

Address: 7 Bates Court, East Brisbane

Date: December 22, 2022.

This home has 3 bedrooms, 1 bathroom and 2 car spaces.

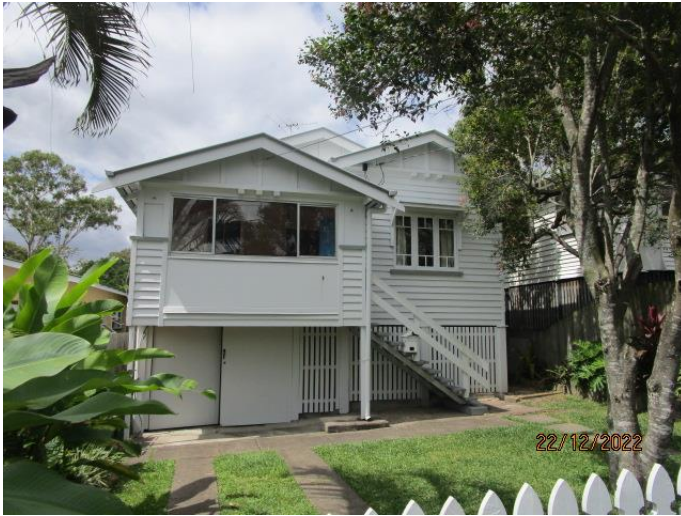
1. The home is quite well presented and in very good structural condition. The home is approximately 100 years old. The home does have imperfections and defects. I'm going to consider these as character as this style home that has had no major renovations does require an overhaul or refurbishment if you want all surfaces to be perfect.

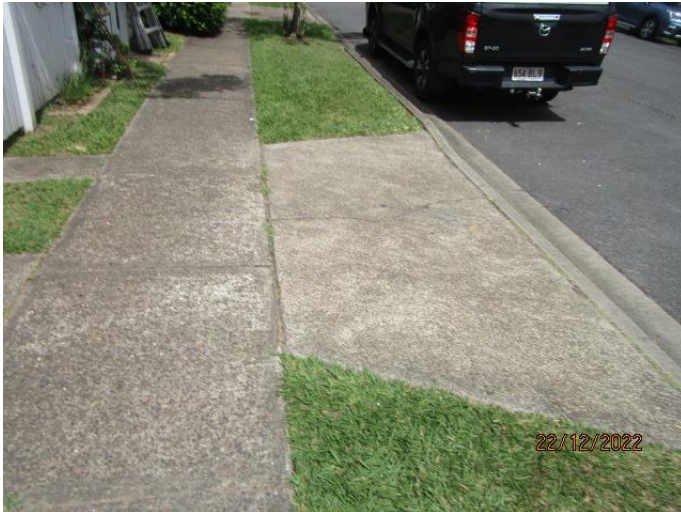
2. The driveway crossover is in good condition.

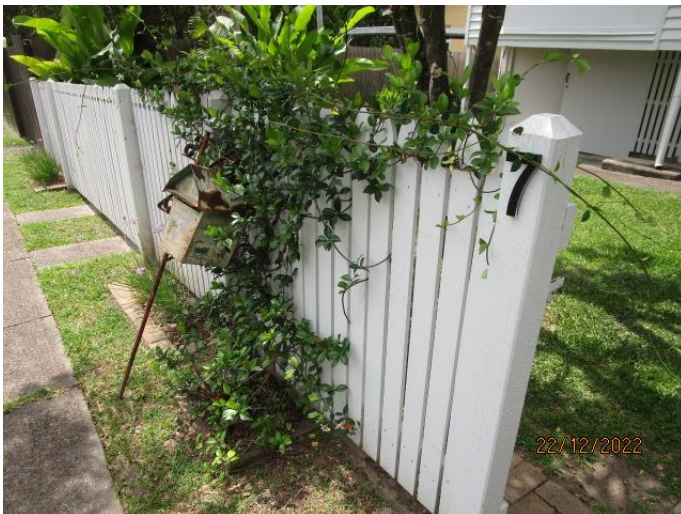
3. The front fence is in good condition. The letterbox requires reinstating.

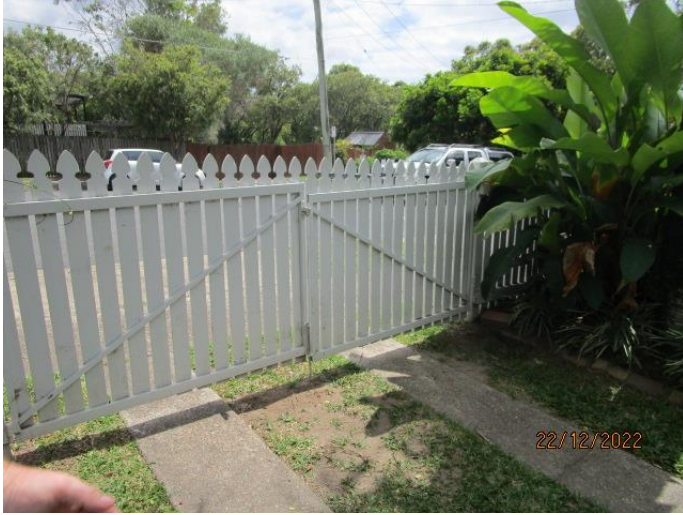
4. The gates require slight adjustment. The driveway tracks were in quite good condition.

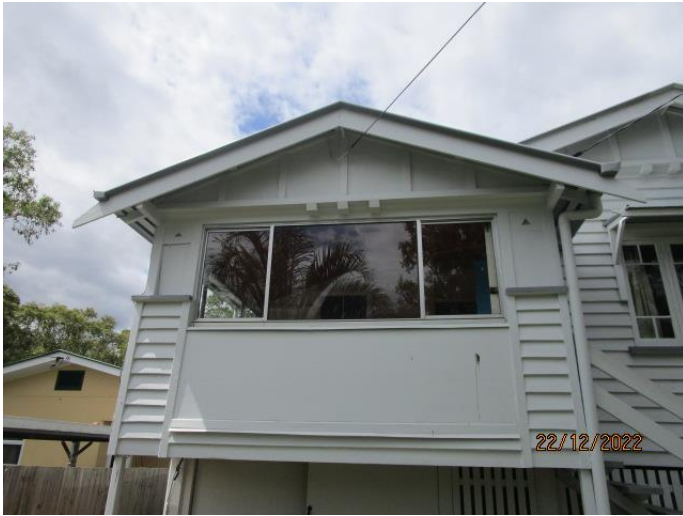
5. The exterior of the home does have some imperfections. There is no major damage. This front panel underneath the window does have damage on the inside and requires repairs. This is an enclosed balcony. The overhead telecommunications bracket was secure.

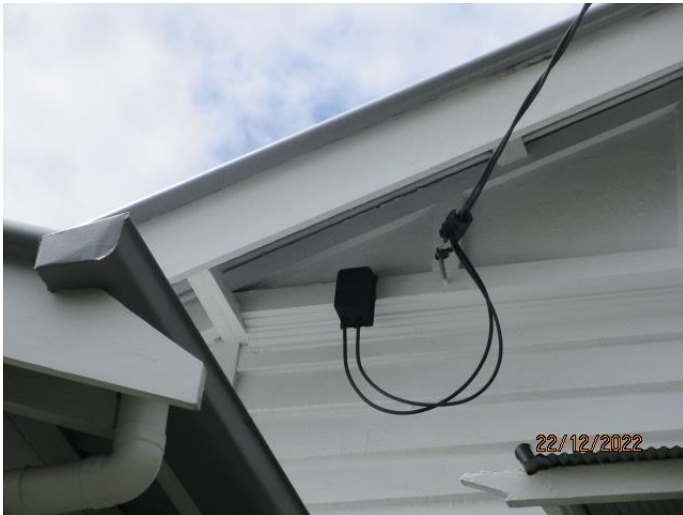
6. The overhead power connection was secure.

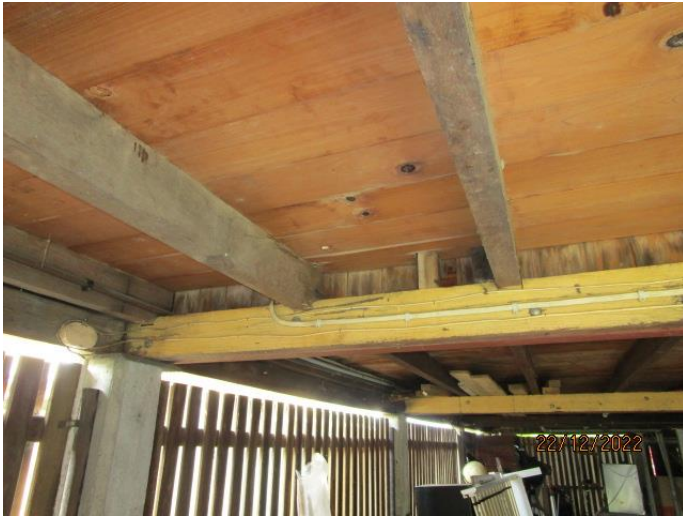
7. The subfloor structure had no evidence of any major damage. There are items that are not perfect and there is evidence of deterioration.

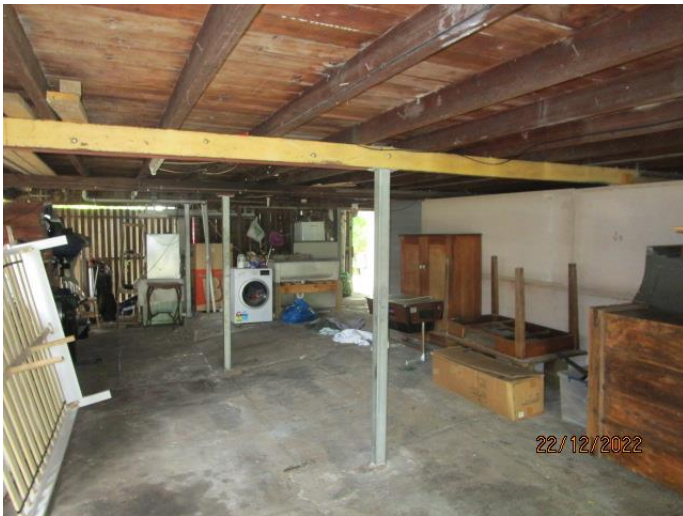
8. The structural steel columns that have been installed are neat. There is no sign of structural deficiency. The historical floor boards do have imperfections. From the top there are some boards that could be replaced if required as the surfaces do have damage. The concrete floor underneath the house was considered to be in fair condition.

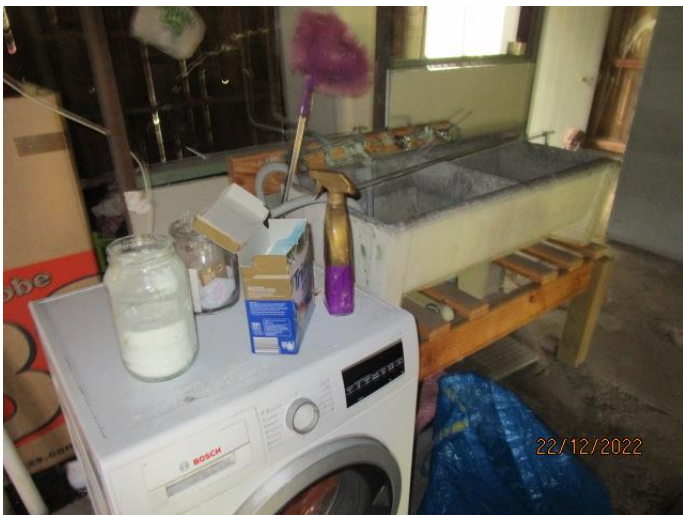
9. The laundry is in simple form. There are no formal walls or tiles. The plumbing services do function.

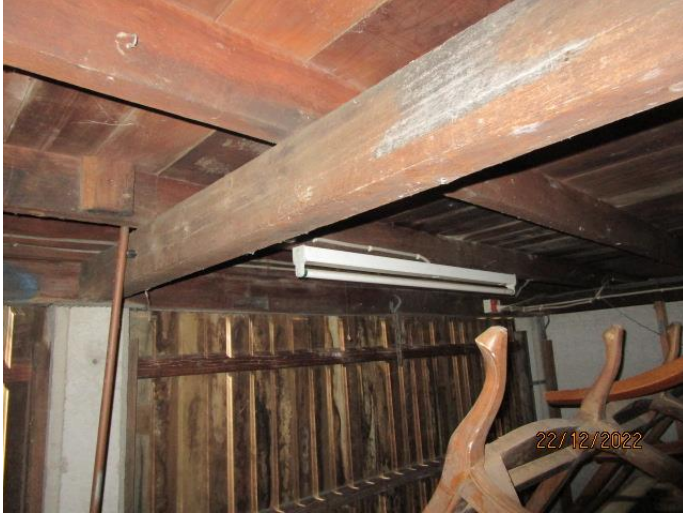
10. damage.

The subfloor structure had no evidence of any major

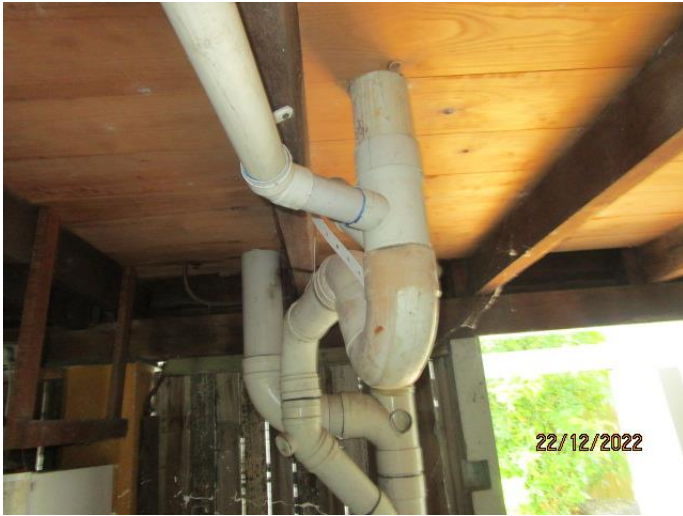
11. leaks.

The plumbing services to the bathroom have no

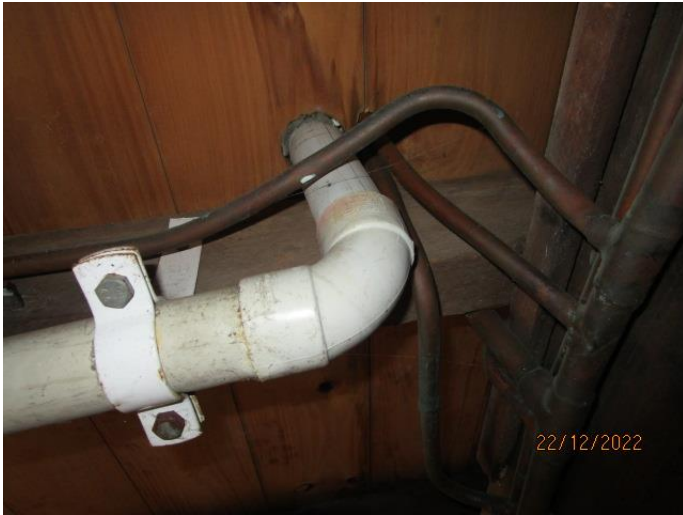
12. leaks.

The plumbing services to the bathroom have no

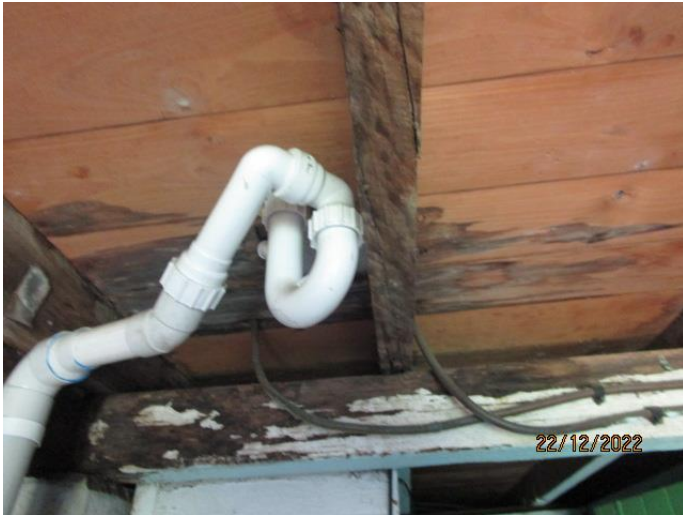
13. This is underneath the bath. There is evidence of a historical leak. This was not leaking at the time of the inspection. The floor has water stain but no major water damage.

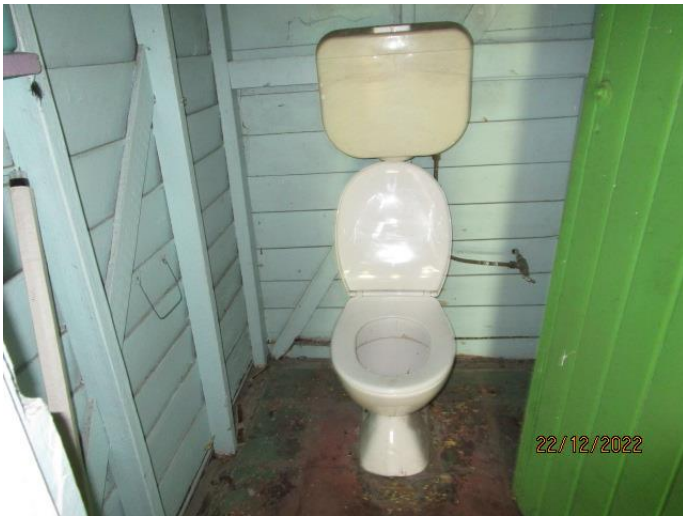
14. The lower-level toilet flushed and refilled. The base of the walls do have some deterioration. Maintenance or minor repairs are required.

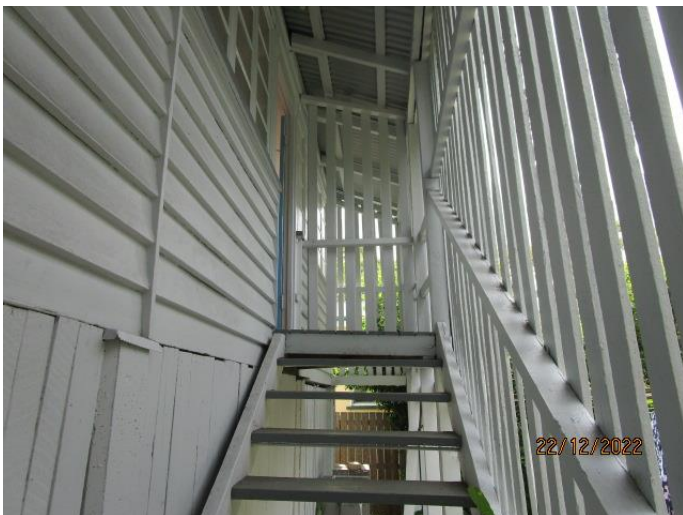
15. The rear stairs were in quite good condition. The balustrade of the top of the stairs requires upgrading to remove the possibility of a fall hazard. These privacy screens on the back of the home require general maintenance and minor carpentry maintenance.

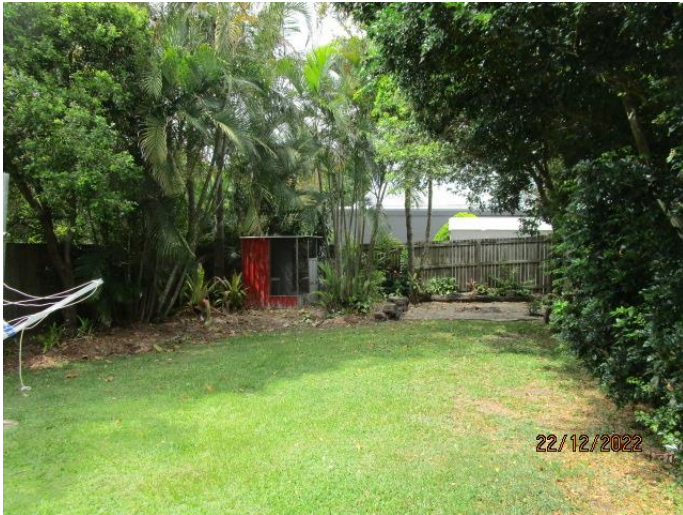
16. The backyard is well-maintained. The backyard drains to the left at the rear.

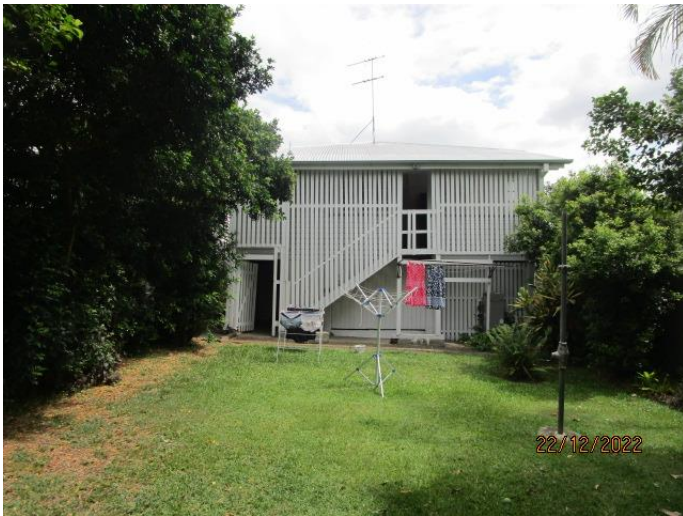
17. The rear of the home is well presented.

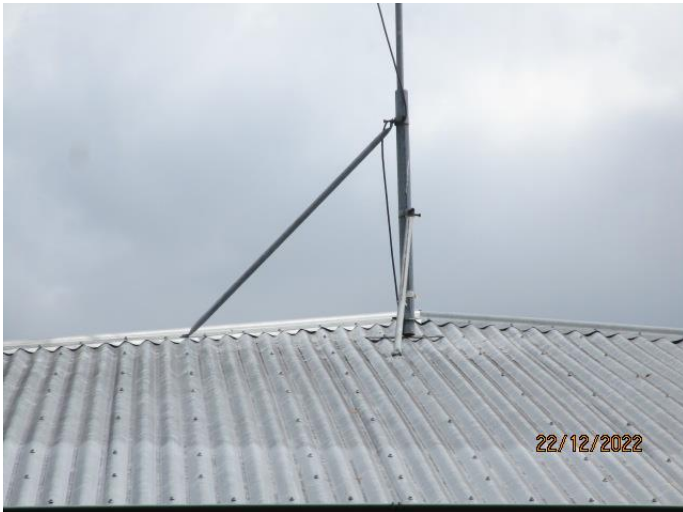
18. The roof is in very good condition.

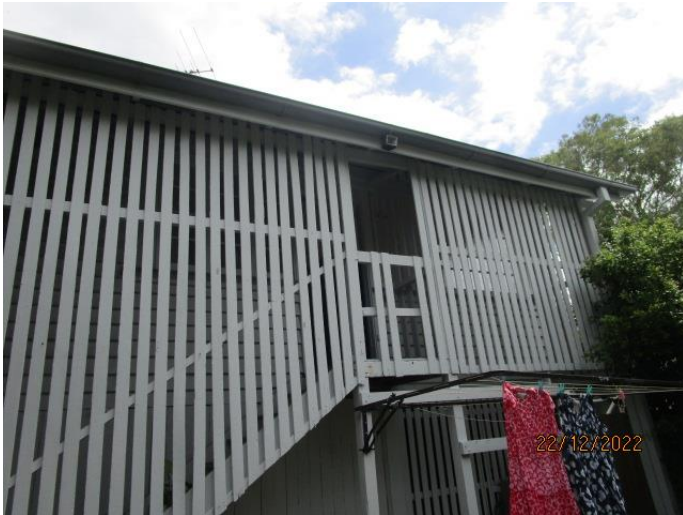
19. The privacy screens require maintenance. The balustrade in the centre requires repairs as it is considered a fall hazard in current form.

5. The front panel to the kitchen sink requires reinstating.
6. The rear central balustrade at the time of the stairs requires upgrading as it is considered a fall hazard.

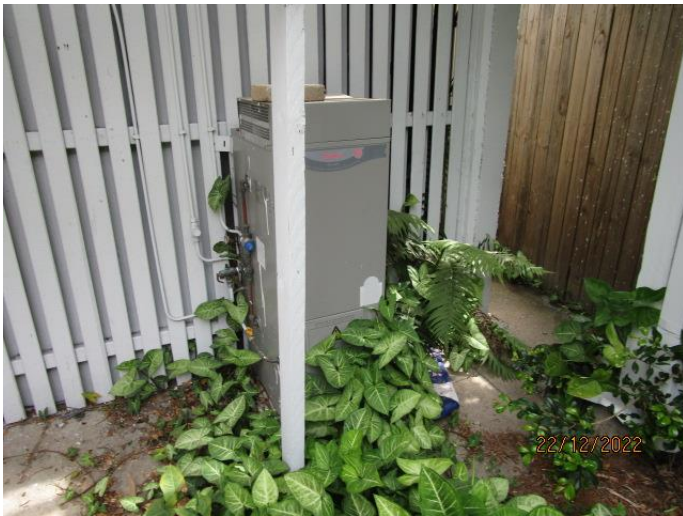
20. The gas hot water unit functions. I recommend all appliances are serviced. The vine climbing around the hot water unit requires removal.

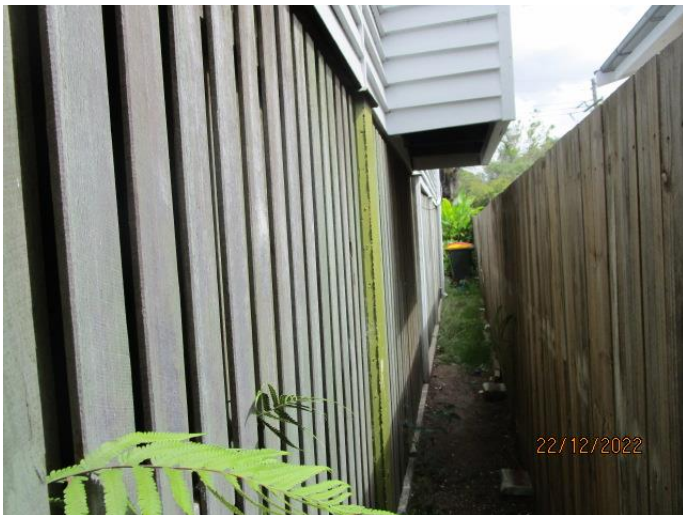
21. The fences were in quite good condition. The lower-level exterior tickets were in quite good condition. The base does have some damage.

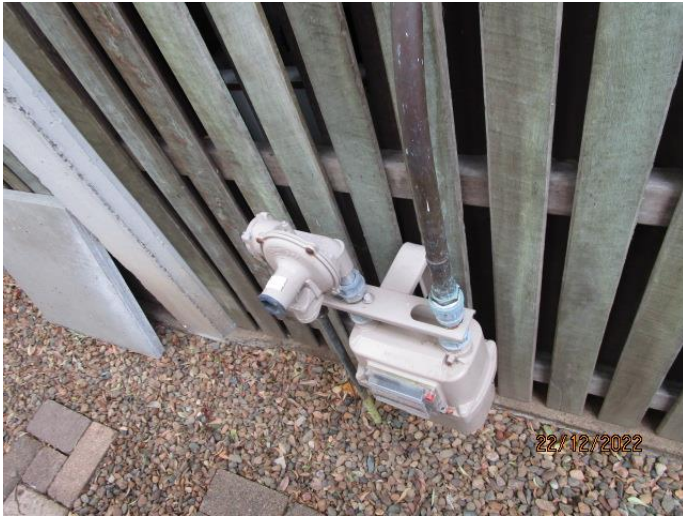
22. The gas service functions.

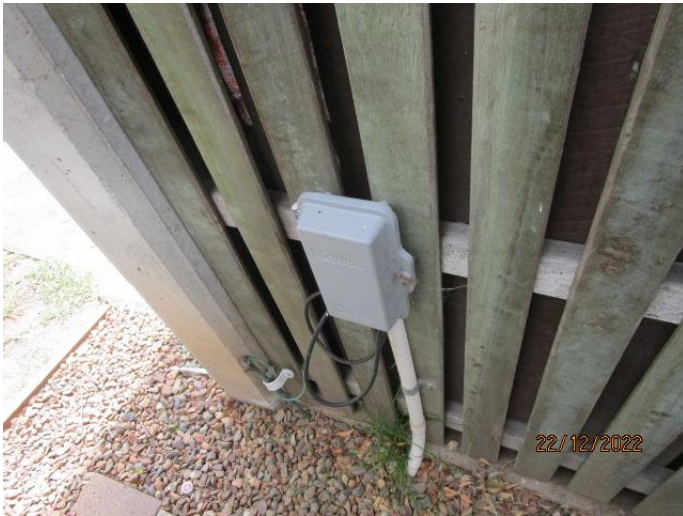
23. Telecommunications was connected. This was not tested for speed or reception ability.

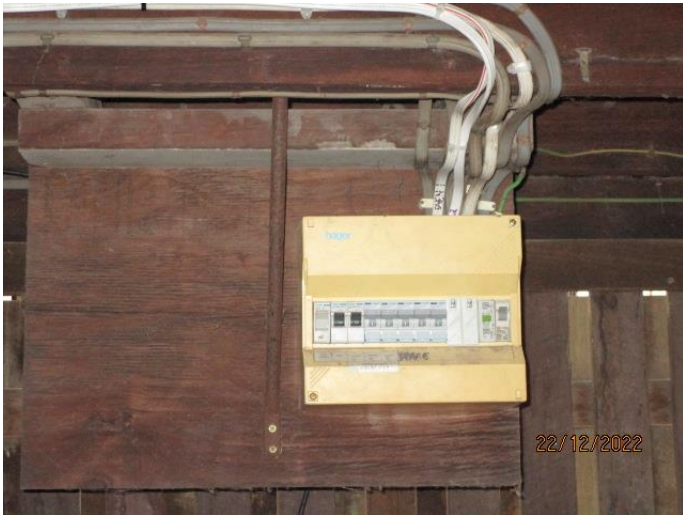
24. The home has safety breakers. Electricity was functioning.

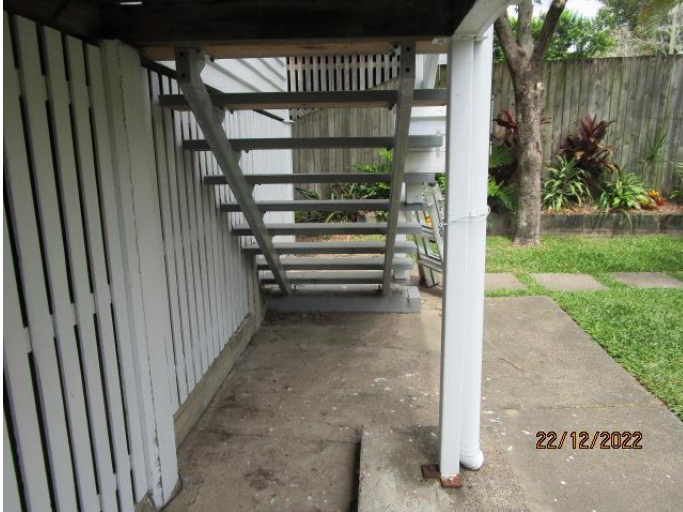
25. The base of the front column has rust and requires treating against rust. The stairs are in very good condition.

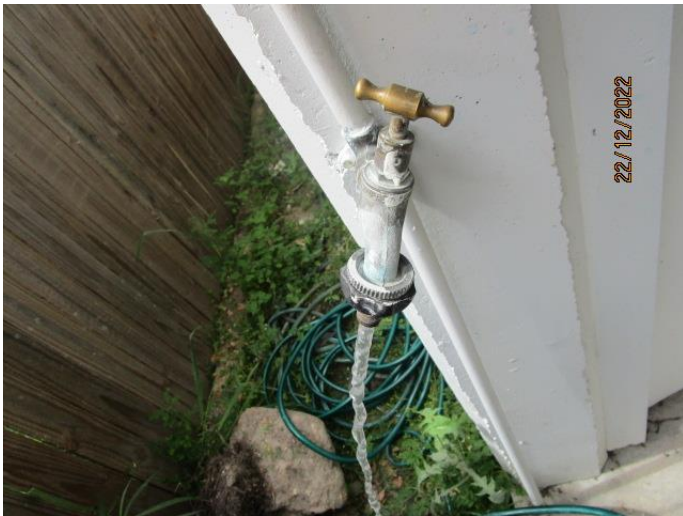
26. The exterior hose tap functions. Water pressure is good. There are no leaks.

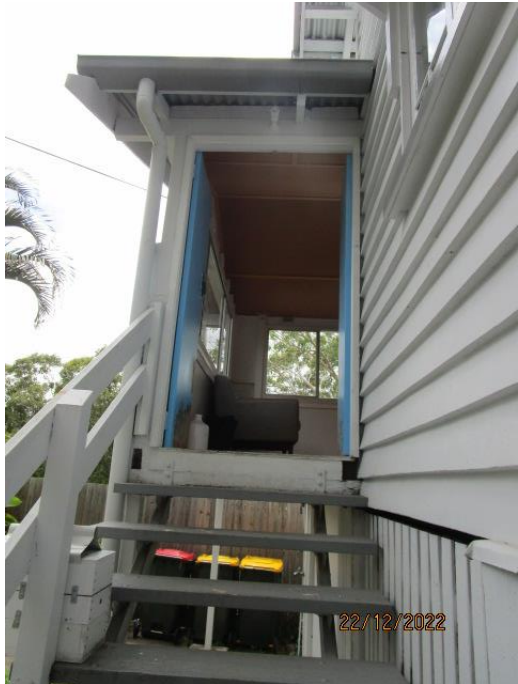
27. The entry door functions and locks. The entry doors require rejuvenation as they have scratch marks.

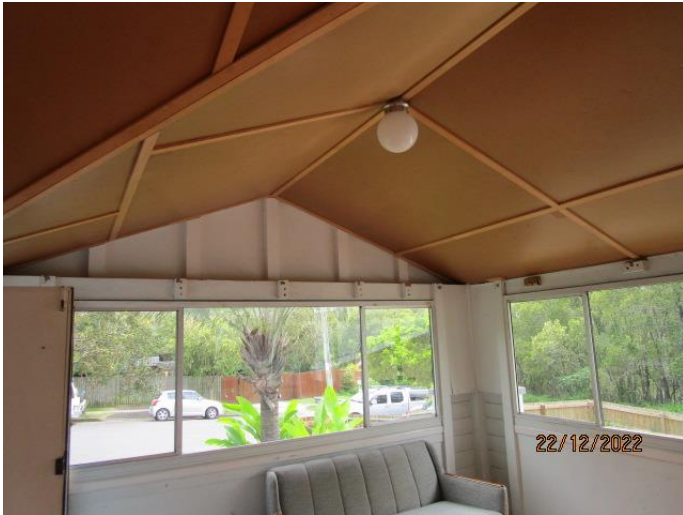
28. This is an enclosed balcony. The front wall has damage and require some repairs. Craft wood ceilings have been installed in the entry.

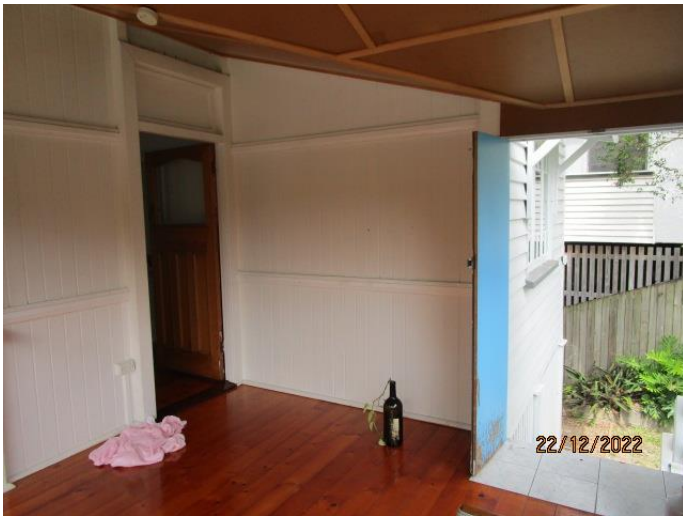
29. The doors require rejuvenating.

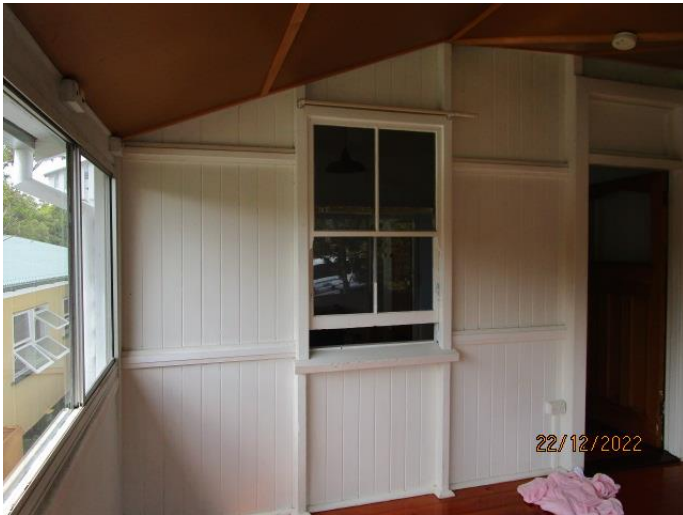
30. The front of the house is quite well presented. All timber joinery windows and doors require servicing.

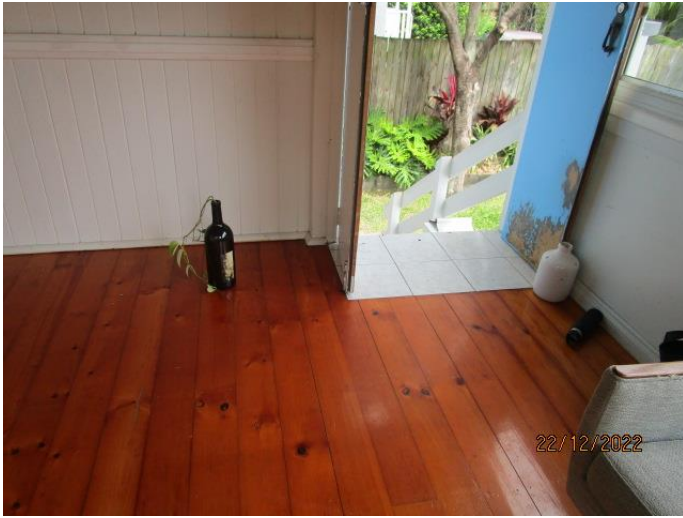
31.

The tiles at the entry do have some cracks.

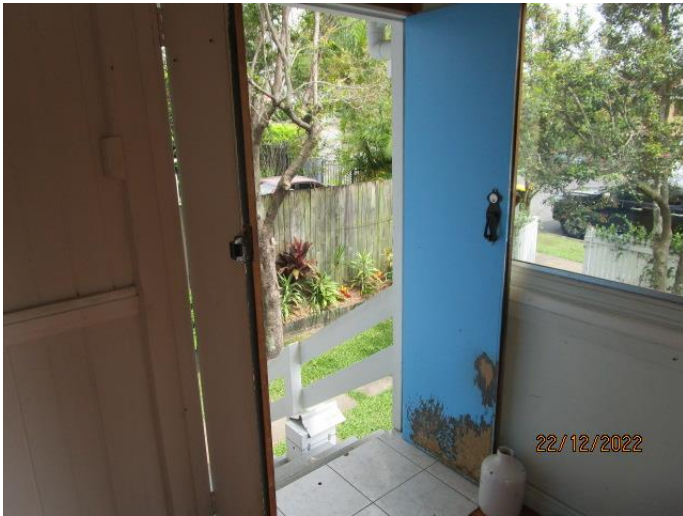
32.

The entry doors require rejuvenating and painting.

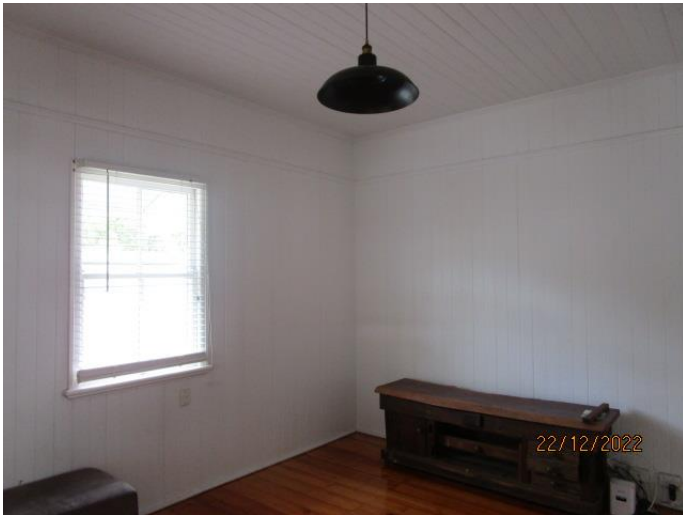
33.

The room is well presented. All windows require servicing and painting.

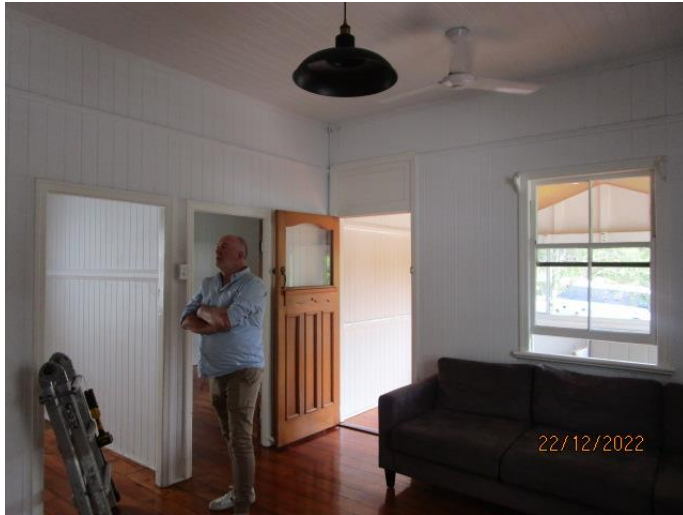
34. The living room is in good condition. The entry door functions.

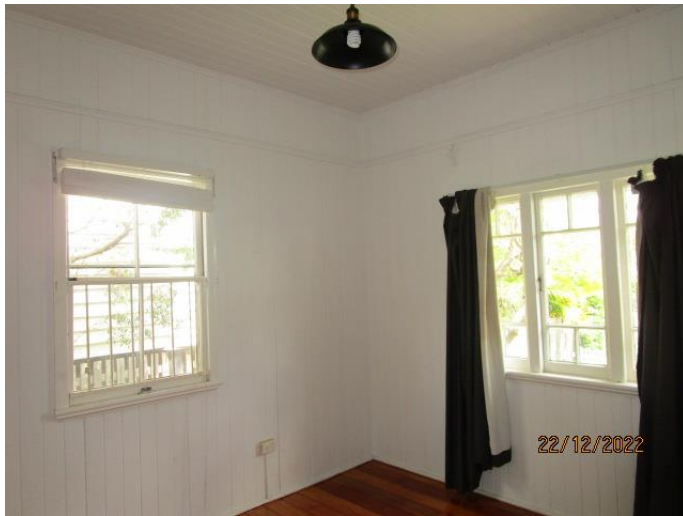
35. The bedrooms were well presented. The timber joinery windows require servicing.

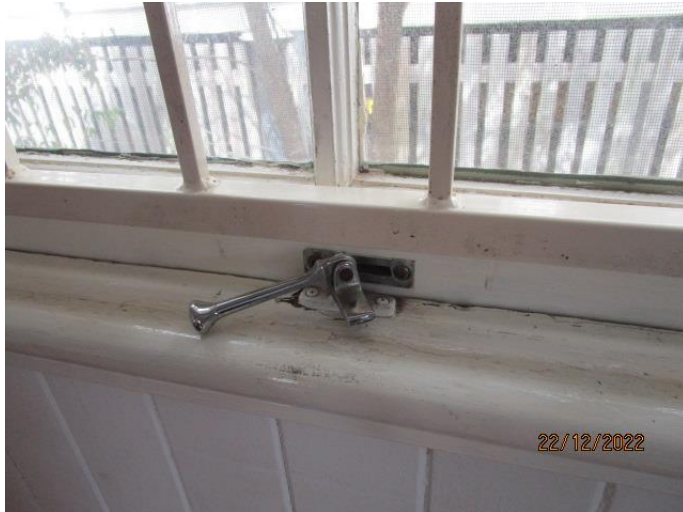
36. The timber joinery windows do function but require servicing and paint maintenance.

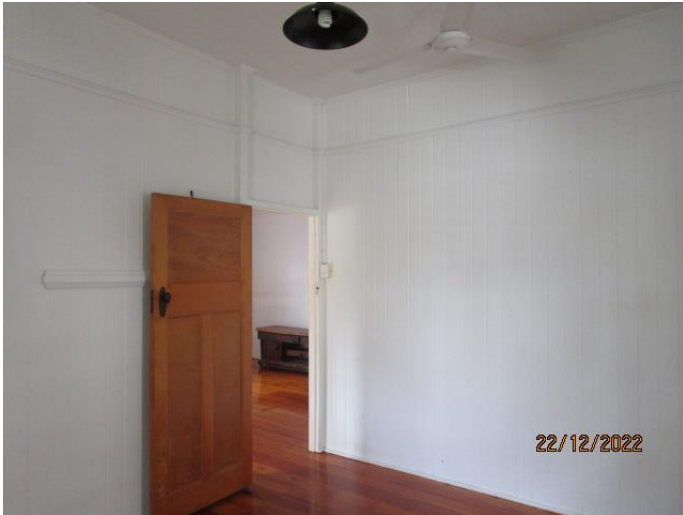
37. The entry doors to the bedrooms function. The bedrooms require interconnected smoke alarms.

1. **Smoke alarms are non-compliant and require upgrading to interconnected smoke alarms. The new smoke alarms Should be installed by an electrician or fire safety expert. A form 16 compliance should be issued as confirmation the alarms are installed correct and compliant. New photoelectric smoke alarms must be installed in all bedrooms.**

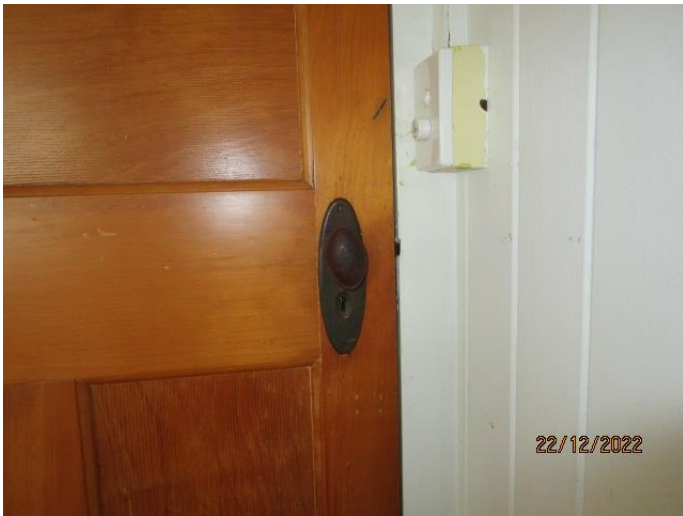
38. The entry doors function.

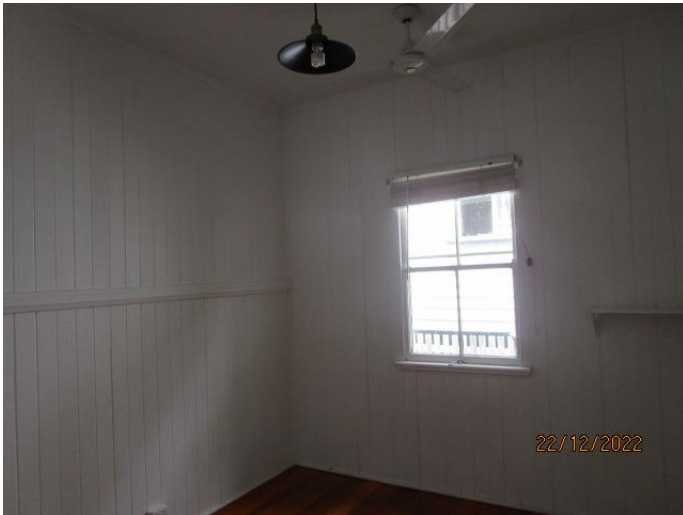
39. The second bedroom is in good condition. The windows require servicing. The cladding has no evidence of any major damage.

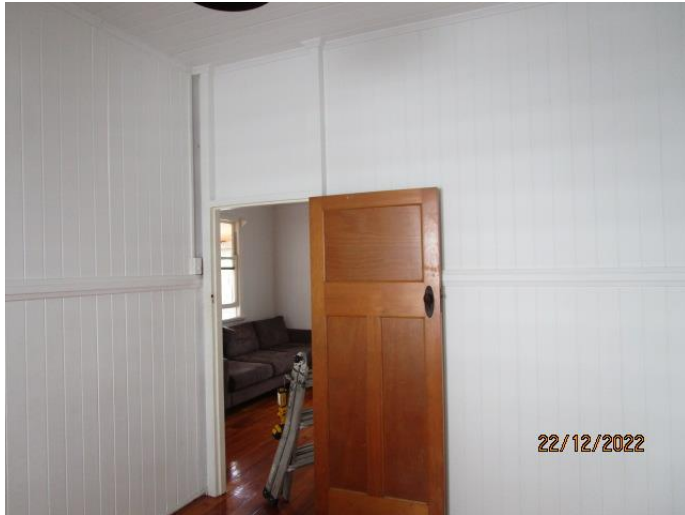
40.

The doors function well.

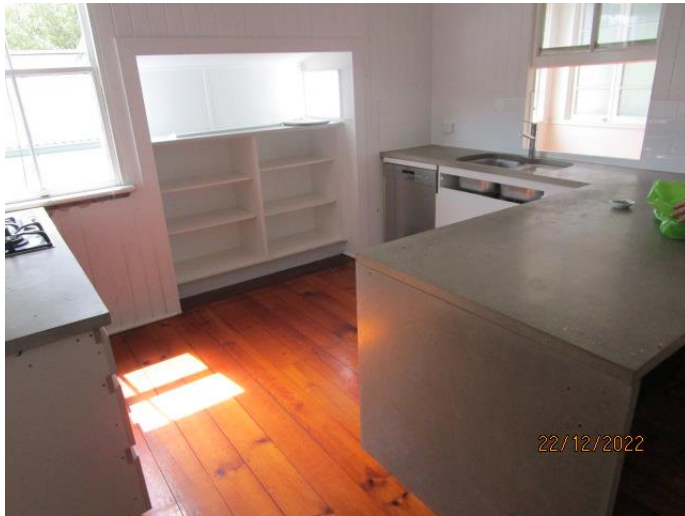
41.

The kitchen cabinets are in fair condition.

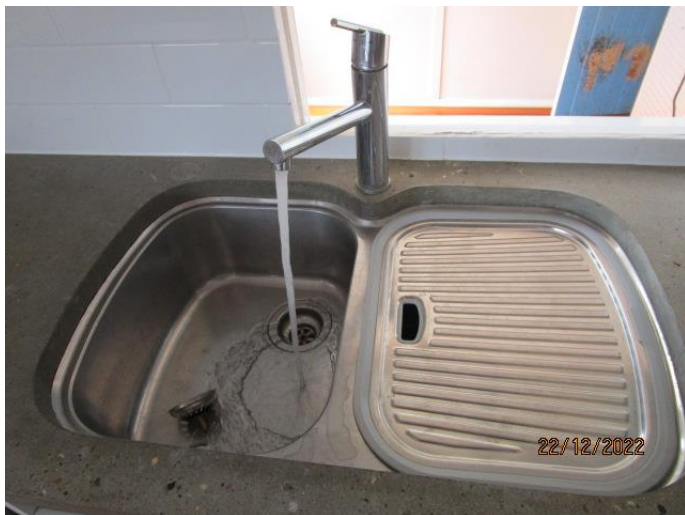
42.

good.

The sink and tap had no leaks. Water pressure was

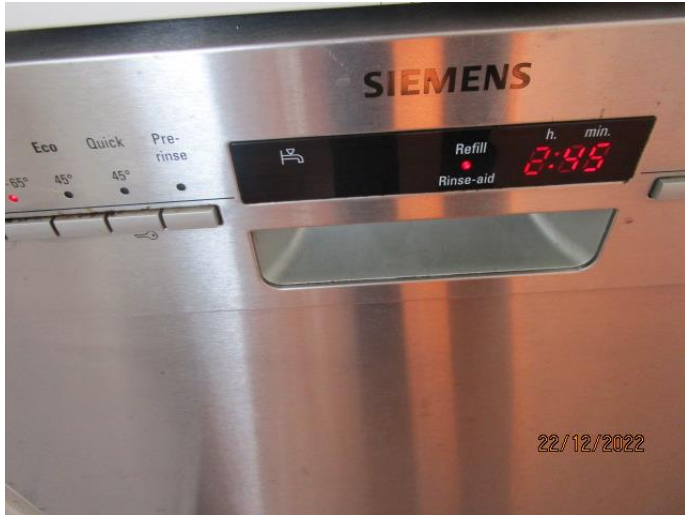
43. The dishwasher functions, but we did not run a complete cycle to test fully.

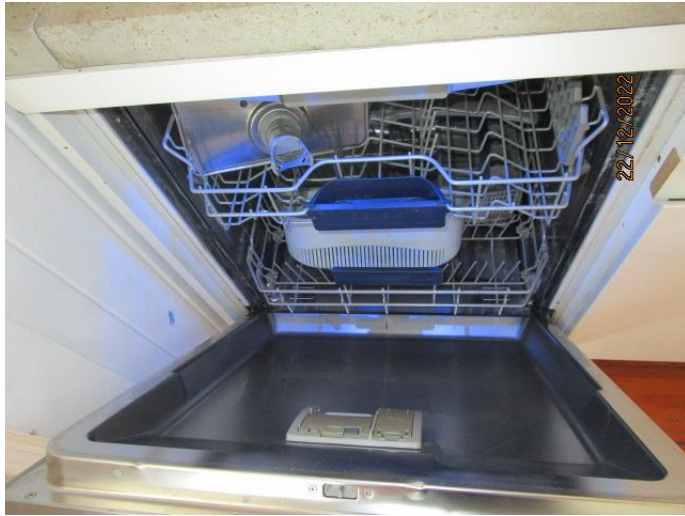
44. The dishwasher has no evidence of any major damage.

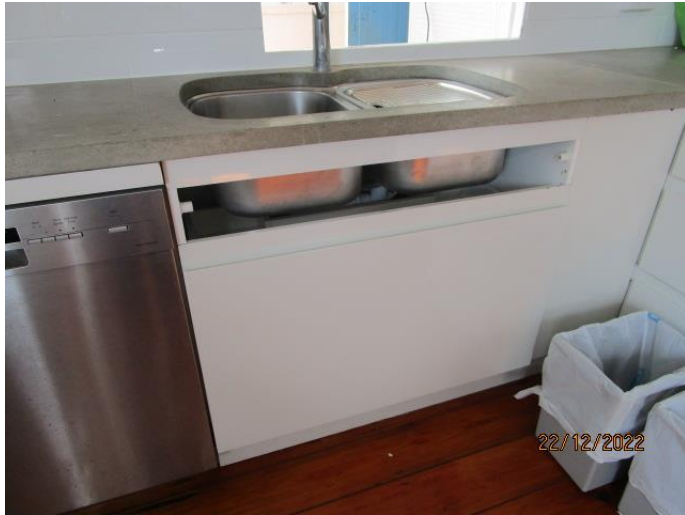
45. The panel at the front of the sink requires reinstating.

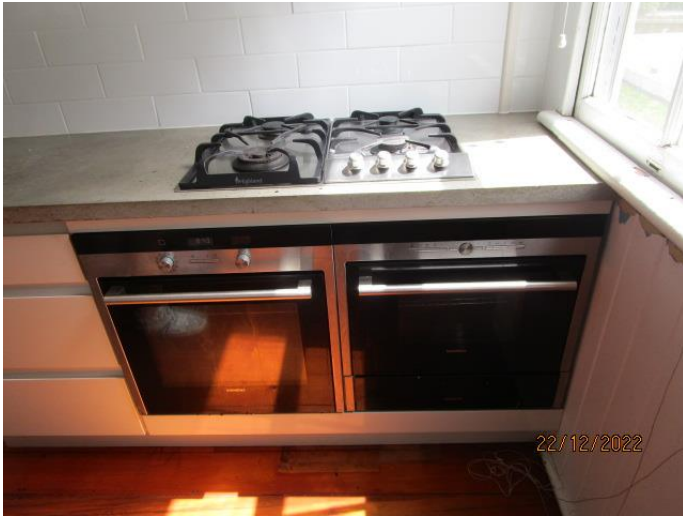
46.

The appliances function but require servicing.

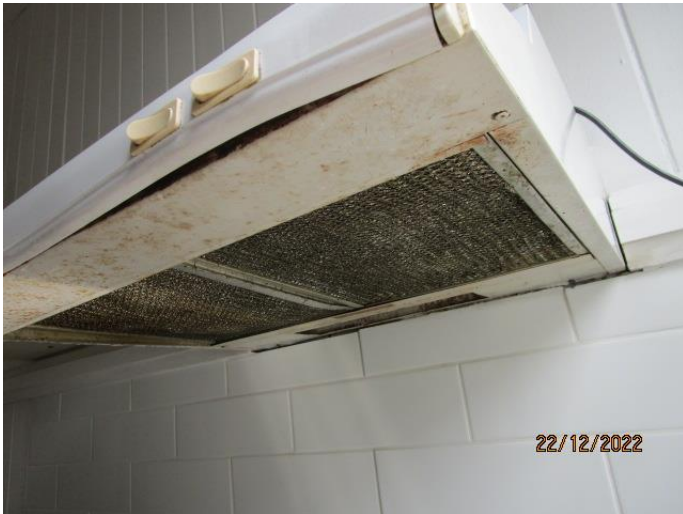
47.

The range hood light requires replacement. The grease catcher requires repairs or replacement. The front panel does have a buckle.

3. Although the appliances function, we still recommend they are serviced.
4. The range hood requires maintenance. The range hood requires a new light and the grease catcher requires upgrading.

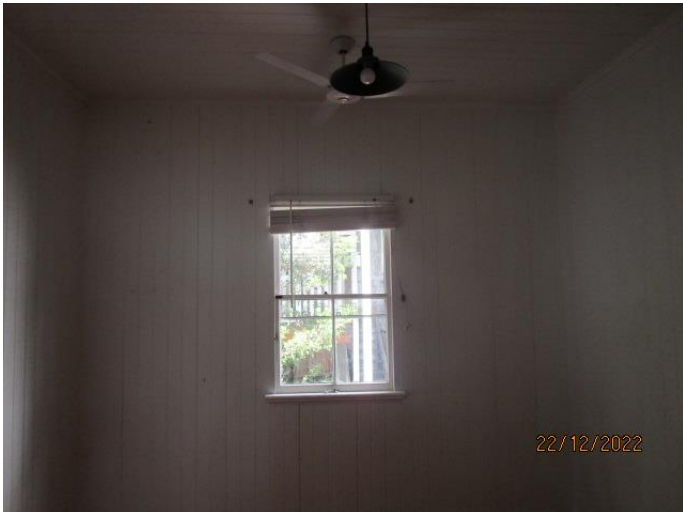
48.

This bedroom is in good condition. The windows require servicing.

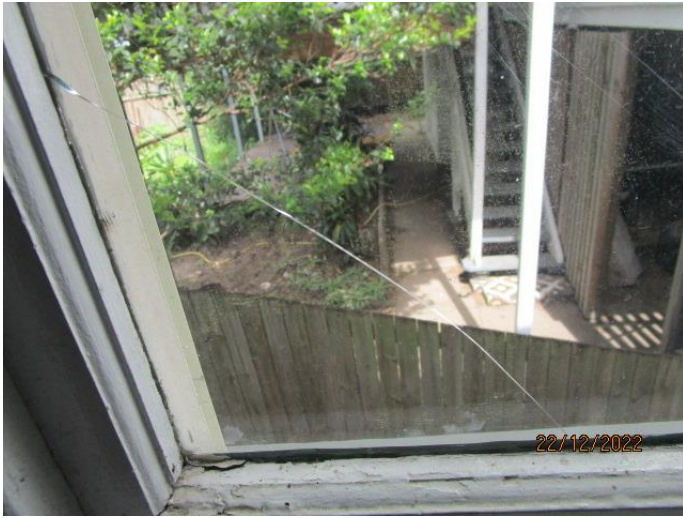
49.

The window requires one new glass panel.

7. One glass panel in the third bedroom requires replacement as it is cracked.
8. All timber joinery windows and doors require servicing and adjusting.
9. The home has imperfections but there is no evidence of any major damage. In the photographs and comments I have made observations of items are require general maintenance and minor repairs.

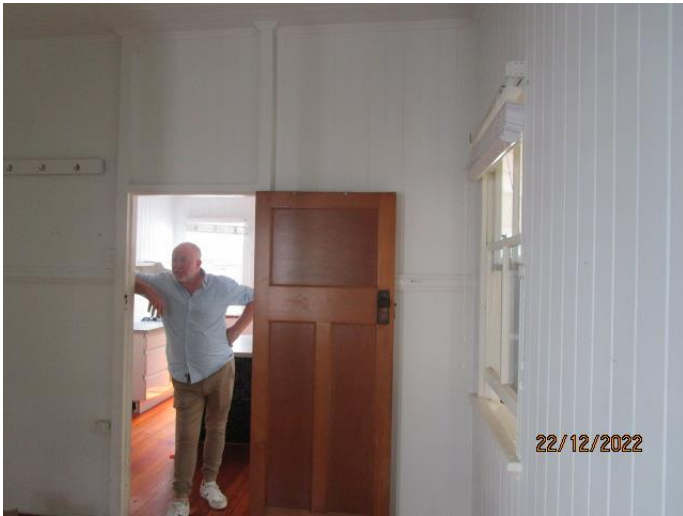
50.

The bedroom doors function well.

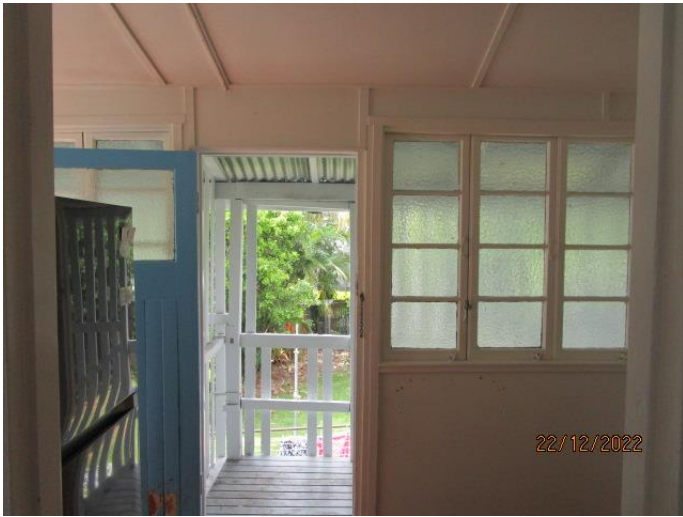
51.

I'm standing in the historical rear door exit. The door has been removed. This is just an observation. A new door has been installed in the enclosed balcony area.

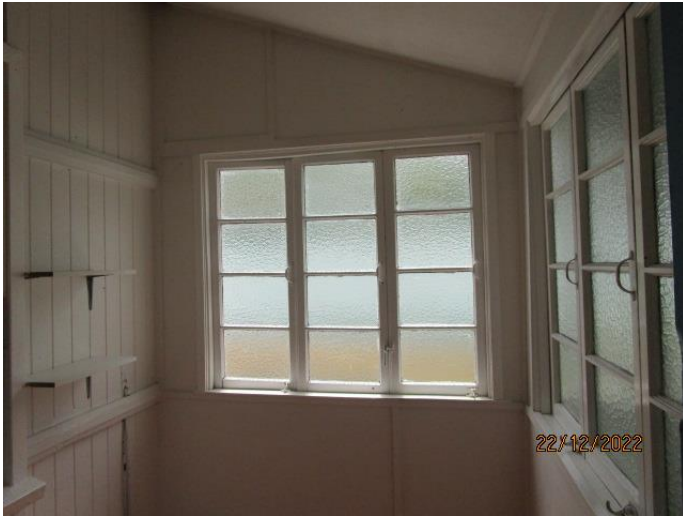
52. The enclosed balcony area was in good condition.

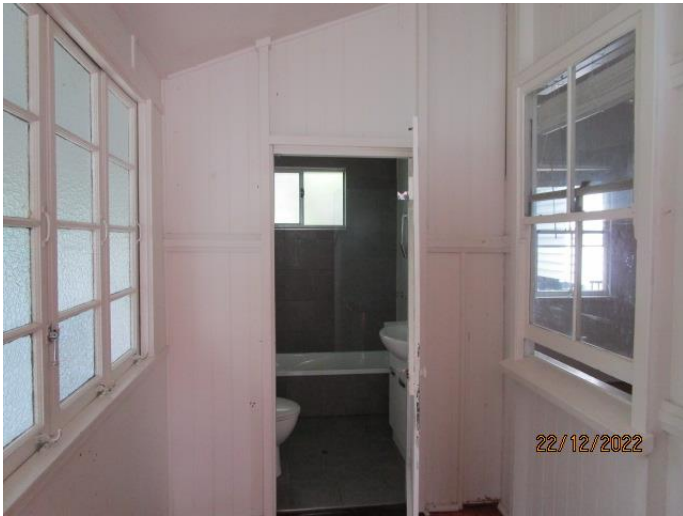
53. The enclosed balcony area houses the bathroom.

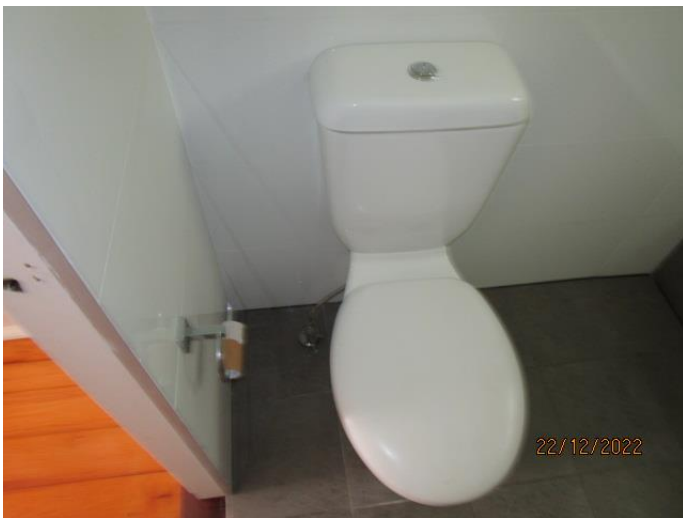
54. The toilet flushed and refilled.

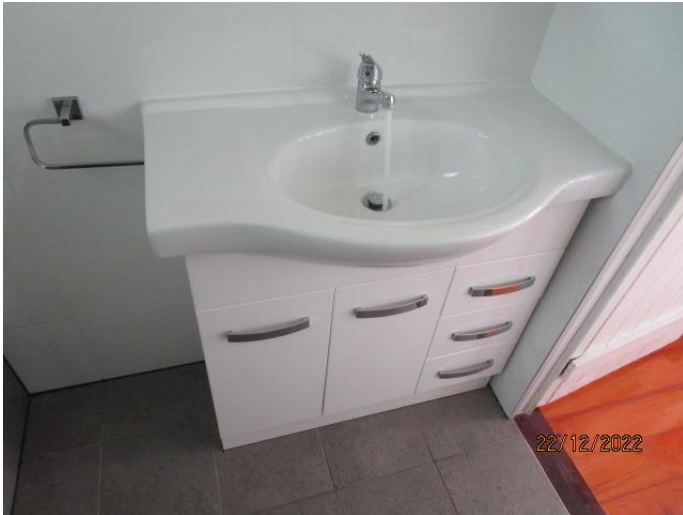
55. The vanity sink and tap had no leaks. The cabinet was in good condition.

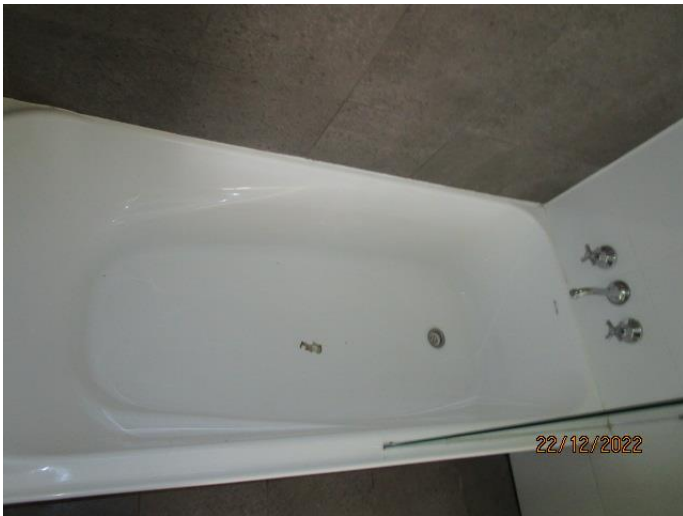
56. The bath plumbing functions. Underneath the bath has evidence of a water leak. This was not leaking at the time of the inspection.

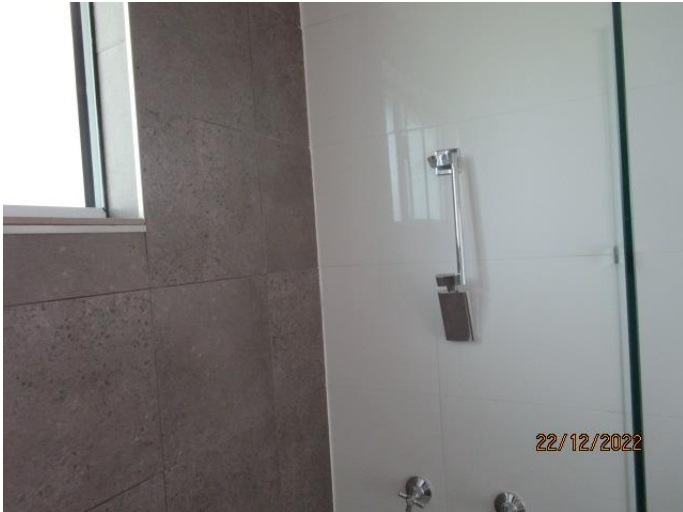
57. The shower plumbing functions.

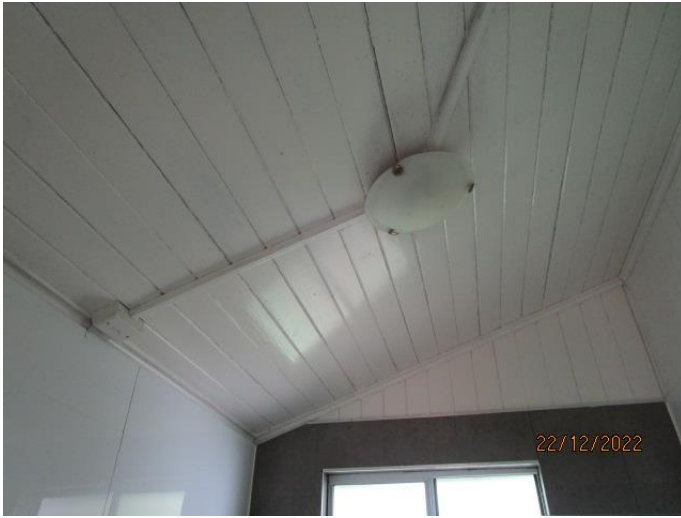
58.

The ceilings were in quite good condition.

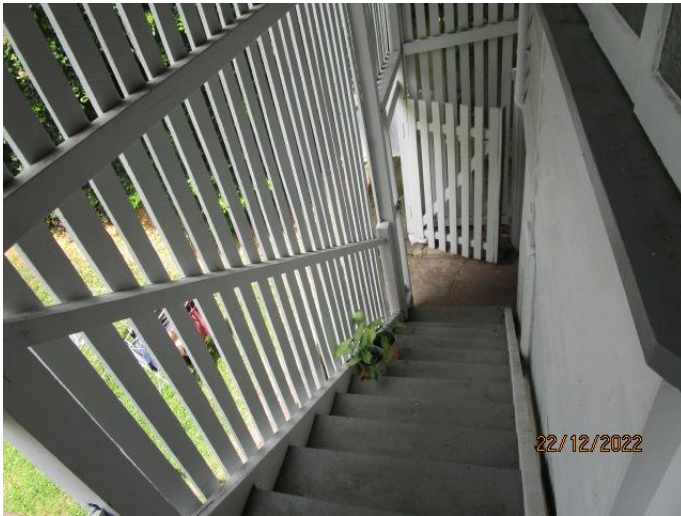
59.

The rear stairs are in quite good condition.

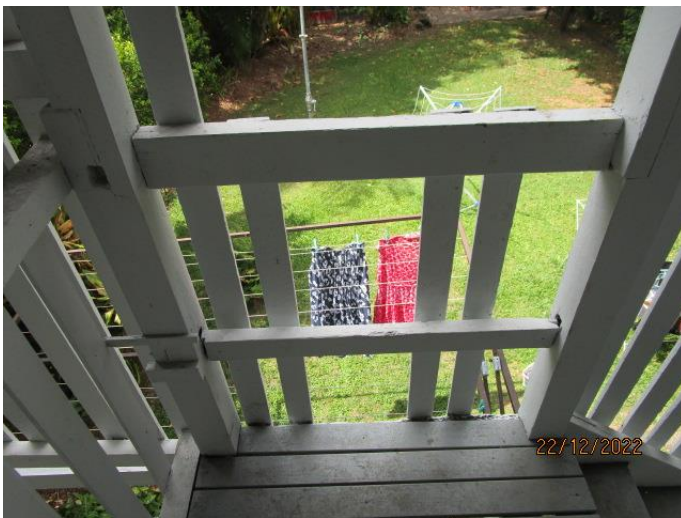
60.

The balustrade of the rear of the home requires upgrading as it is considered a fall hazard in its current form.
