# BUILDING AND PEST INSPECTION REPORT

Address: 7 Bates Court, East Brisbane

Date: December 22, 2022.

This home has 3 bedrooms, 1 bathroom and 2 car spaces.

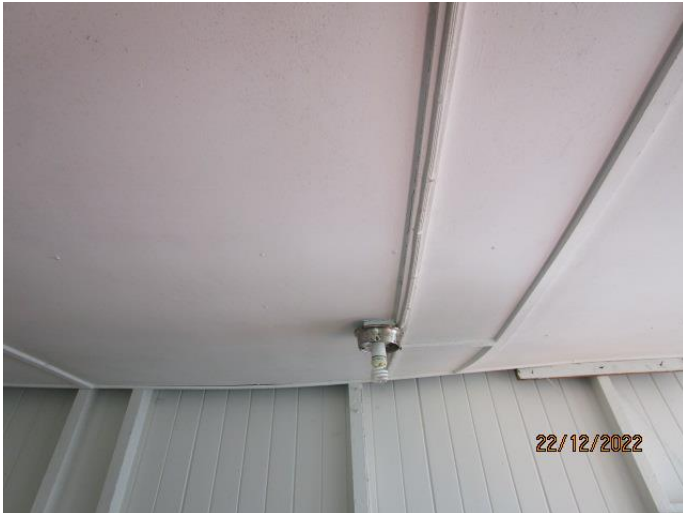
61. The ceiling in the enclosed balcony central area has released itself. This requires pushing back up with additional nails and screws.

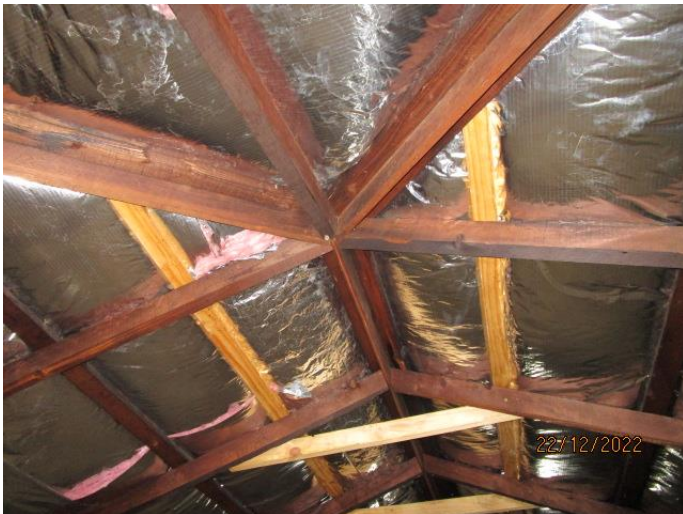
62. The roof structure was in very good condition. There is a moisture barrier and installation underneath the roofing iron.

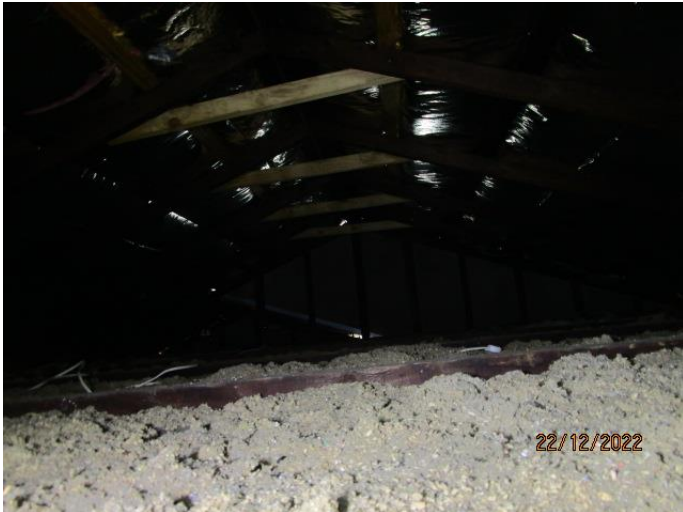
63. The ceiling is also insulated.

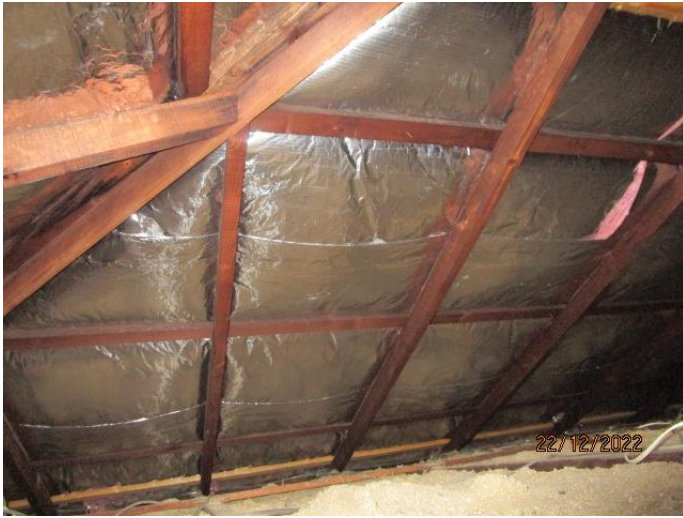
64. The roof structure is in very good condition.

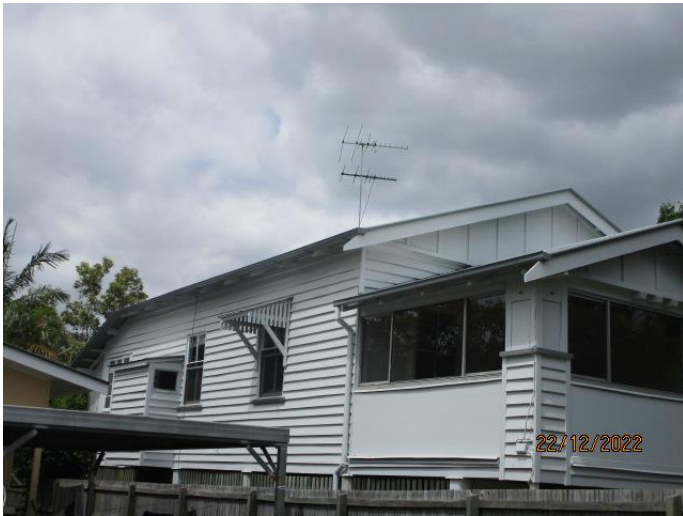
65. The exterior of the home in general was well presented. There are some imperfections but there is no evidence of any major damage.

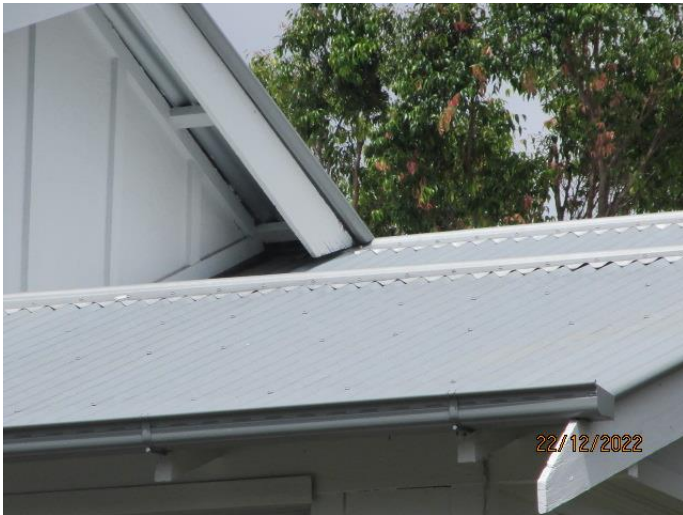
66. The roof is in very good condition.

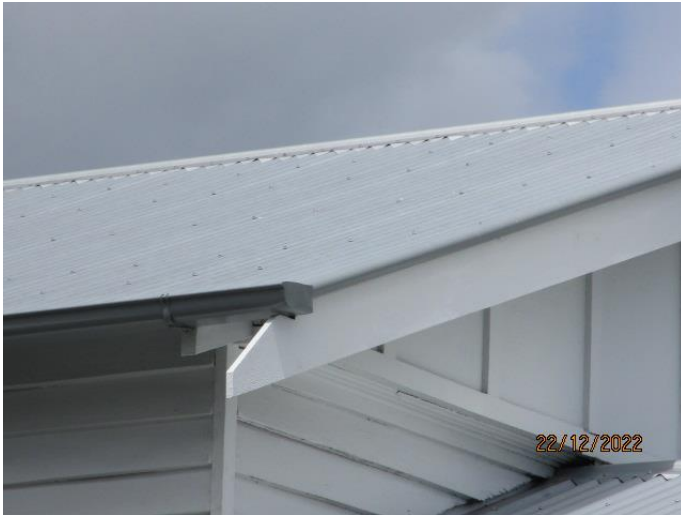
67.

The roof is in very good condition.
