# Condition Report

**CSR LTD**  
*WA380-5 / H50383*

<b>Case Number</b>	R1389790
<b>Date</b>	02/11/2022
<b>Equipment</b>	Wheel Loader
<b>Model</b>	WA380-5
<b>Serial No.</b>	H50383
<b>S.M.R</b>	13693

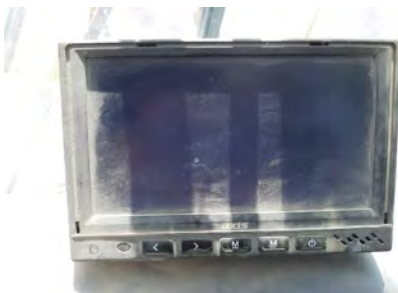
Machine camera's

Rear camera monitor displays no image, further investigation and repair recommended
