## Used Sale Safety & Compliance Check

MHE-000298 / 123458 / Melbourne Service / 27/04/2026 /  
Jungheinrich / ETR335D

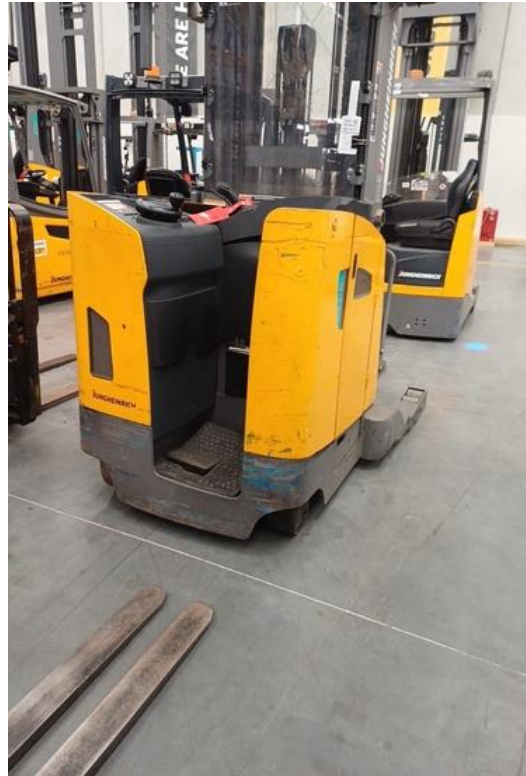
Photo 6

**Include Images of the Front, Rear & Sides of the Unit**

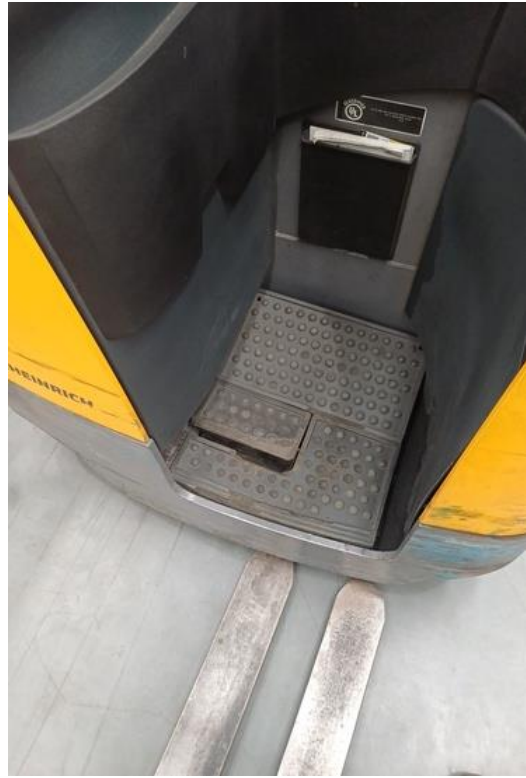
Photo 14

**Foot switch allows operation only when depressed**

Yes

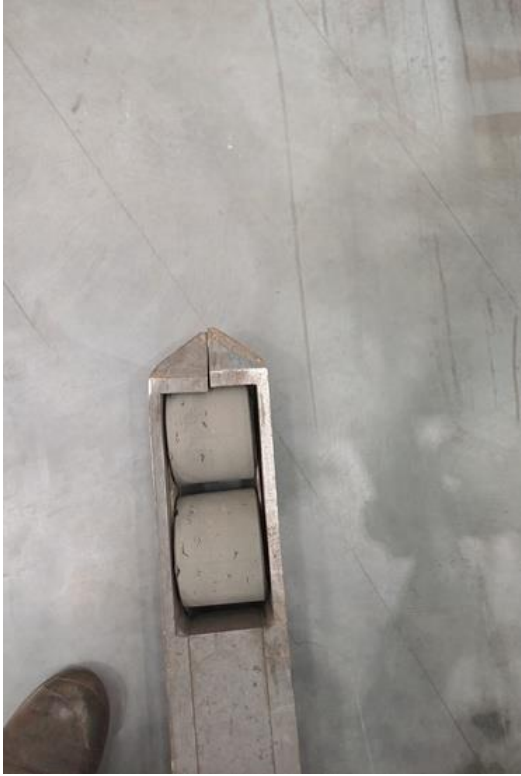
Photo 18

**Are tyre treads within limits and/or free from damage?**

Yes

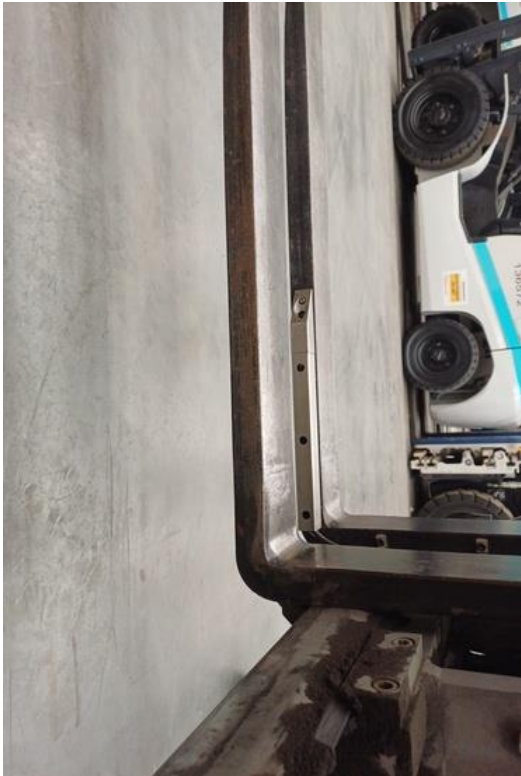
Photo 19

**Are fork tynes in good condition and within specification?**

Yes
