CERTIFICATE OF INSPECTION AND TESTING OF "TOWER CRANE" **MAJOR INSPECTION / ASSESSMENT**

Type of Crane:	Favelle Favco Tower Crane	Certificate No:	18 / 066 / 1
Crane Manufacturer:	Favelle Favco P/L	Crane Model:	120RX
Crane Serial No:	917	Year of manufacture:	1996
Plant Registration No:	N/A	Rebuilt:	2018
		Precision Crane Inspections NDT Report No:	5272-02

INSPECTION REPORT

Client:	RIGCON ENGINEERING 16 Chester Rd Altona VIC 3018	Report No:	5272-01
Location of Crane:	Chester Road, Altona	Date of Inspection:	06, 30 & 31 st May 2018
Description of Crane:	9T FAVCO Tower Crane	Model Number:	120 RX
Plant Identification:	917	Serial Number:	917
Clients Order No:	917	Requested by:	Mr J. Williams
Request No:	Not Applicable	Surface Preparation:	Coated Item: <484µm Cal: 484µm
Client's Job No:	Not Applicable	Criteria Specific Clause:	Not Applicable
Acceptance Spec.:	Clients Requirements - Nil Cracking Permitted		
Material:	Carbon Steel - Not Further Specified		
Test Specification:	ISO17643, UT03.1, AS1171		
Test Procedure:	ET01.2, UT03.1, MT02.4		
Technicians:	Ken Darby - Certified ET, UT, MT, AS3998/ISO9712

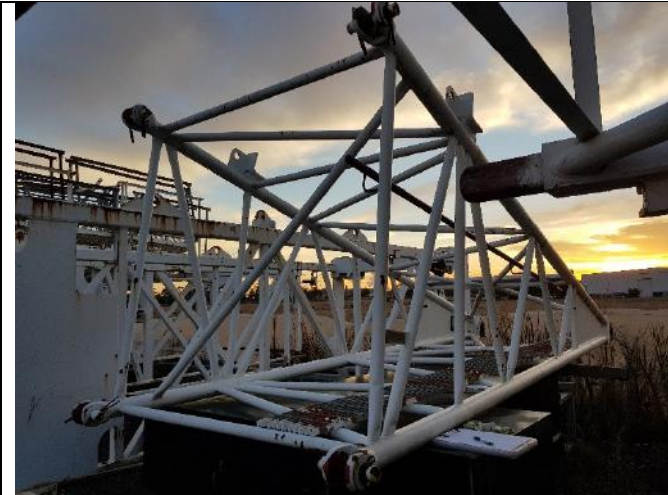
Figure.1 Butt Section 917/1

Component	NDT Inspection	Area of inspection	Result
917/1 Butt Section	Eddy Current Inspection	4 off Head Connection Point Weldments (100%) 2 off Butt Connection Point Weldments (100%) 10% of Lacing Weldments (near head connection)	No cracking detected
917/2 Intermediate Section	Eddy Current Inspection	4 off Head Connection Point Weldments (100%) 4 off Butt Connection Point Weldments (100%) 10% of Lacing Weldments (near head connection)	No cracking detected
917/3 Intermediate Section	Eddy Current Inspection	4 off Head Connection Point Weldments (100%) 4 off Butt Connection Point Weldments (100%) 10% of Lacing Weldments (near head connection)	No cracking detected
917/4 Intermediate Section	Eddy Current Inspection	4 off Head Connection Point Weldments (100%) 4 off Butt Connection Point Weldments (100%) 10% of Lacing Weldments (near head connection)	No cracking detected
917/5 Intermediate Section	Eddy Current Inspection	4 off Head Connection Point Weldments (100%) 4 off Butt Connection Point Weldments (100%) 10% of Lacing Weldments (near head connection)	No cracking detected

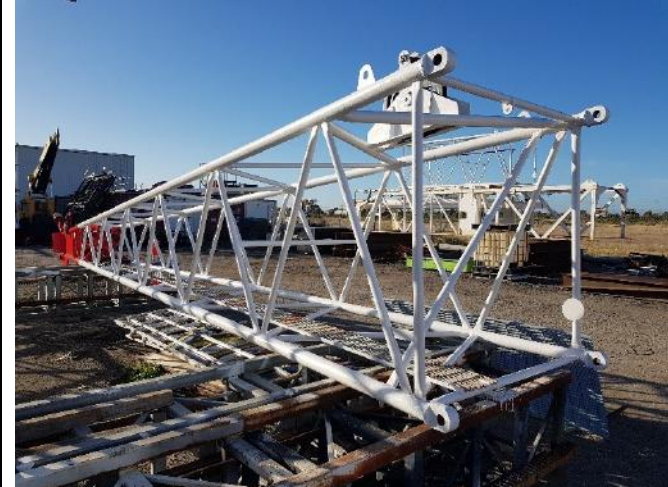
Figure.11 Tip Section 917/6

917/6 Tip Section (Head)	Eddy Current Inspection	4 off Butt Connection Point Weldments (100%) Idler Sheave Mount Weldments Head Area Weldments – where accessible Pennant Connection Pad-eye – attachment welds	No cracking detected

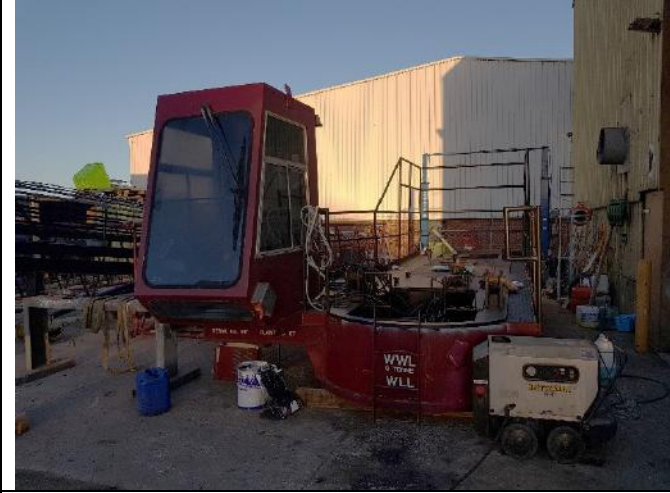
Figure.15 Machine Deck

Component	NDT Inspection	Area of inspection	Result
Machine Deck	Eddy Current Inspection	A-Frame Connection Points - 4 off Connection Pad-eye Weldments Slew Ring Mount Weldment - accessible weldment Operators Cap Support to Slew Mount	No cracking detected
A-Frame	Eddy Current Inspection	Connection End Point Weldments - where accessible Pennant (solid) Connection Pad-eye Weldments - where accessible Support Bracing Weldments - where accessible Main Top Head Weldment - where accessible	No cracking detected
Mounting Frame (Rigcon-01)	Eddy Current Inspection	Main Structural Weldments (100% of accessible) Pad-Eye Attachment Weldments (100% of accessible) Slew Mount Weldment (100% of accessible)	No cracking detected
Starter Tower #1	Eddy Current Inspection	Connection Point Weldments (100% of accessible) Support Lacing Weldments (100% of accessible)	No cracking detected
Connection Pins (Boom)	Ultrasonic Inspection	1-6 @ 225mm in Length 7-10 @ 250mm in Length 11-14 @ 225mm in Length 15-18 @ 225mm in Length 19 @ 250mm in Length 20 @ 225mm in Length	No transverse cracking

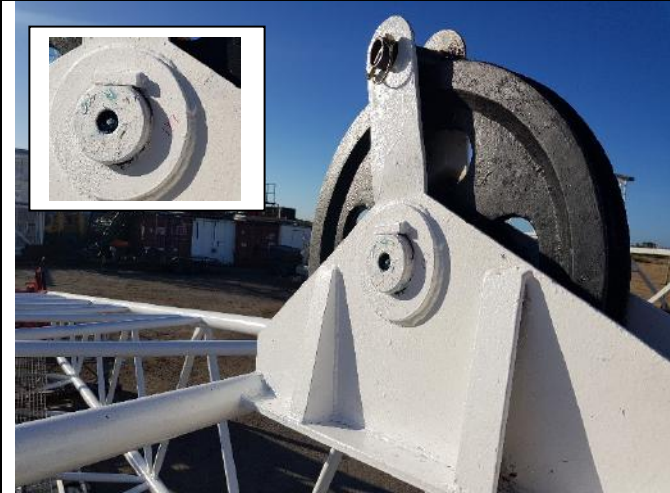
Figure.38 Boom Tip (Idler Sheave Shaft)

Boom Tip	Ultrasonic Inspection	Head Sheave Shaft @ 625mm in Length Pennant Pins (2 off) @ 130mm in Length Idler Sheave Shaft @137mm in Length (Butt Area)	No transverse cracking
Monkey	Ultrasonic Inspection	Sheave Shaft (2 off) @122mm in Length	No transverse cracking
Slew Bolts	Ultrasonic Inspection	#1 to #47 Slew Bolts @ average length 216mm #48 to #68 Slew Bolts @ average length 216mm	No transverse cracking

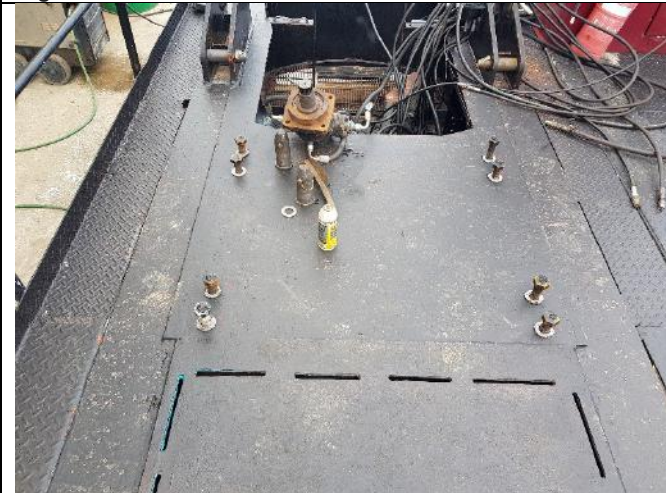
Figure.46 Winch Pack Mounting Bolts

Component	NDT Inspection	Area of inspection	Result
Winch Pack	Ultrasonic Inspection	#1 Mounting Bolt @ 100mm in length #2 Mounting Bolt @ 100mm in length #3 Mounting Bolt @ 100mm in length #4 Mounting Bolt @ 110mm in length #5 Mounting Bolt @ 128mm in length #6 Mounting Bolt @ 105mm in length #7 Mounting Bolt @ 119mm in length #8 Mounting Bolt @ 100mm in length	No transverse cracking
Hook SWL 16t (#S57561)	Magnetic Particle Inspection	Inner radius of Hook and Saddle	No cracking detected
