**Professional Independent Boat Inspection**

# Boat Condition Overview - GRAYS

Raeline 185 Bowrider

10.02.2026

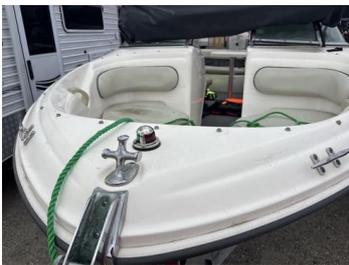
Photo 11

Gelcoat oxidization - recommend cut and polish

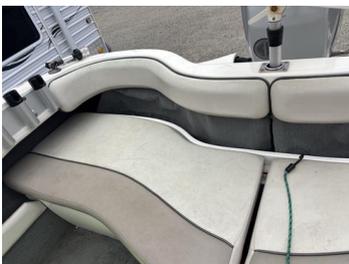
Photo 12

Nominal wear and tear from UV, aligned with age of vessel

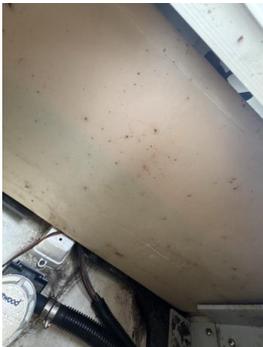
Photo 20

Satisfactory

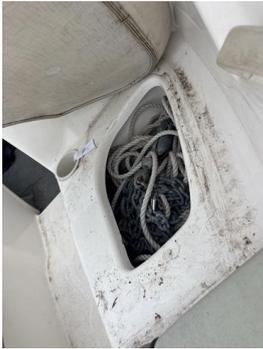
Photo 21

Starboard bow under seat has mud/dirt - would clean now

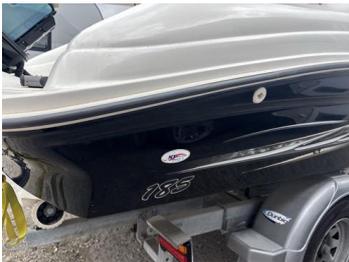
Photo 24

No damage noted, very minor scratches on underside of Boat

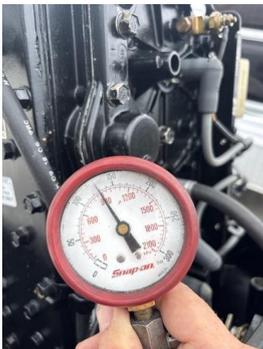
Photo 41

130 psi cold

accept

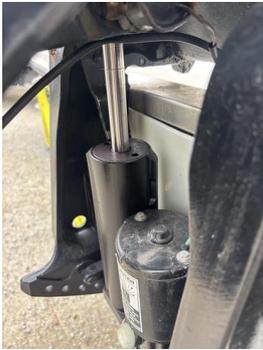
Photo 48

Slightly due to lack of use that operating clean and freely

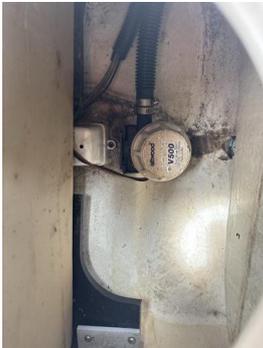
Photo 64

Poor

Pump not operating

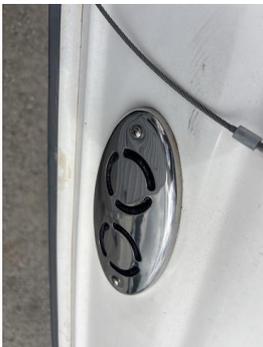
Photo 73

Poor

not operating
