MARINE INSPECTION
SURVEY REPORT

Motor Vessel : “Reel-Hab”

Surveyed : Rosshaven Slipway, T'ville.

Date : 1/9/2022

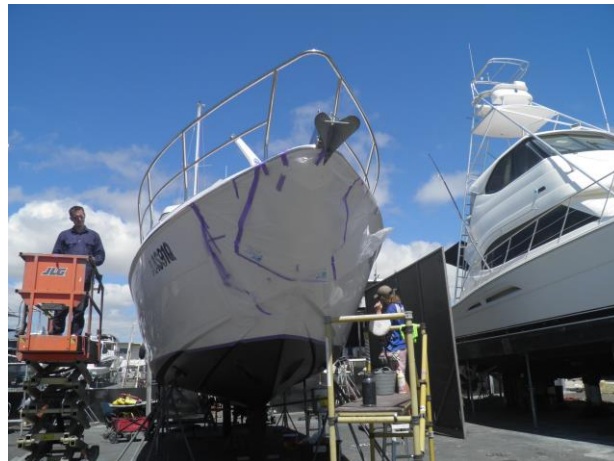
Single chine solid fibreglass hull in good condition.

Bulkheads glassed to hull, good condition.

Stem and stern posts : Solid fibreglass, good condition.

Deck construction : ½" fibreglass, good condition.

Hull to deck fastenings : fibre glass and s/steel bolts appear in good condition.

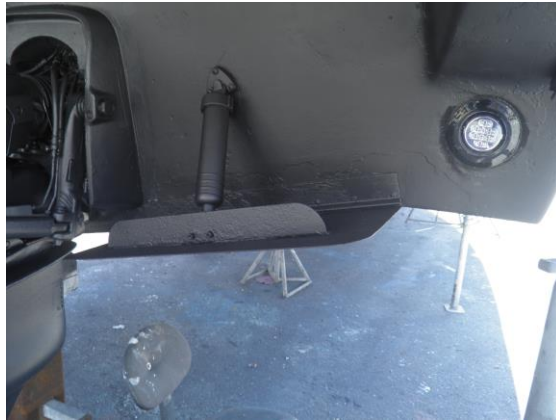
Newly antifouled.

Anodes, new.

The hull is in good overall condition, no osmosis.

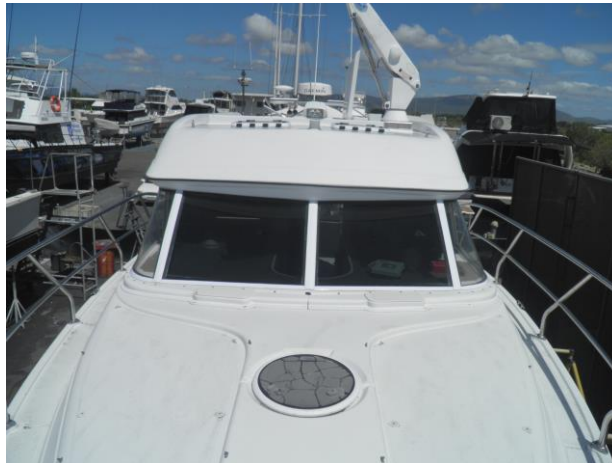
Stainless steel bow rail from pulpit to aft of mid-ships, good condition.

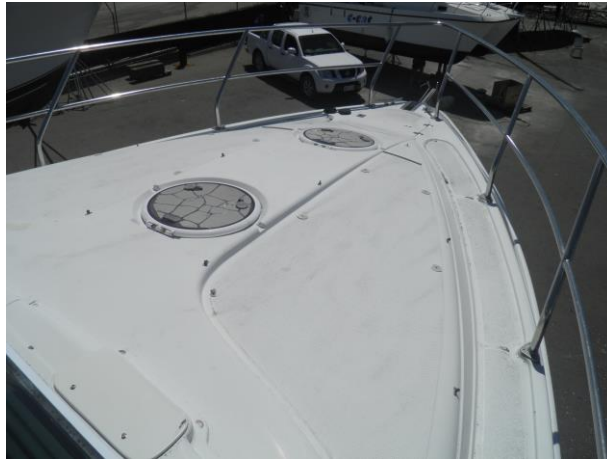
S/steel stanchions, well secured, good condition.
Fibreglass duck-board, good condition.

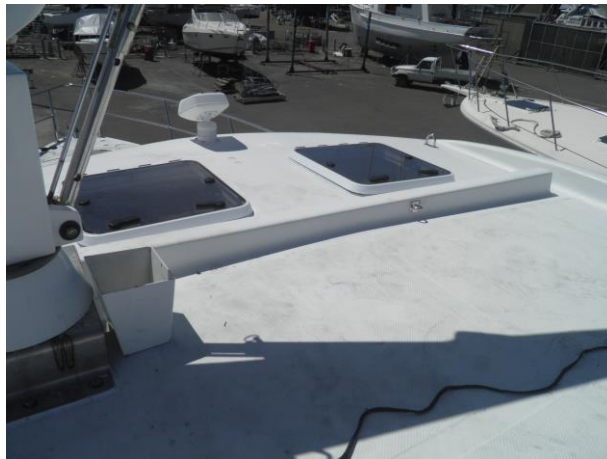
F/glass chain/anchor well hatches in good condition.

F/glass chain/anchor well hatches in good condition.
Chain locker in good condition.

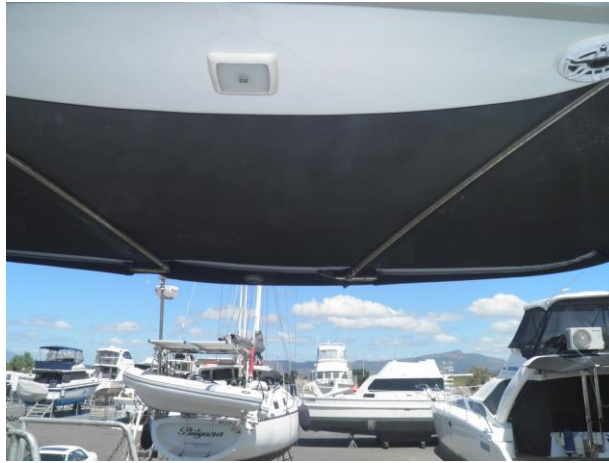
All deck fittings well secured and in good condition.
Non-skid decks.
S/steel frame and canvas aft deck/sun cover, good condition.
Fibreglass cockpit/aft deck in good condition.
ADC Crane in good conditionj

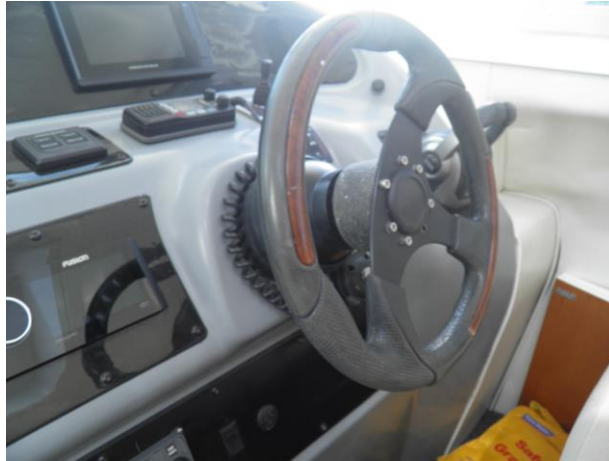
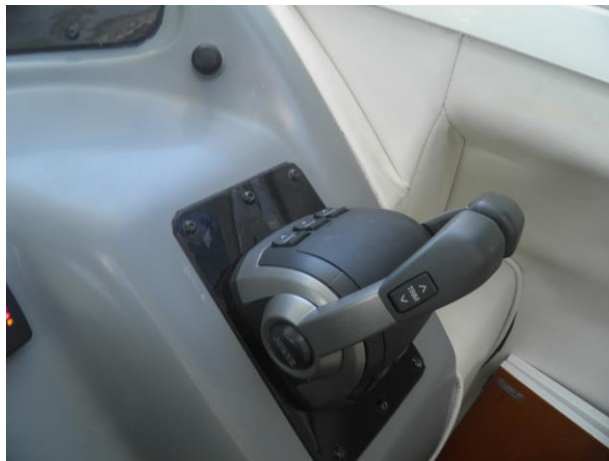
Alloy wheel helm in wheel-house.

Hydraulic.

Steering and associated fittings appear to be in good condition.

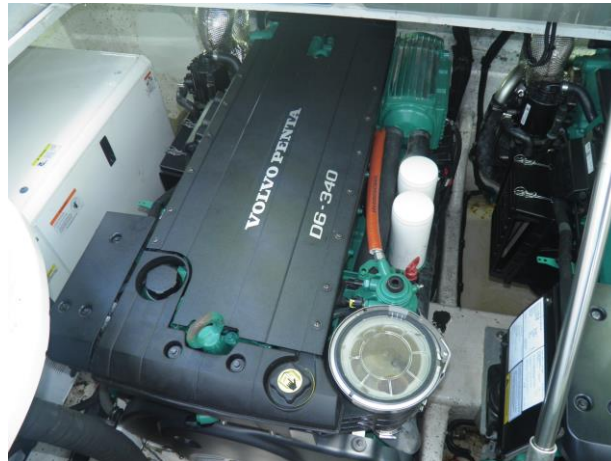
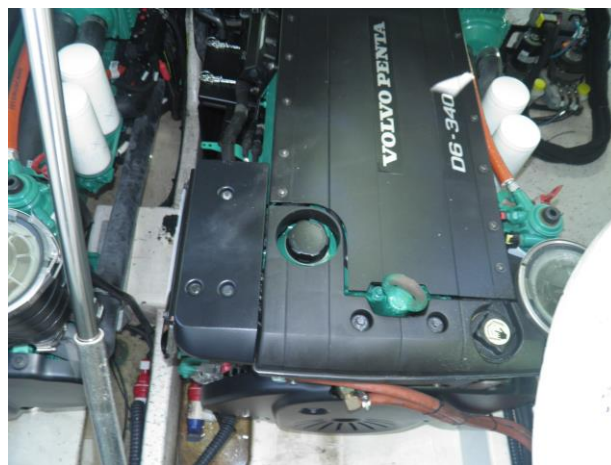
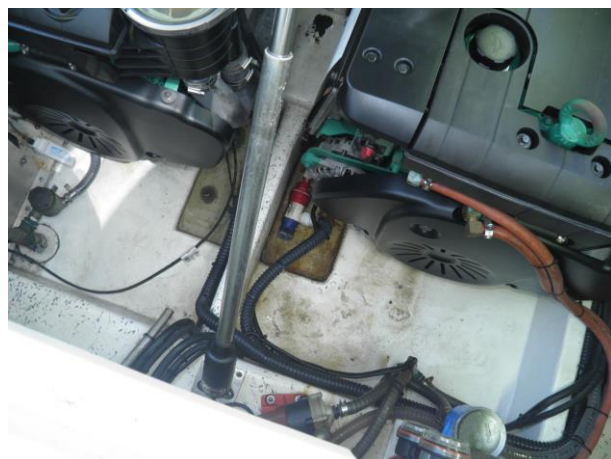
2 x Volvo D6 340hp fresh water cooled diesel engines.

No obvious water/fuel/oil leakage, engines & gearboxes appear in good condition.

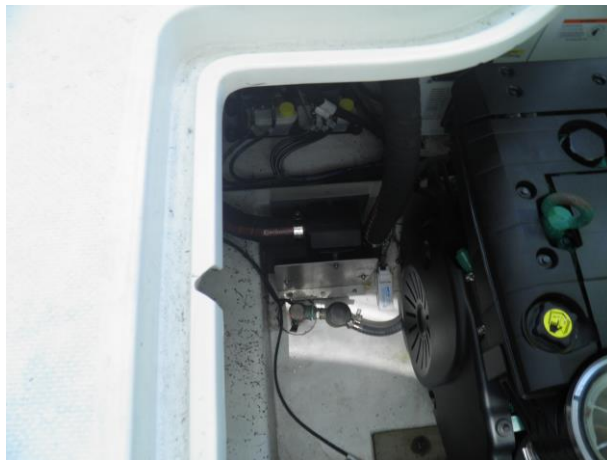
Engine mountings in good condition.

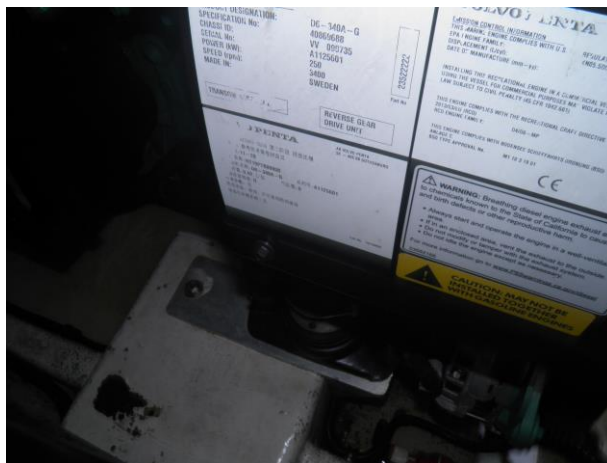
Exhaust and fuel systems in good condition.

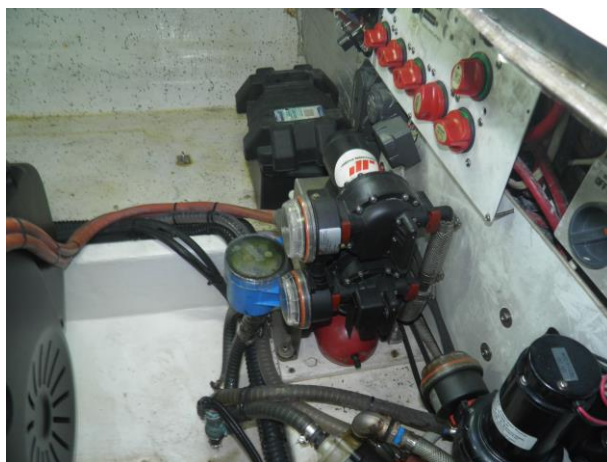
Engines bronze ball valves/shut-off valves, good condition.

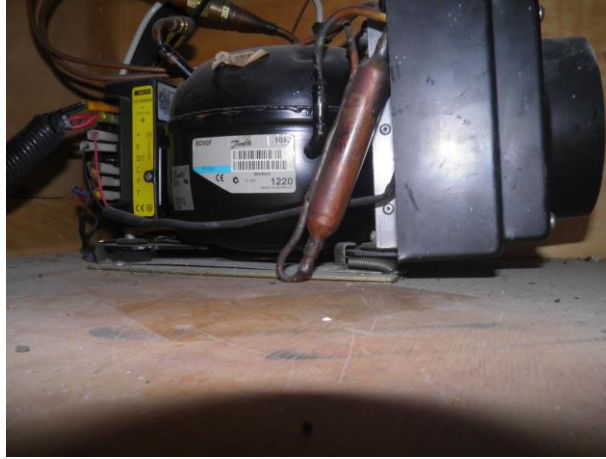
Kohler gen. set, good condition.

Danfoss refrigeration compressor appears in good condition.

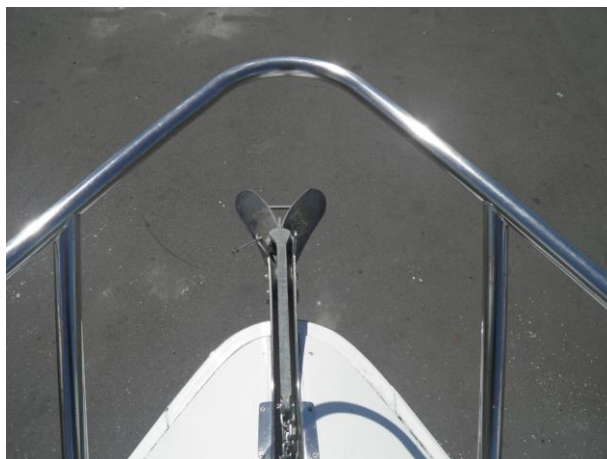
1 x 35lb. CQR anchor with 30m of 5/16" chain.

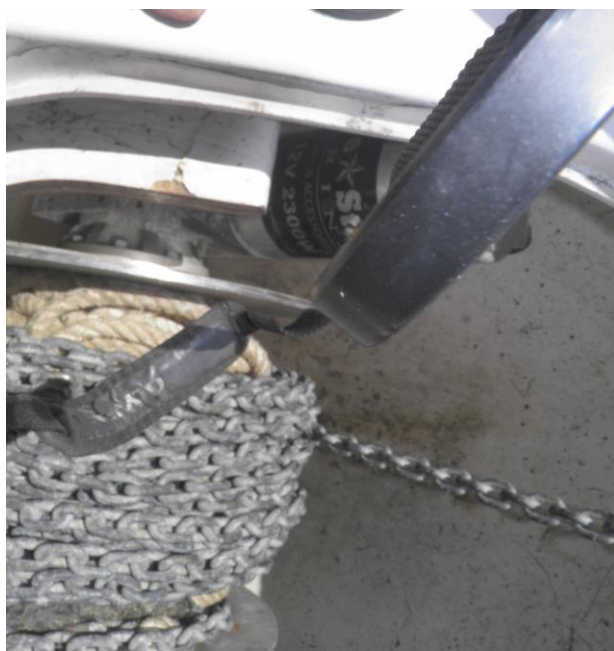
2 x reef picks with 80m 3/4" rope.
Star anchor winch, good condition.

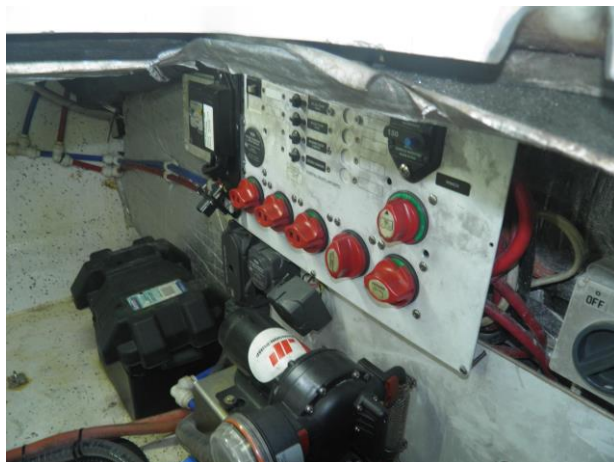
Batteries in good condition.
Isolating switches.

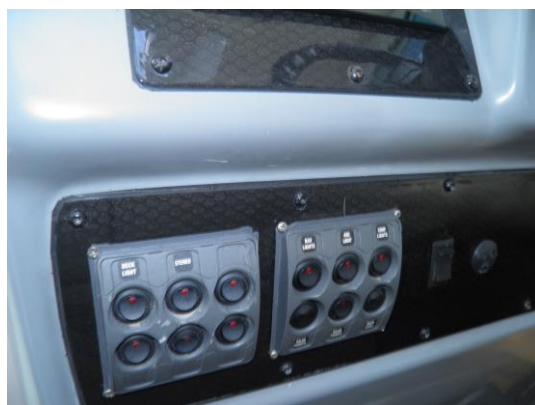
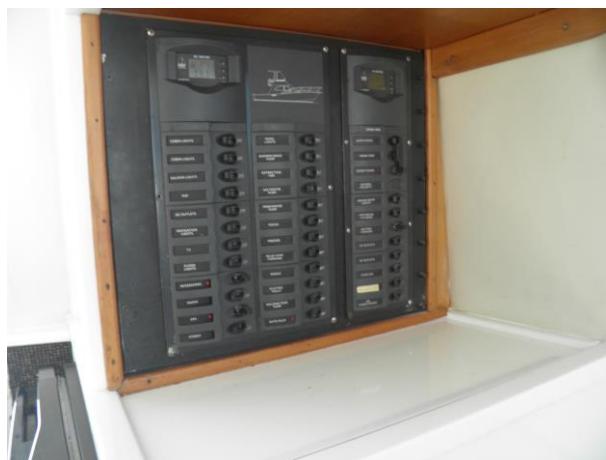
Wiring in good condition.

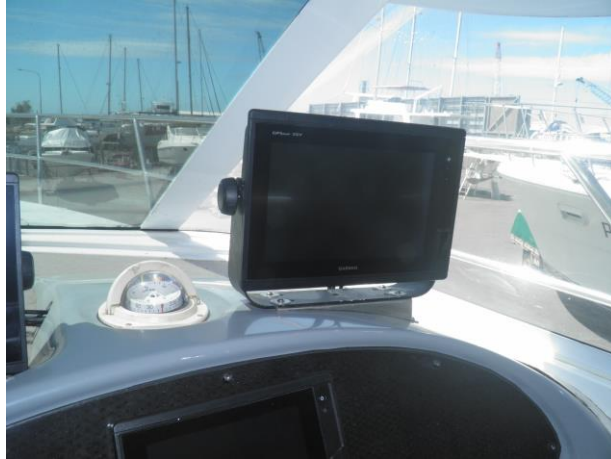
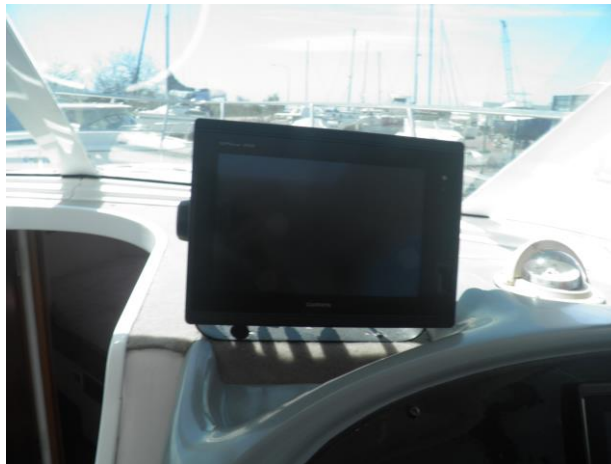
3" Ritchie compass in good condition.

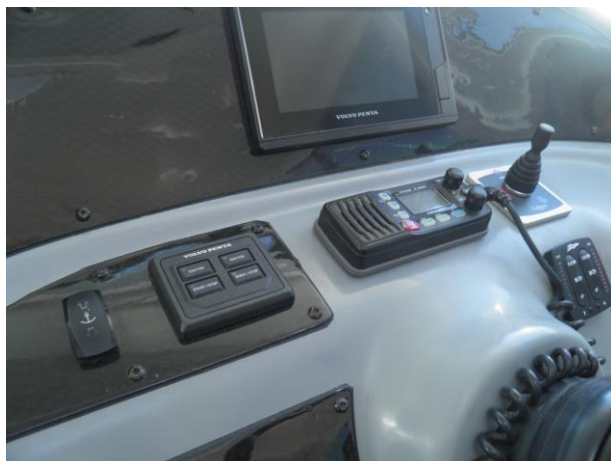
2 x Garmin depth sounder/plotter/GPS, working order.
Icom VHF radio, working order.

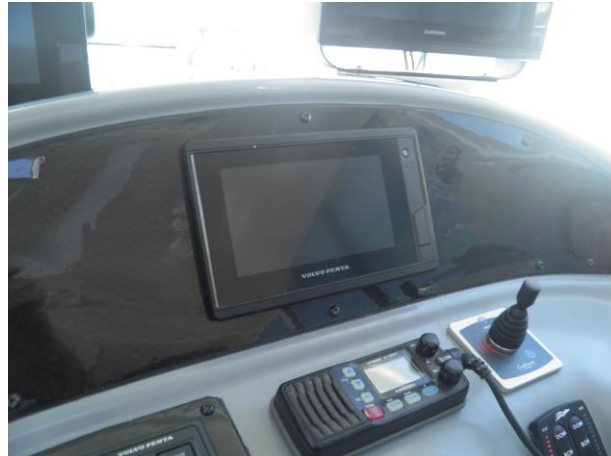
Instrument panels in good condition.
