R1 Building & Pest Inspections  
7 Laurel street  
Port Macquarie NSW 2444  
Tel: 0423207989  
r1buildingandpest@gmail.com

# Visual Timber Pest Inspection and Report in Accordance with AS 4349.3-2010

81 Matthew Mitchell Drive

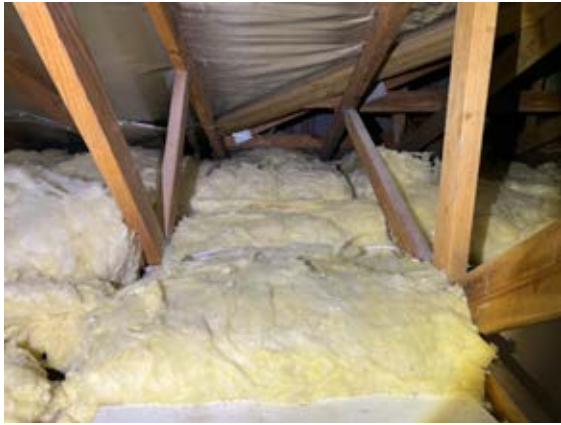
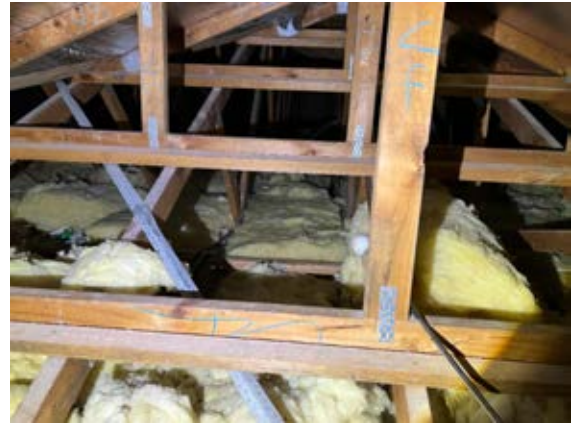
#### ACCESS ISSUE - Roof Void

<b>Access Issue Type:</b>	Restricted Access
<b>Reason(s) Why:</b>	Insulation, Pitch

Due to pitch of the saddle truss's and insulation access was restricted.

**Important:** If a complete inspection of the above areas was not possible, timber pest activity and/or damage may exist in these areas. Further Inspections are strongly recommended to areas where Reasonable Access is Unavailable, Obstructed or Restricted or a High Risk of possible Timber Pests and /or Damage exists.

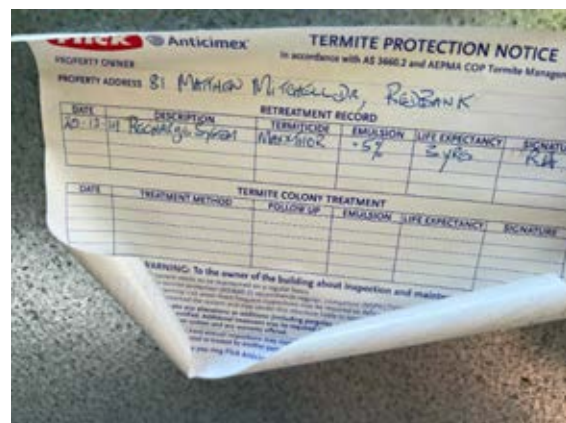
#### Image of Termite Management Sticker

Yes

Post-Construction

A termite management system has been installed by another company. It is recommended you consult that company for full details of the system installed.
