## Insurance Risk Survey

Bavaria, DS 29, 2004

Survey type:	Insurance Risk Survey
Survey No#:	IRS24113
Client:	[REDACTED]
	[REDACTED]
Inspection date:	13th November 2024
In-Water location:	Not Applicable, Inspected Out of Water Only.
Out-Water location:	SYC, Sandringham, Victoria

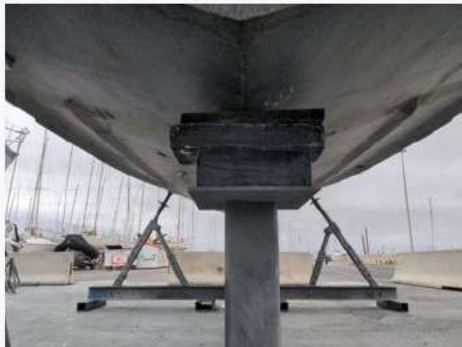
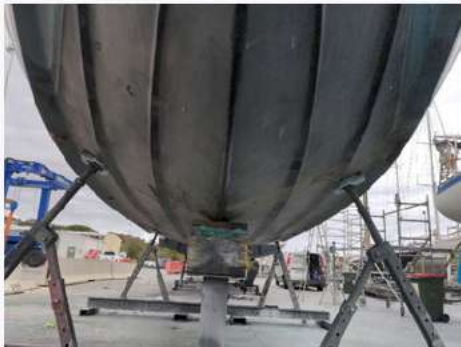
Ref # 2.1

Ref	Item	Material / Construction	Condition	Comments
2.1	Hull Bottom	FRP Composite	Sound	No damage or defect found to the hull bottom, appeared structurally sound throughout.
2.2	Keel	FRP Composite	Sound

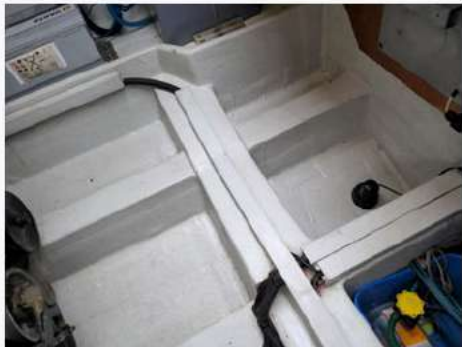
Ref # 2.4

2.3	Bulkheads	FRP Composite	Sound	
2.4	Hull stringers	FRP Composite	Sound	
2.5	Bilge	Flowcoat	Sound	Note: It is important to check all bilges prior and post vessel operation and immediately following vessel launch for water ingress as part of your standard operating procedures.
2.6	Transom	FRP / Timber Composite	Sound	
2.7	Hull side / Topsides	Gelcoat / FRP	Sound	
2.8	Gunnel	Rubber with Stainless Insert	Sound	White Ok ue oxidisation
2.9	Bow Stem	Gelcoat / FRP	Sound	
2.10	Skin Fittings	Plastic	Sound	
2.11	Swim platform	FRP Composite / Integral	Sound	
2.12	Antifouling	Black Ablative Application	Fair	Build up and flaking, currently being prepared for new antifoul while out of the water.

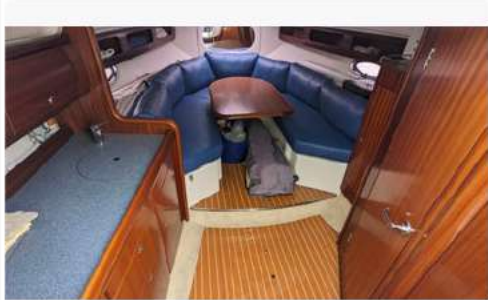
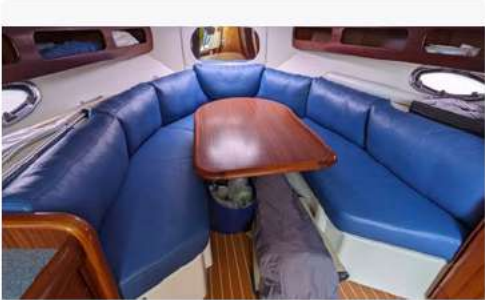
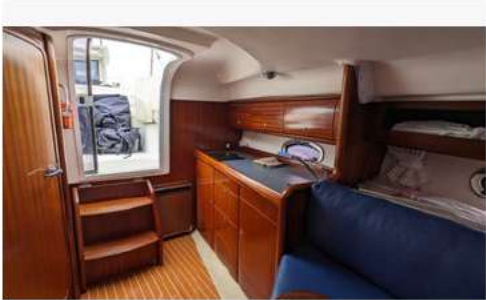
Ref #5

Ref	Item	Material / Construction	Condition	Comments
5.1	Interior Frames	FRP Composite	Sound	Vessel interior appear original and suitably maintained with only minor wear and tear present to commensurate with age.
5.2	Cabinetry & Fitout	Timber Veneer	Sound	
5.3	Headlining	Moulded Panels	Sound	
5.4	Cabin Sole	Timber Veneer	Sound	
5.5	Galley Fitout	Timber Veneer	Sound	
5.6	Seating & Upholstery	Leather	Sound

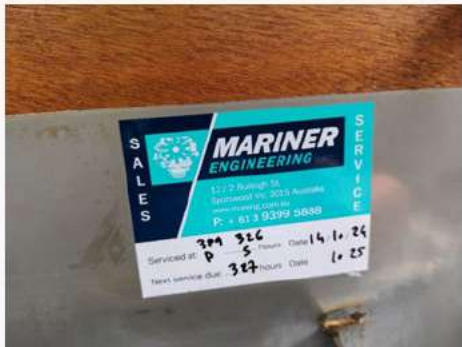
Ref # 7.1

Ref	Item	Type / Make	Condition	Comments
7.1	Engine Block	Volvo Penta	Sound	4.3 liter, 225 horsepower V-6 raw water cooled, fuel injected marine petrol engine.;  Appears to have good service history.

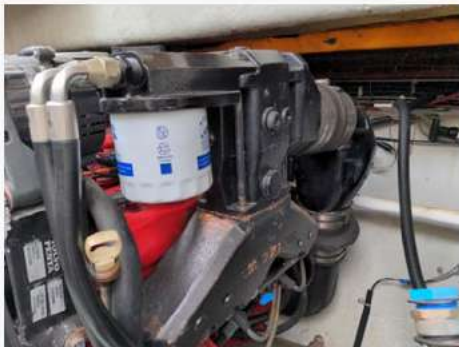
Ref # 7.3

7.2	Sump	Pressed Steel	Sound	
7.3	Manifolds	Cast	Sound	Some light surface corrosion present.
7.4	Fuel Delivery System	Fuel Injected	Sound	
7.5	Exhaust System	Reinforced Marine Hose	Sound

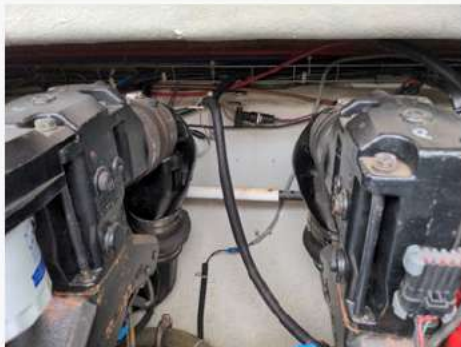
Ref # 7.6

7.6	Exhaust Riser / Elbow	Cast	Sound	Note: Exhaust manifolds and risers are a service item and require replacement as recommended by the manufacturer.
7.7	Serpentine Belt	Reinforced Rubber	Sound

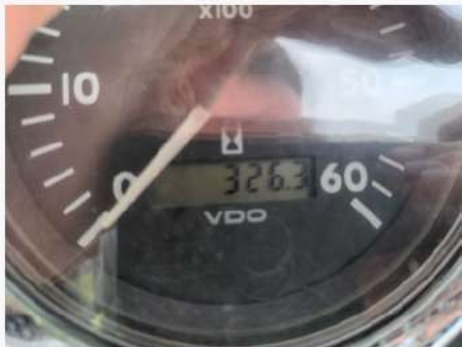
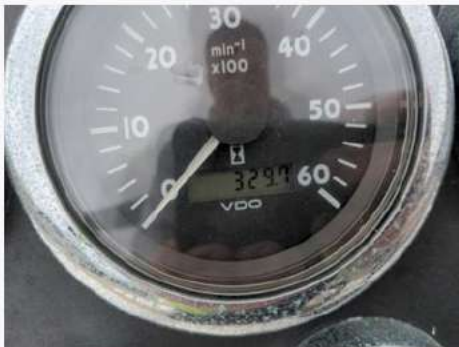
Ref # 7.23

7.18	Thermostat	Cast	Sound	
7.19	Throttle connections	Mechanical Terminals	Sound	.
7.20	Gear shift connections	Mechanical Terminals	Sound	
7.21	Throttle levers	Morse Type	Sound	
7.22	Engine bilge	Flow coat	Sound	
7.23	Engine Hours	Helm Gauge Reading	Sound	Stbd: 329 Port: 326
7.24	Engine Operation	Engine was not operated		<p>The findings reported are from a visual inspection only, no assessment has been made of the internal condition of the engine(s).;</p> <p>Access to some parts of the engine, driveline and exhaust system were restricted by fixed components and preclude inspection.</p>

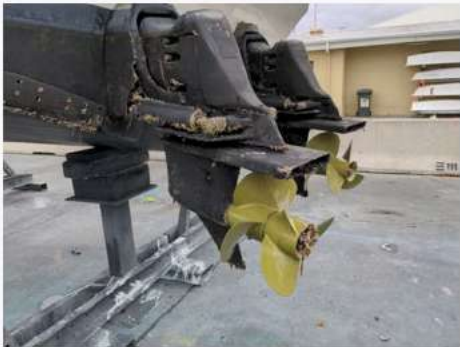
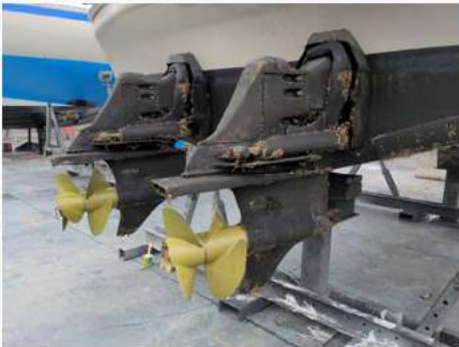
Ref # 8.1

Ref	Item	Type / Make	Condition	Comments
8.1	Type	Stem Drives	Sound	Appear in serviceable condition
8.2	Gear Box	MerCruiser	Sound	
8.3	Propellers	Stainless Steel	Sound	Duo props

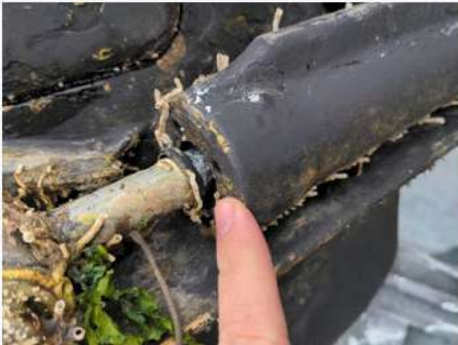
Ref # 8.7

8.4	Shaft	Stainless Steel	Sound	
8.5	Transom Shields	Cast Aluminium	Sound	
8.6	Steering Seal	Seal	Sound	
8.7	Leg Trim Rams	Hydraulic	Sound	Functional, end o-ring seals at loose.
8.8	Bellows	Rubbers	Sound	<p>Note: All sterndrive bellows have a limited service life and require regular service and replacement.;</p> <p>Please refer to manufacturers maintenance and service guidelines.</p>
8.9	Bonding	Wire	Sound	
8.10	Drive Anodes	Zinc or Aluminium	Sound	
8.11	Drive Coatings	Antifouling / Prop-speed	Sound

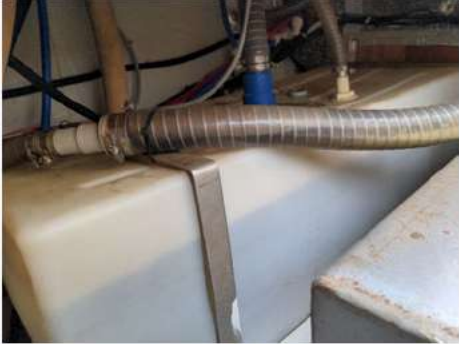
Ref # 11.2

Ref	Item	Type / Make	Condition	Comments
11.1	Fresh Water Pump	12-Volt	Sound	
11.2	Water Tank	Polyethylene or similar	Sound	Said to be 120 litre capacity
11.3	Plumbing / Hose	Reinforced Hose	Sound	
11.4	Sinks	Stainless Steel	Sound	
11.5	Showers	Head Shower	Sound	
11.6	Shower Drainage	12-volt	Sound	
11.7	Toilet / Head	Electric Flush	Sound	
11.8	Toilet Plumbing	Sanitation Hose	Sound

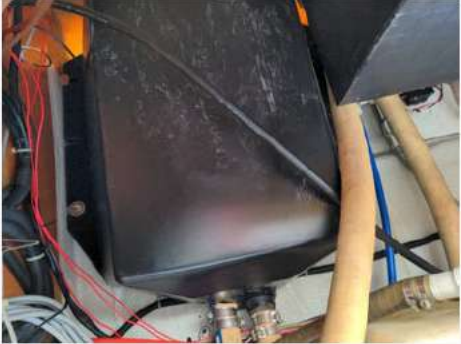
Ref # 11.10

11.9	Vented	Vented Loop	Sound	
11.10	Holding Tank	Polyethylene or similar	Sound	Small holding tank fitted.

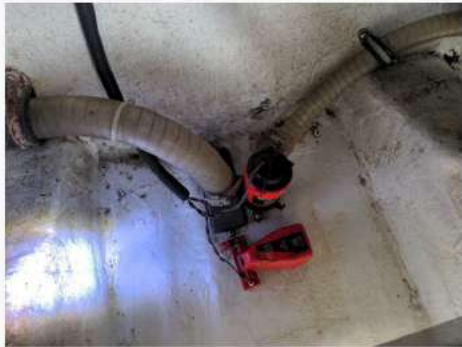
Ref # 14.1

Ref	Location	Number / Type	Comments
14.1	Aft Pump/s	1 x 12-Volt	powered up with automatic float.
14.2	Manual Hand Pump	Whale	Serviced from the Cockpit
