PRE-PURCHASE STANDARD PROPERTY & TIMBER PEST REPORT

Report number: 425

Inspection date: 7 October, 2021

Property address: 26 Constitution Crescent, Alexandra Hills, Qld 4161

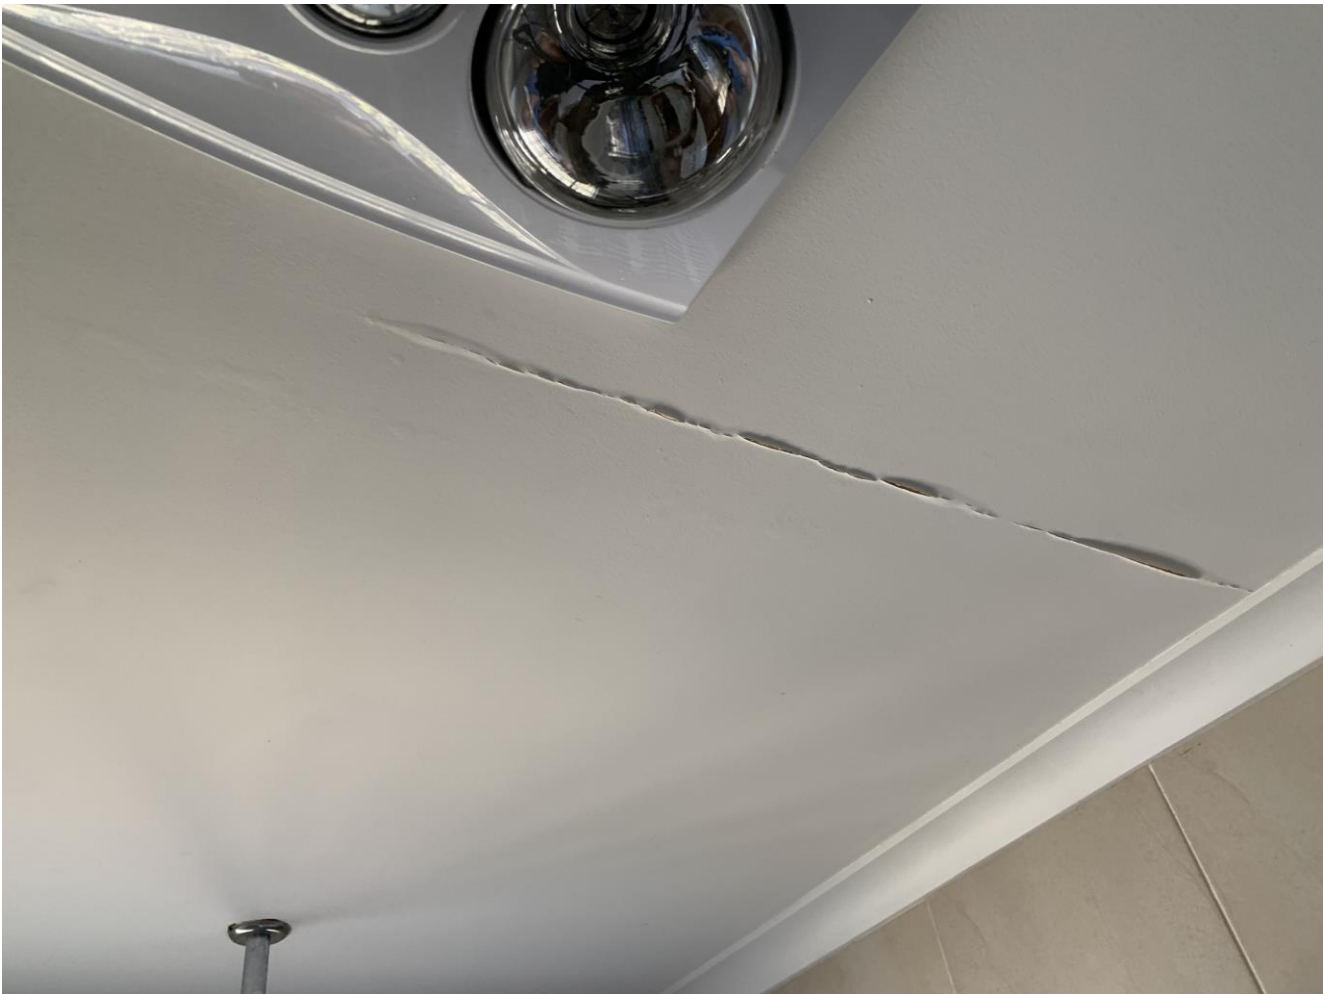
Crack to the ceiling of the bathroom due to building movement - repairs recommended recommend seek further advice from a licenced and practicing plasterer

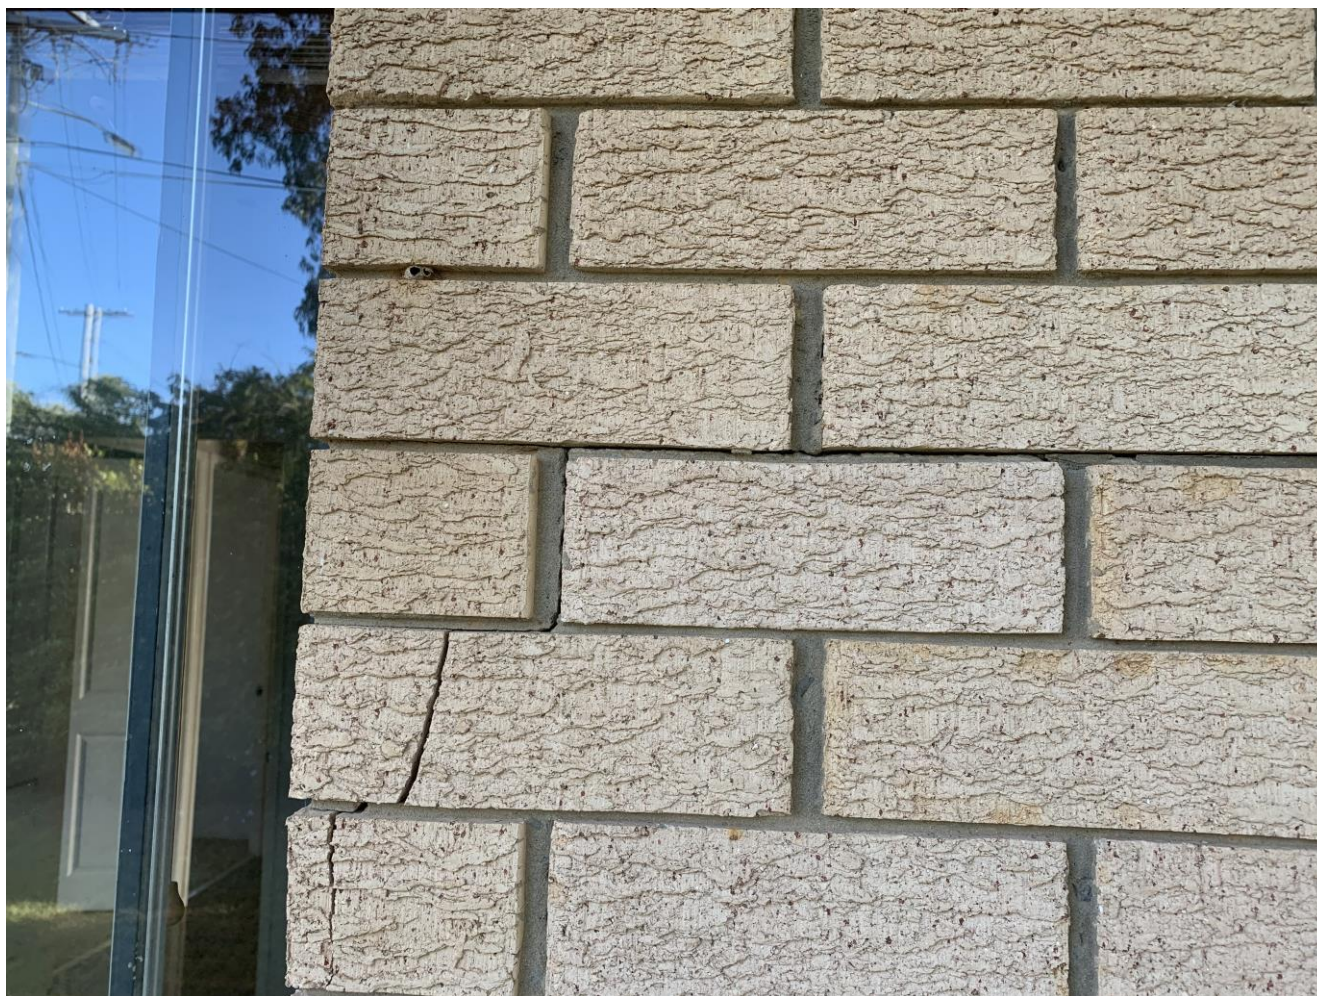
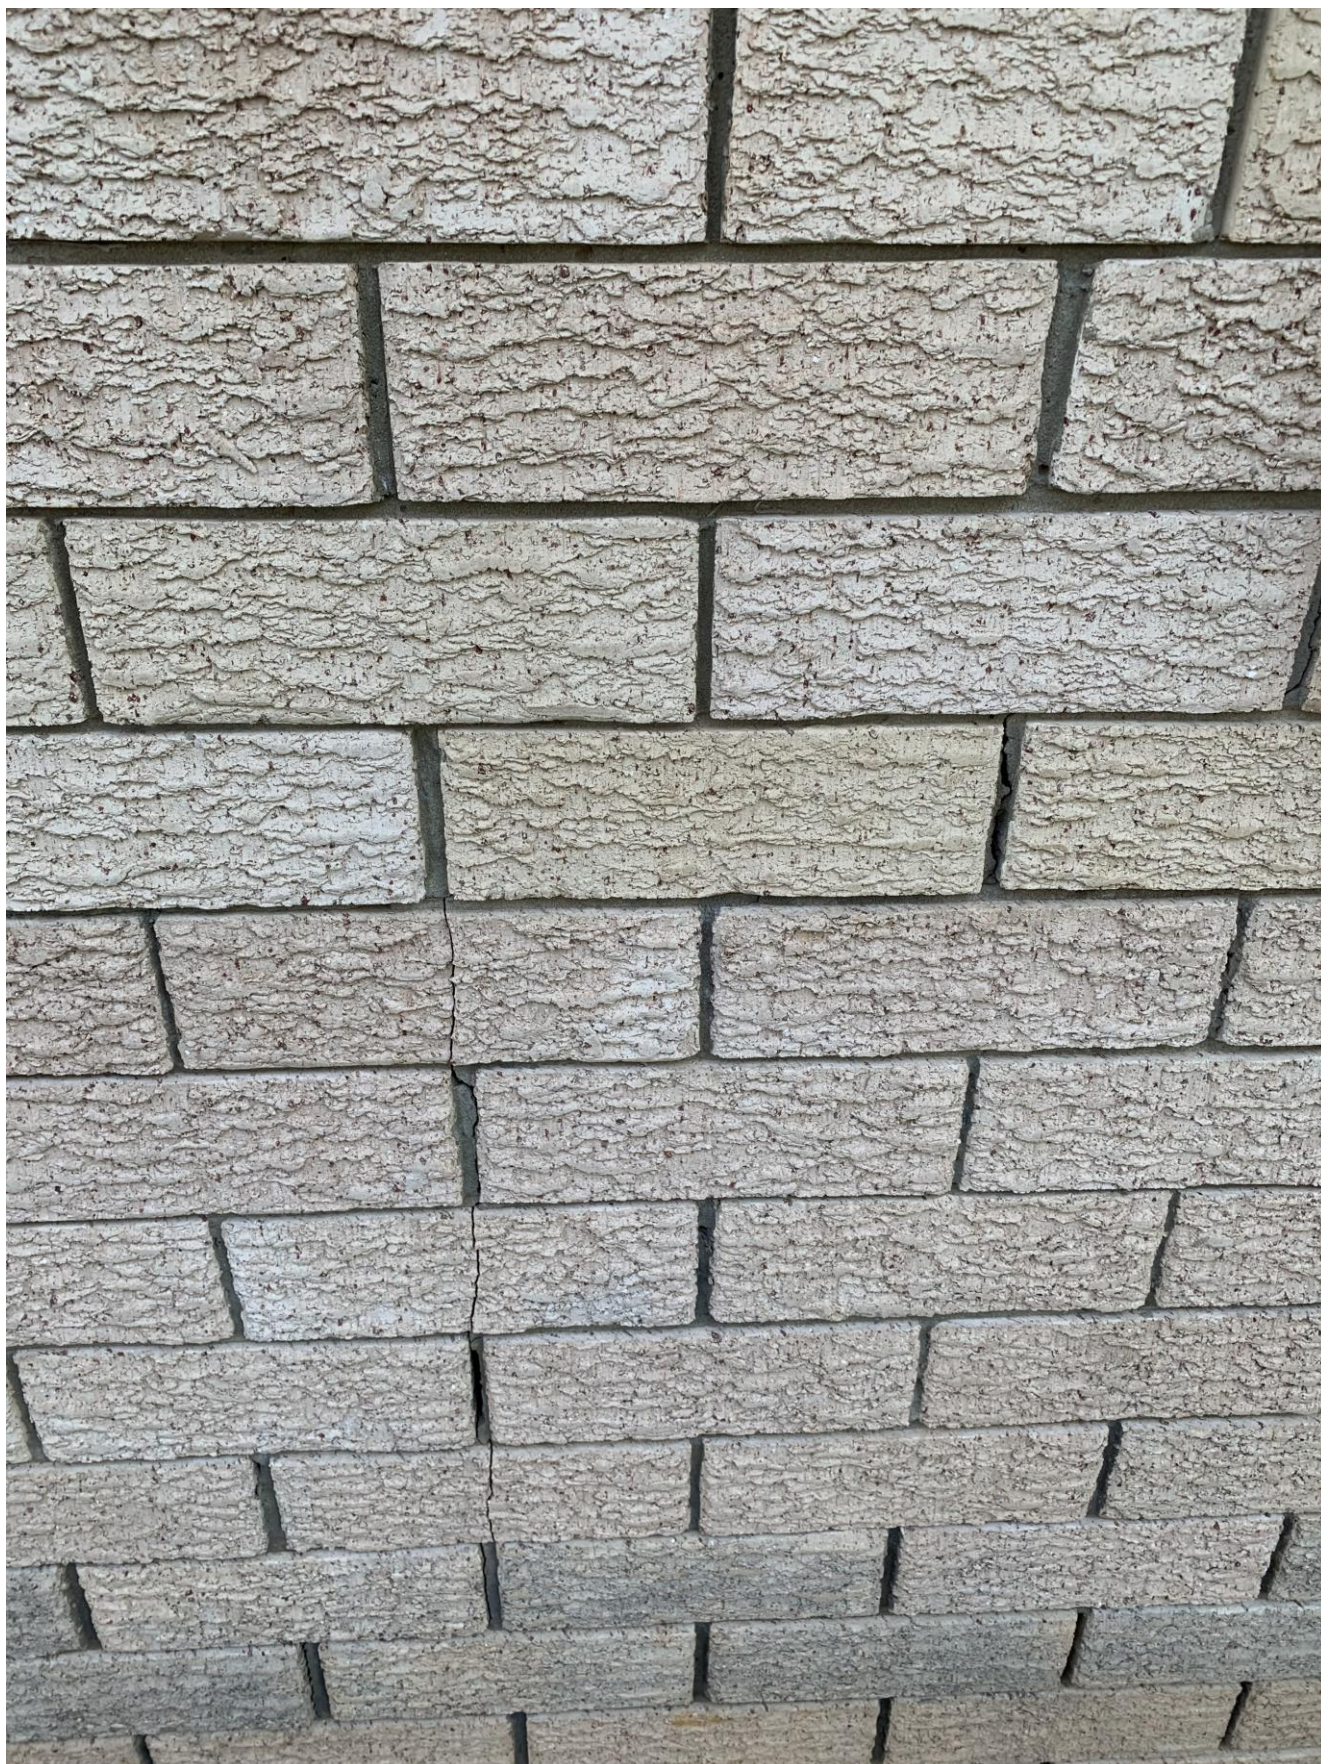
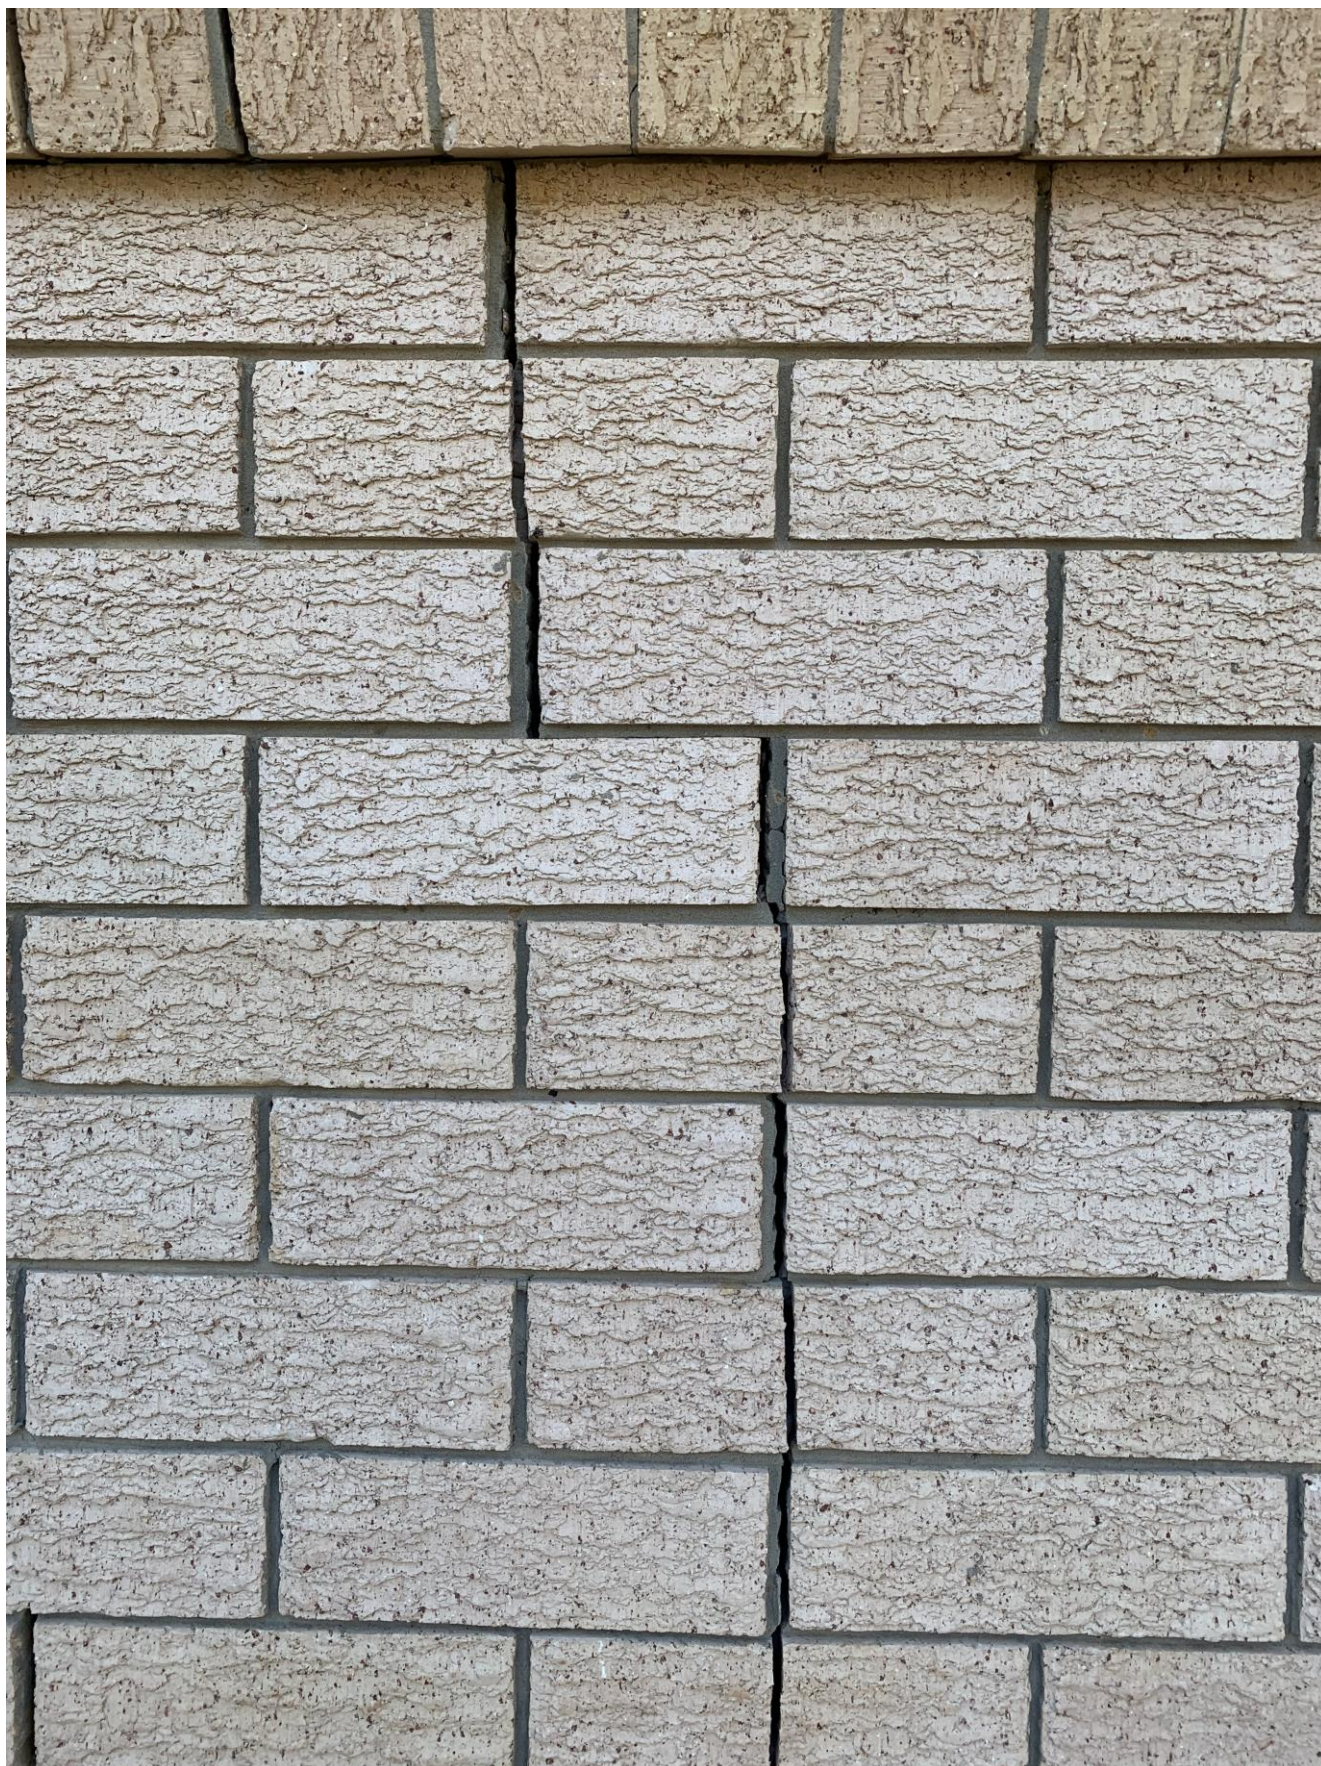
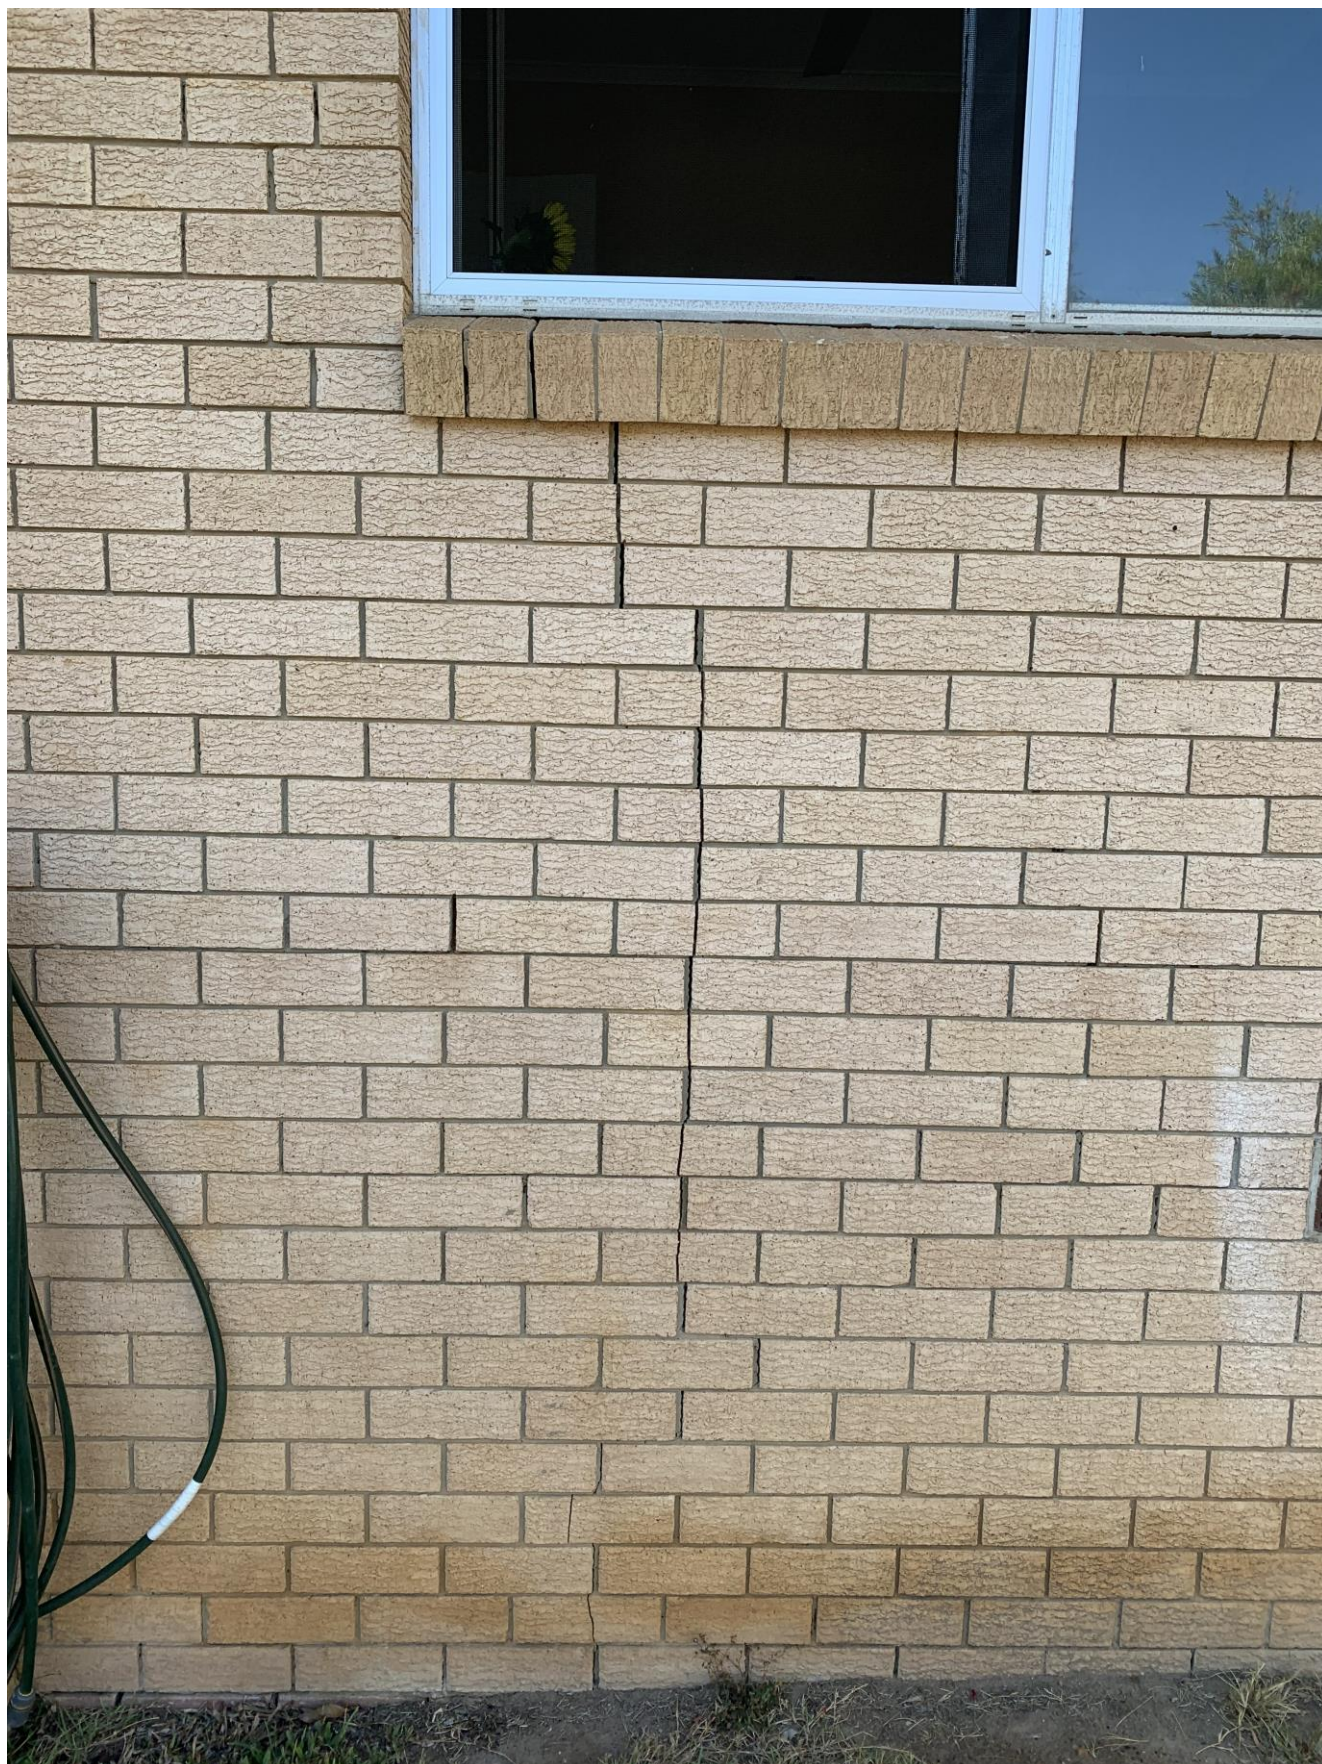
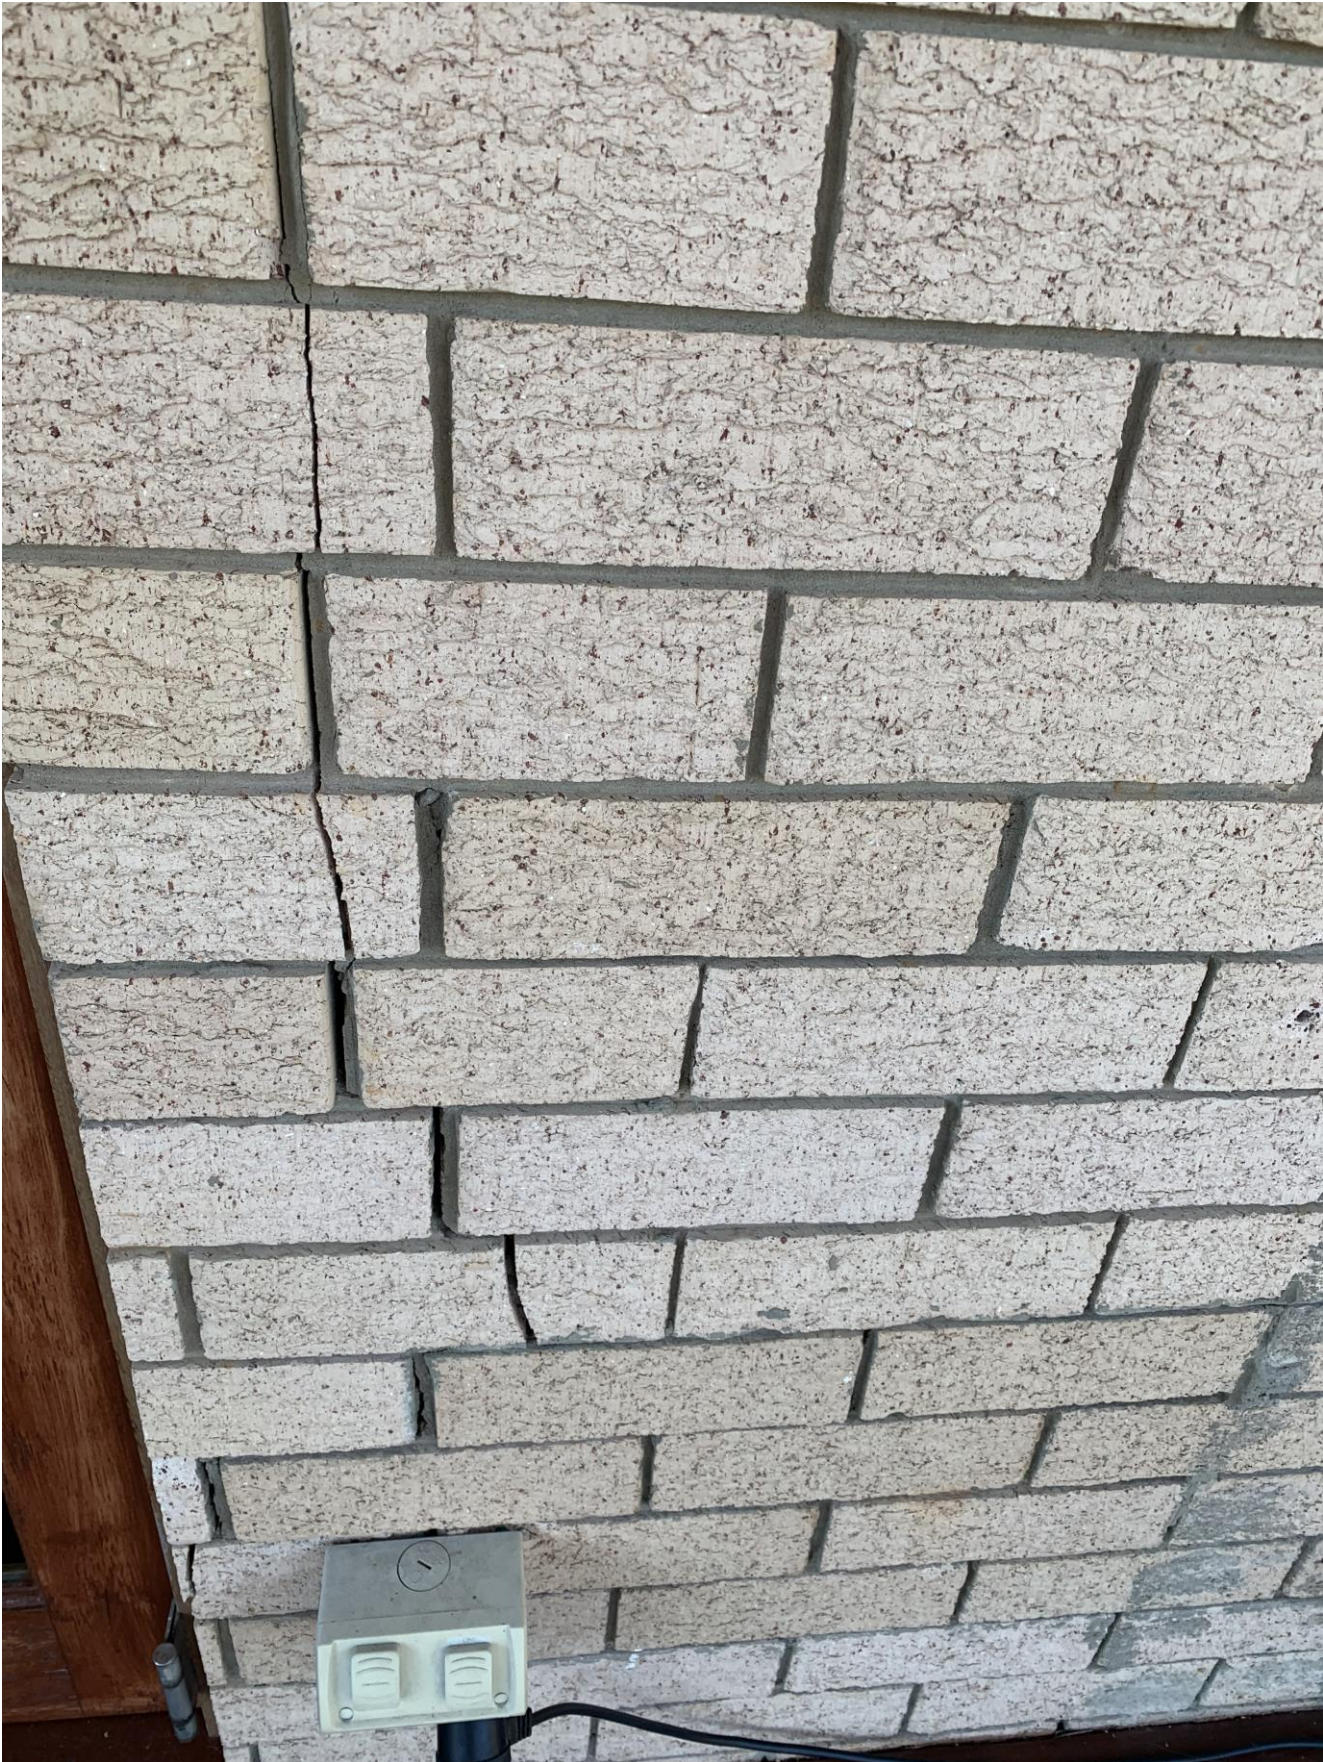
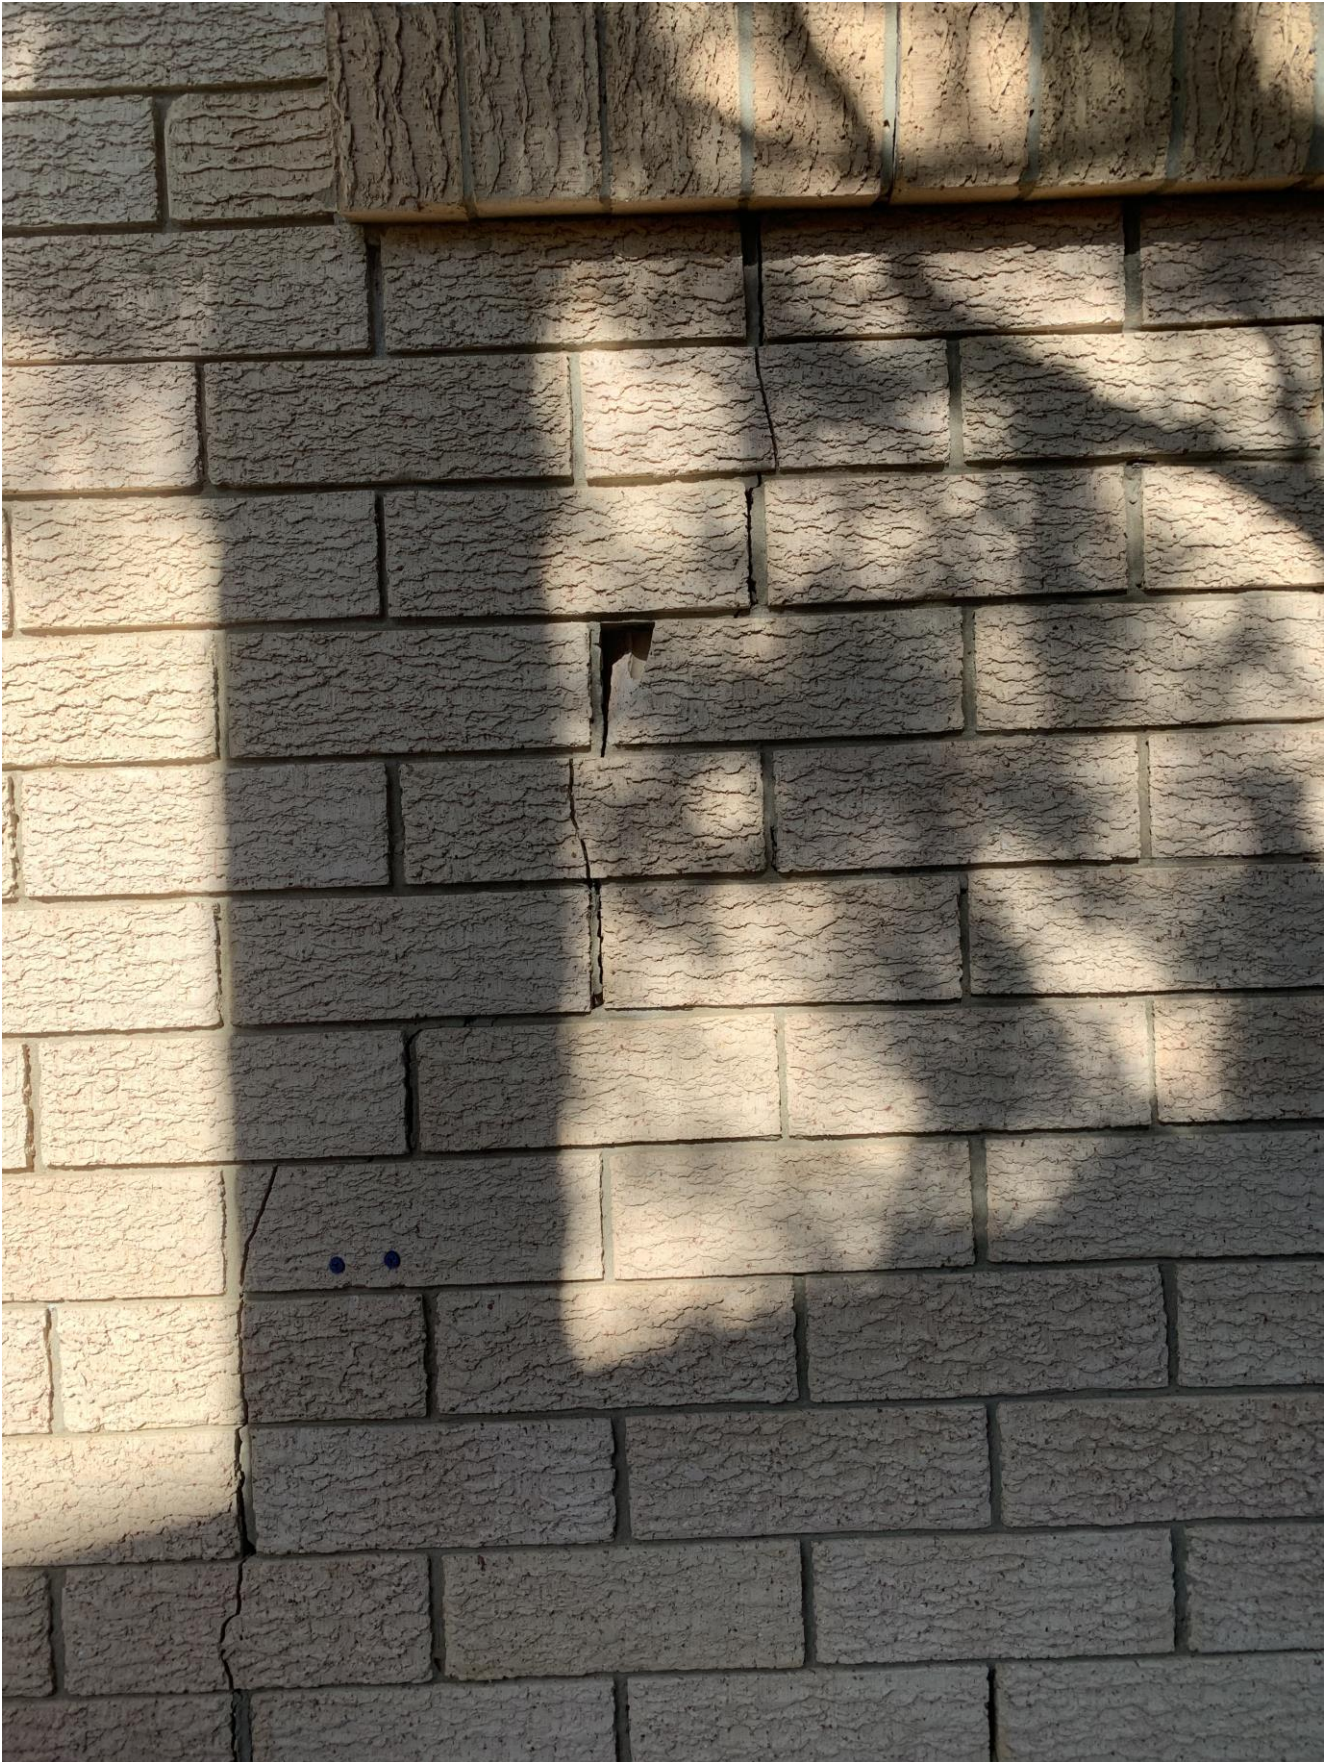
Structural movement / cracking to the the walls of the dwelling

Three cracks to the front wall approx 0-10mm wide and up to 1.0m long,

Two cracks to the rear wall 0-10mm wide and 2.0m long

one sheer crack to the right side wall approx 0-3mm wide and 2.0m long

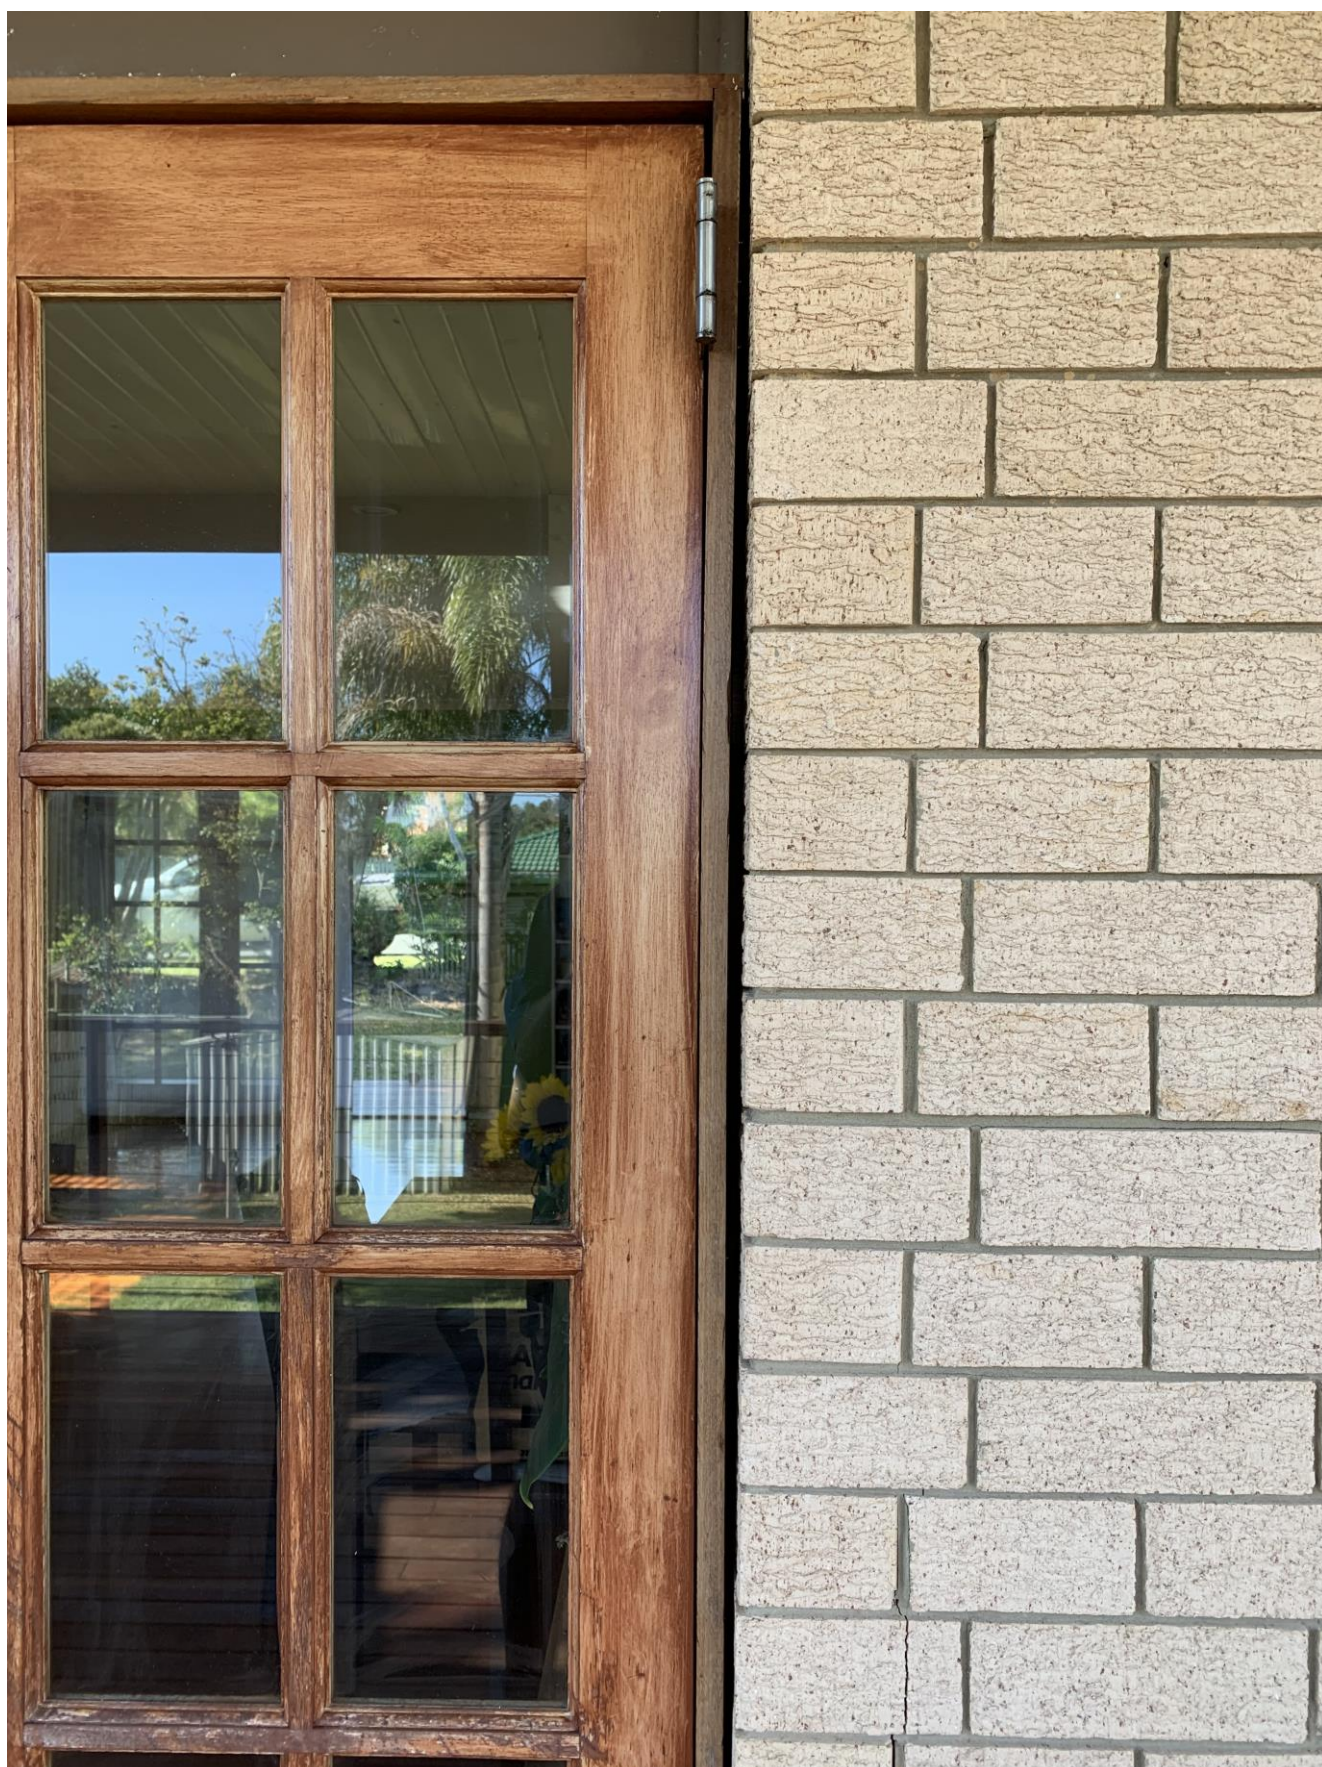
The french door to the rear wall is poorly installed - no flashings, gaps around the frame and not water proofed - repairs required recommend seek further advice from a licenced and practicing builder
