Pre-Purchase Inspection - Residential Building Report

Complies with Australian Standard AS 4349.1- 2007 Inspection of Buildings Part 1: Pre-Purchase inspections - Residential buildings

81 Matthew Mitchell Drive
Redbank NSW

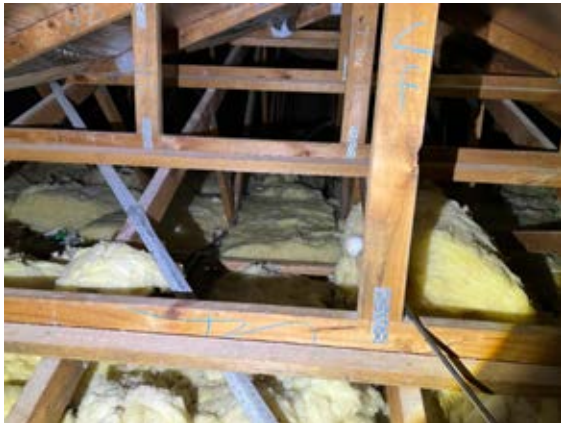
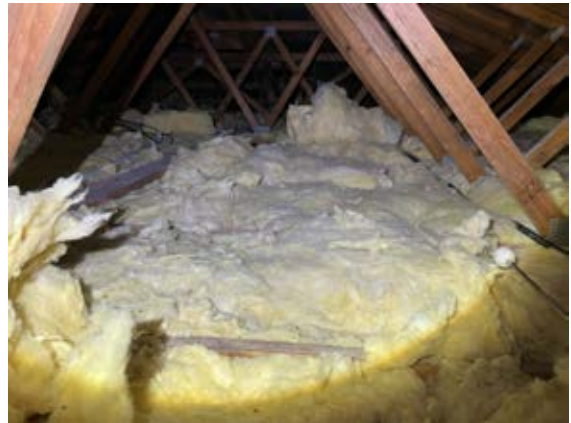
Access Issue 1. - Roof Void

Restricted Access

Insulation, Pitch

Due to pitch of the saddle truss's and insulation access in the roof void was restricted.

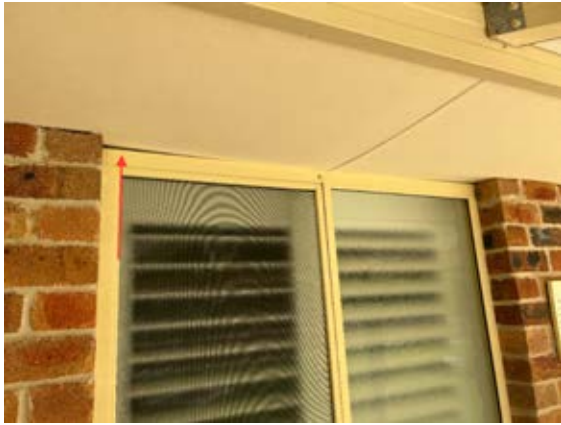
Defect 1. - Roof Exterior

Eaves.

Distortion, warping, twisting

Eaves have settled over the external brick walls causing the eave lining to in places move and crack.

Gap has been created between window and eave, cracks in eave lining will remain.

Settlement has created a gap between eave and window.

Note: This defect should be referred to a qualified building professional for the repairs/scope of work required.

Building Professional Required: Carpenter

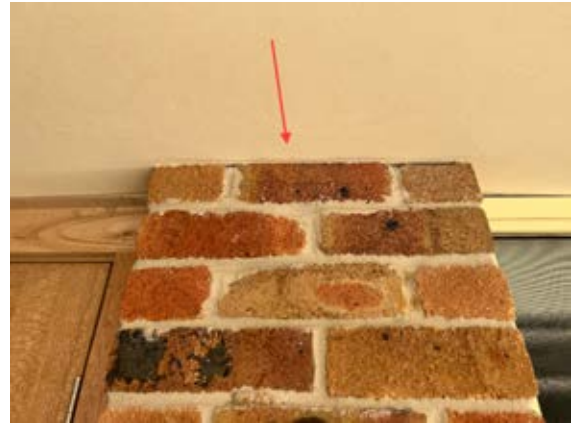
Crack in eave lining.

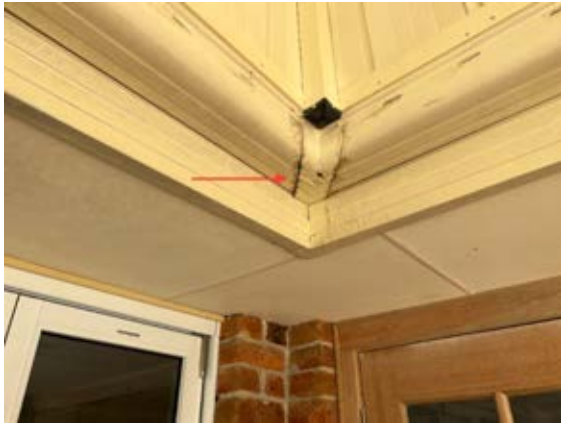
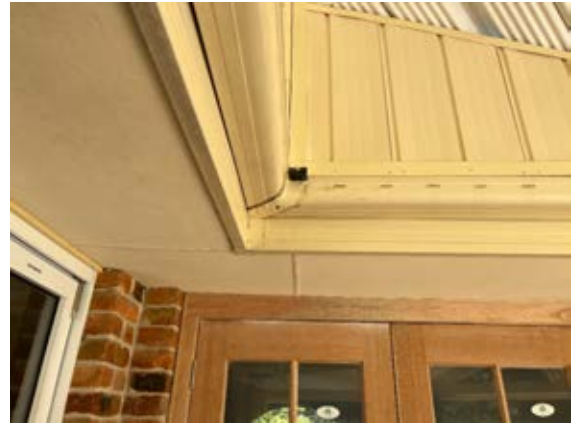
Defect 2. - Exterior

Defect Location:	North Side
Defect Summary:	Patio
Type of Defect:	Operational, Installation
Description:	Patio roof has been installed above the above the house gutter.
Ongoing Consequence:	House gutter is susceptible of leaking in heavy rain.
Opinion of Cracking:	Not Applicable
Building Professional:	<p>Note: This defect should be referred to a qualified building professional for the repairs/scope of work required.</p> <p>Building Professional Required: Roof Plumber</p>

Area where susceptible of leaking.
