JOINERY INVESTIGATION AND QUANTITY COUNT AT WAREHOUSE AT 15 DUNLOP ROAD, HOPPERS CROSSING

PROJECT: 820 FGR , 820-830 FERNTREE GULLY ROAD, WHEELERS HILL
 DATE: 12 AUGUST 2021
 REV 2

BATHROOM AND KITCHEN JOINERY STATUS SUMMARY ON SITE ON 15MAR2021

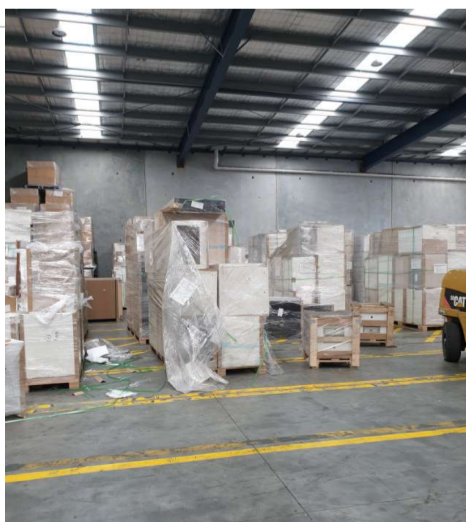
- Joinery inspections were carried out at 15 Dunlop Road, Hopper Crossing on 09 & 19 March 2021 plus in the garage for Townhouse D13.
- 52 pallets were found. Based on the "summary" labels on each pallet, it appears that they covered the kitchen joinery and bathroom cabinets for the apartments (residential units only) and townhouses A12-A16 & E1-E4.

TYPICAL PALLET AT WAREHOUSE

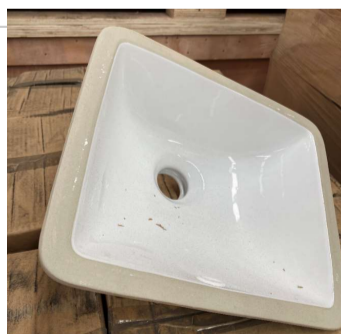
- Basins J02(FX30) (140hx265wx230d) are undersized and not comparable with the basin nominated in the Fittings and Fixture Schedule specified as (140hX350w340d) or that present in the Display Townhouse D13.

BASINS J02(FX30) ARE UNDERSIZED COMPARED TO IWOLFF FF&E SCHEUDLES (140HX350W340D)

7
 Apartments J02 Small Vanity Undermo
 unt Basin
 External Size: 310*270*140mm
 Internal Size: 265*230mm
 Code: C1201
 Total quantity: 84pcs

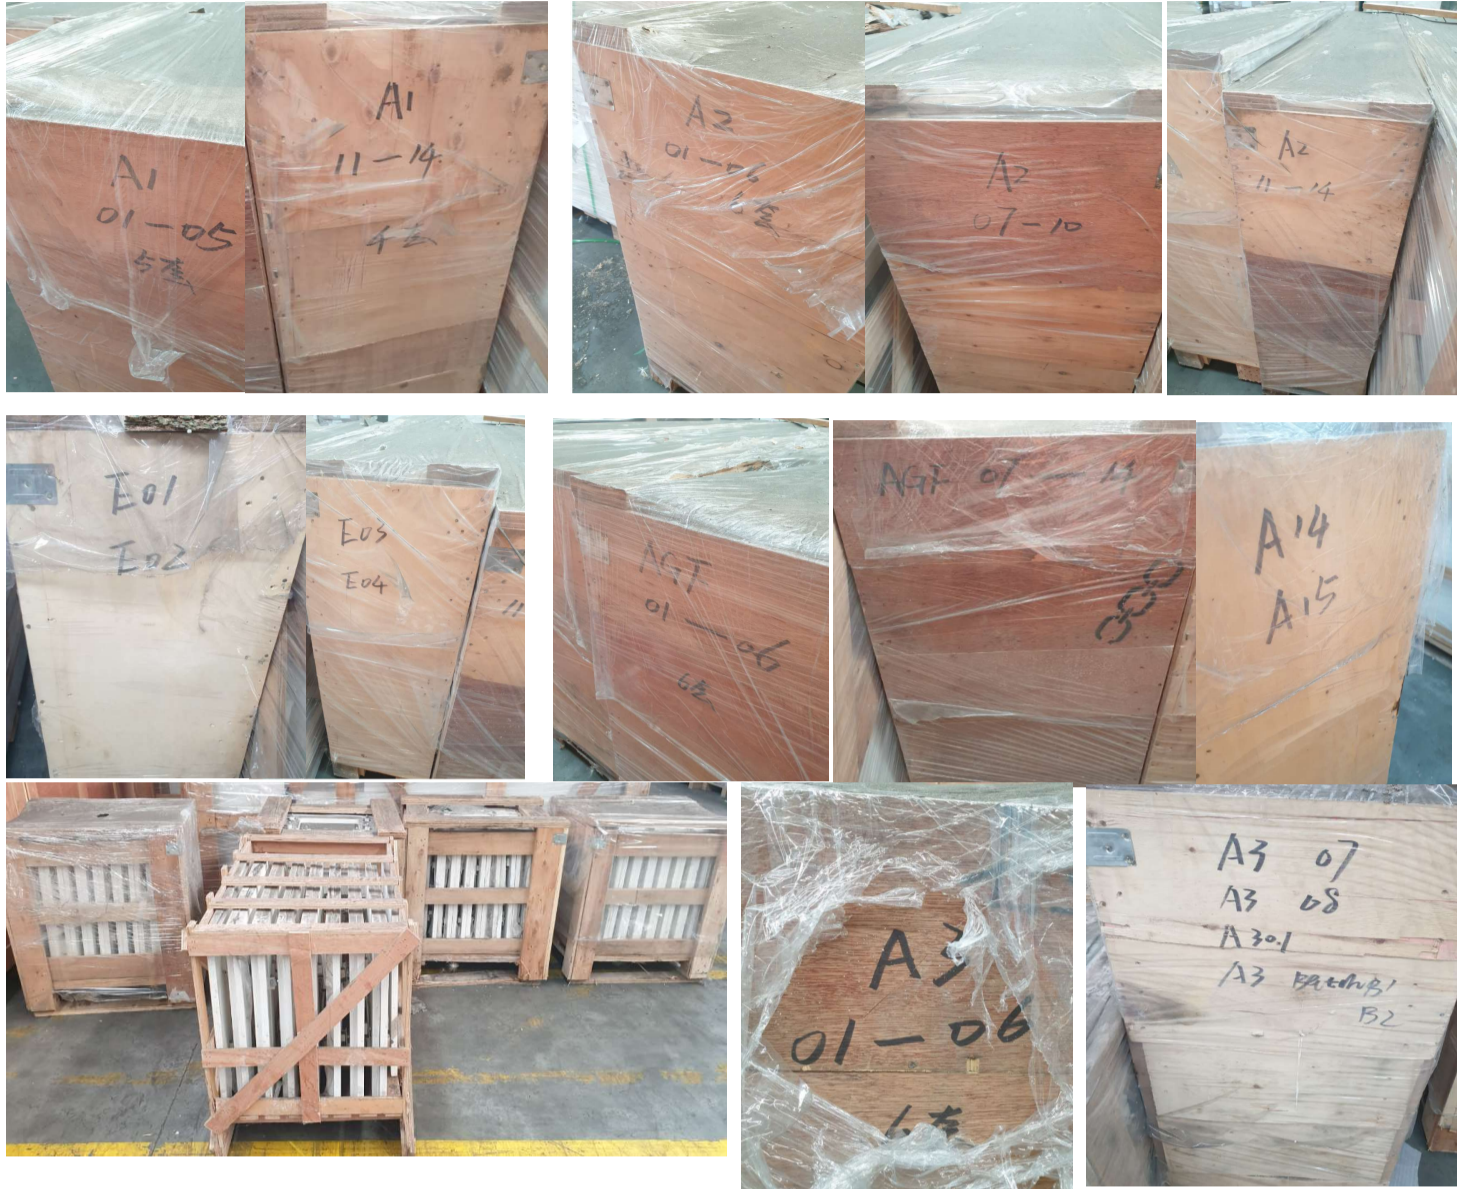
- More than a dozen pallets of stone tops were present in the warehouse. These were not opened as the warehouse attendants were concerned of damaging these items therefore these items were not identified relating to each residential apartments (as no allocation was present).

STONE TOPS FOUND AT WAREHOUSE BUT UNABLE TO IDENTIFY TO BELONGING UNITS
