Condition Report

Greys Auction Perth
WD600-6 | 55016

General Information		Customer Details	
Case Number	AD61161741060937	Customer Name	Greys Auction Perth
Date	04/03/2025	Customer No.	
Equipment	Wheel Dozer	Location	Jandakot
Model	WD600-6	Contact Name	Taine Yates
Serial No.	55016	Contact No	0452482963
S.M.R	23127	Contact Email	
Engine Serial No.	512384	Service Details	
Technician	Ruby Livingstone		
Supervisor	Kieron Hinsley		
Case Description	Condition Report on a used WD600-6		
Report Completed By	Ruby Livingstone	Component Report Recommended	
		Delivery Name

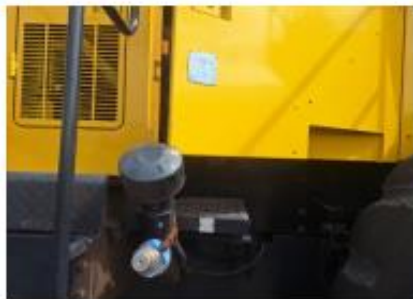
Component:
Outer body panels and paint

Comments:
Paint and body panel in good order-
normal amount of wear around machine

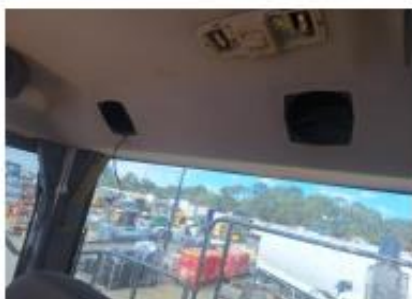
Component:
Monitor panel

Component:
Dash upholstery appear in good condition
