# Condition Report

**CSR LTD**  
*WA380-5 / H50383*

<b>Case Number</b>	R1389790
<b>Date</b>	02/11/2022
<b>Equipment</b>	Wheel Loader
<b>Model</b>	WA380-5
<b>Serial No.</b>	H50383
<b>S.M.R</b>	13693

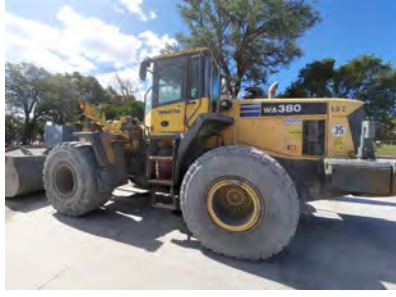
A/C system fault diagnosed. Pressure test carried out, leak found in blocked evaporator core. Poor air flow a result of blocked evaporator core. Customer requests a quote for repair and repair to be scheduled.
