CERTIFICATE OF INSPECTION AND TESTING OF "TOWER CRANE" **MAJOR INSPECTION / ASSESSMENT**

Type of Crane:	Favelle Favco Tower Crane	Certificate No:	18 / 066 / 1
Crane Manufacturer:	Favelle Favco P/L	Crane Model:	120RX
Crane Serial No:	917	Year of manufacture:	1996
Plant Registration No:	N/A	Rebuilt:	2018
		Precision Crane Inspections NDT Report No:	5272-02

INSPECTION REPORT

Client:	RIGCON ENGINEERING 16 Chester Rd Altona VIC 3018	Report No:	5272-01
Location of Crane:	Chester Road, Altona	Date of Inspection:	06, 30 & 31 st May 2018
Description of Crane:	9T FAVCO Tower Crane	Model Number:	120 RX
Plant Identification:	917	Serial Number:	917
Clients Order No:	917	Requested by:	Mr J. Williams
Request No:	Not Applicable	Surface Preparation:	Coated Item: <484µm Cal: 484µm
Client's Job No:	Not Applicable	Criteria Specific Clause:	Not Applicable
Acceptance Spec.:	Clients Requirements - Nil Cracking Permitted		
Material:	Carbon Steel - Not Further Specified		
Test Specification:	ISO17643, UT03.1, AS1171		
Test Procedure:	ET01.2, UT03.1, MT02.4		
Technicians:	Ken Darby - Certified ET, UT, MT, AS3998/ISO9712

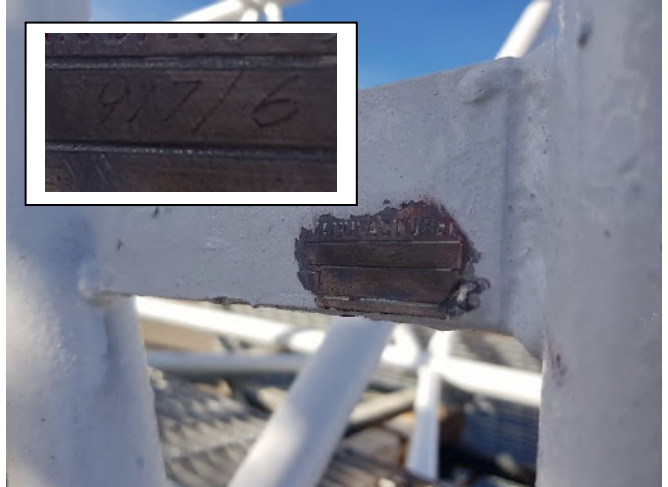
Figure.12 917/6 Identification

917/6 Tip Section (Head)	Eddy Current Inspection	4 off Butt Connection Point Weldments (100%) Idler Sheave Mount Weldments Head Area Weldments – where accessible Pennant Connection Pad-eye – attachment welds	No cracking detected

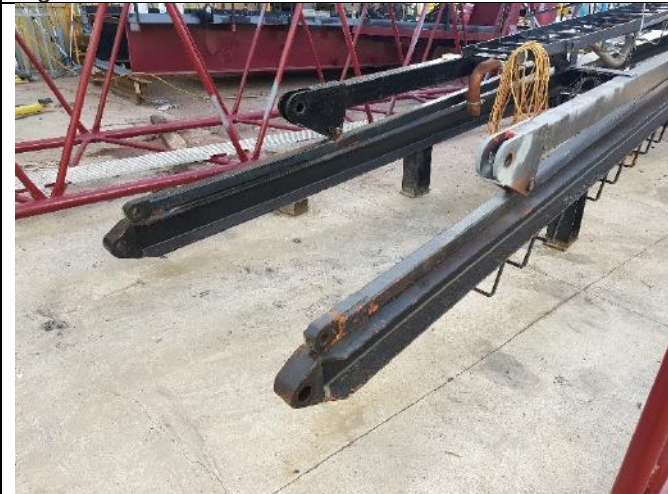
Figure.21 A-Frame Connection Points

Component	NDT Inspection	Area of inspection	Result
Machine Deck	Eddy Current Inspection	A-Frame Connection Points - 4 off Connection Pad-eye Weldments Slew Ring Mount Weldment - accessible weldment Operators Cap Support to Slew Mount	No cracking detected
A-Frame	Eddy Current Inspection	Connection End Point Weldments - where accessible Pennant (solid) Connection Pad-eye Weldments - where accessible Support Bracing Weldments - where accessible Main Top Head Weldment - where accessible	No cracking detected
Mounting Frame (Rigcon-01)	Eddy Current Inspection	Main Structural Weldments (100% of accessible) Pad-Eye Attachment Weldments (100% of accessible) Slew Mount Weldment (100% of accessible)	No cracking detected
Starter Tower #1	Eddy Current Inspection	Connection Point Weldments (100% of accessible) Support Lacing Weldments (100% of accessible)	No cracking detected
Connection Pins (Boom)	Ultrasonic Inspection	1-6 @ 225mm in Length 7-10 @ 250mm in Length 11-14 @ 225mm in Length 15-18 @ 225mm in Length 19 @ 250mm in Length 20 @ 225mm in Length	No transverse cracking

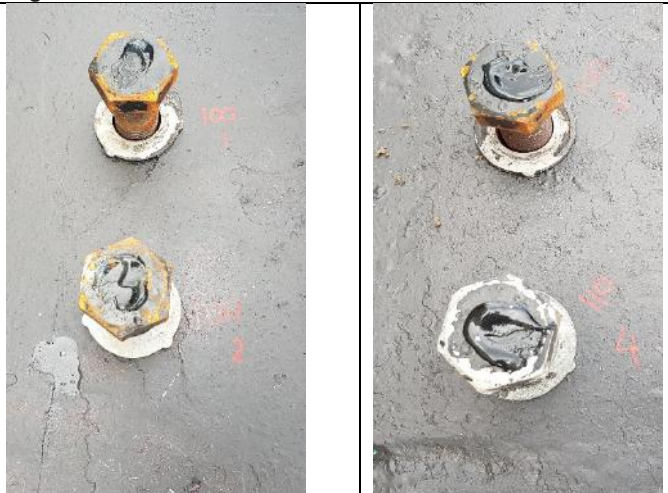
Figure.47 Mounting Bolts #1 to #4

Component	NDT Inspection	Area of inspection	Result
Winch Pack	Ultrasonic Inspection	#1 Mounting Bolt @ 100mm in length #2 Mounting Bolt @ 100mm in length #3 Mounting Bolt @ 100mm in length #4 Mounting Bolt @ 110mm in length #5 Mounting Bolt @ 128mm in length #6 Mounting Bolt @ 105mm in length #7 Mounting Bolt @ 119mm in length #8 Mounting Bolt @ 100mm in length	No transverse cracking
Hook SWL 16t (#S57561)	Magnetic Particle Inspection	Inner radius of Hook and Saddle	No cracking detected
