## Insurance Risk Survey

Bavaria, DS 29, 2004

Survey type:	Insurance Risk Survey
Survey No#:	IRS24113
Client:	[REDACTED]
	[REDACTED]
Inspection date:	13th November 2024
In-Water location:	Not Applicable, Inspected Out of Water Only.
Out-Water location:	SYC, Sandringham, Victoria

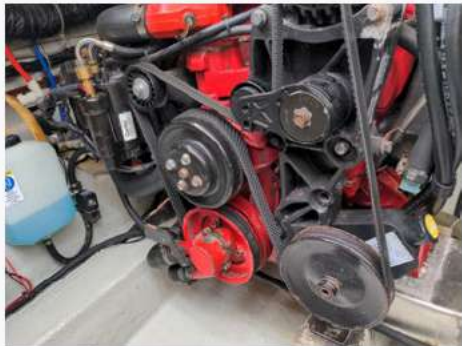
Ref # 7.7

7.6	Exhaust Riser / Elbow	Cast	Sound	Note: Exhaust manifolds and risers are a service item and require replacement as recommended by the manufacturer.
7.7	Serpentine Belt	Reinforced Rubber	Sound

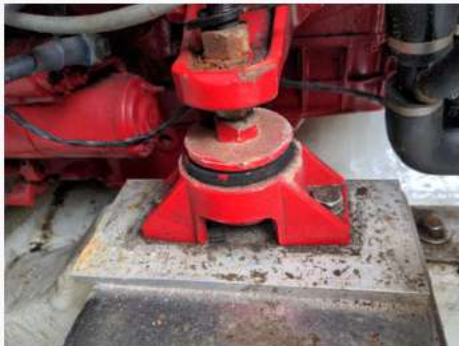
Ref # 7.10

7.8	Pulleys & Wheels	Steel	Sound	
7.9	Engine Bed Frames	FRP Composite	Sound	
7.10	Engine Mounts	Flexible Mounts	Sound	
7.11	Cooling System	Open / Raw water	Sound

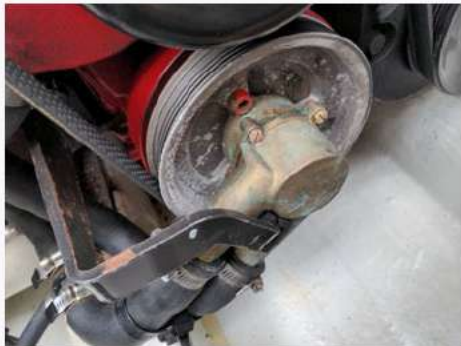
Ref # 7.17

7.17	Raw water pump	Impeller Pump	Sound

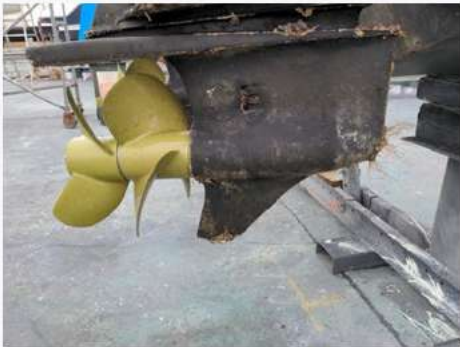
Ref # 8.2

Ref	Item	Type / Make	Condition	Comments
8.1	Type	Stem Drives	Sound	Appear in serviceable condition
8.2	Gear Box	MerCruiser	Sound	
8.3	Propellers	Stainless Steel	Sound	Duo props

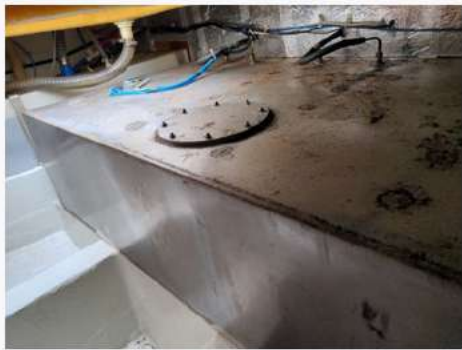
Ref # 10.1

Ref	Item	Type / Make	Condition	Comments
10.1	Fuel Lines	Marine Fuel Hose	Sound

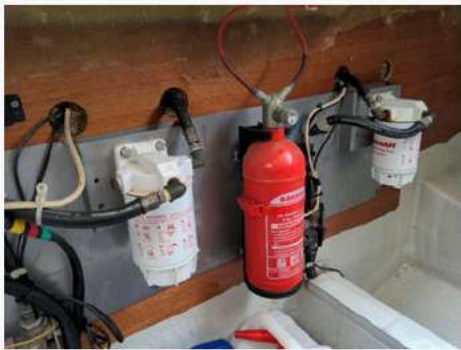
Ref # 10.3

10.2	Fuel Fittings	Compression Fittings	Sound	
10.3	Fuel Filters	Yamar	Sound	
10.4	Fuel Shut-Off	Bronze Valve	Sound	
10.5	Fuel Filler Line	Fuel Hose	Sound	
10.6	Fuel Breather	Fuel Hose	Sound	
10.7	Fuel Tank	Stainless Steel	Sound	Said to be 500 Capacity

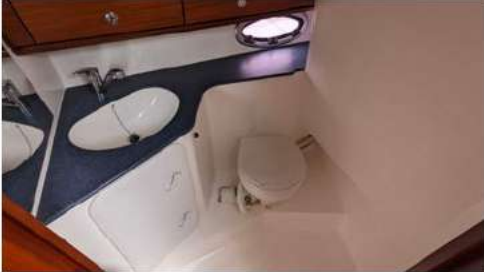
Ref # 11.7

Ref	Item	Type / Make	Condition	Comments
11.1	Fresh Water Pump	12-Volt	Sound	
11.2	Water Tank	Polyethylene or similar	Sound	Said to be 120 litre capacity
11.3	Plumbing / Hose	Reinforced Hose	Sound	
11.4	Sinks	Stainless Steel	Sound	
11.5	Showers	Head Shower	Sound	
11.6	Shower Drainage	12-volt	Sound	
11.7	Toilet / Head	Electric Flush	Sound	
11.8	Toilet Plumbing	Sanitation Hose	Sound

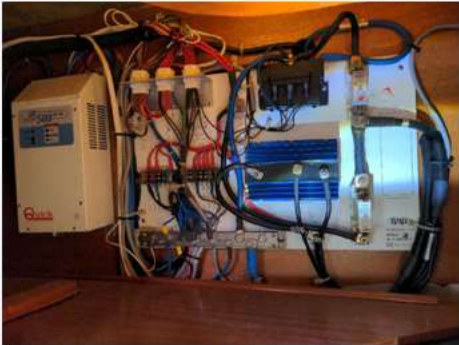
Ref # 12.3

Ref	Item	Type / Make	Condition	Comments
12.1	Shore Power Lead	15-amp Heavy Duty	Sound	
12.2	Shore Power Breaker	15-amp Breaker	Sound	
12.3	Wiring & Cables	Insulated Wire	Sound	
12.4	Switch Panel	AC/DC switch panel	Sound	
12.5	Power outlets / GPO	Australian Type	Sound	Tested using DETA-240 plug tester, resulting in a PASS.
12.6	Battery Charger	240-volt	Sound	
12.7	Batteries	12-volt	Sound

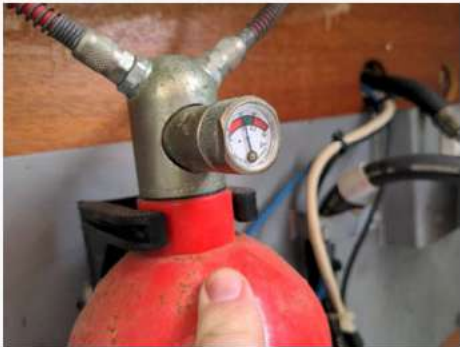
Ref # 15.3

Ref	Safety Gear	Type	Comments
15.1	Life Jackets	Foam PFD type	5x Inflatable & 5 x Foam sighted.  Note: Periodic self inspection of all PFD's and cylinders is essential. Inflatable gas cylinders require replacement, check expiry dates stamped on cylinders.
15.2	Extinguishers	Dry Chemical Type	3 x 1kg Dry Chemical.  Note: Dry powder Fire extinguishers should be discharged and recharged every 5 years.
15.3	Fire Suppression	Fire Boy	In engine bay
15.4	EPIRB	AccuSat	Battery Expired
15.5	Flares	Flare Kit	Flares Expired
15.6	Fire Blankets	One Blanket	Found in galley
15.7	Life rings	Plastic Ring	In cabin along along with a retriever float
15.8	Compass	Rotchie	On helm
