ENGINE

EQUIP NUM: 3KR00809

CAT D10R

OIL CONDITION SATISFACTORY, CONTINUE SAMPLING AT THE RECOMMENDED INTERVAL.

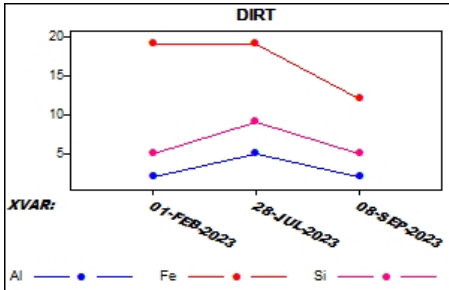
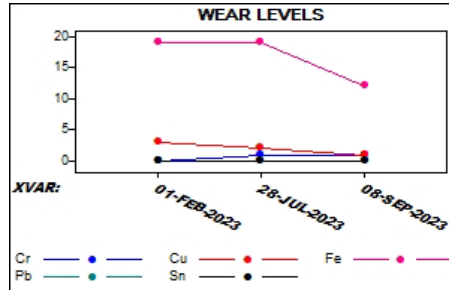
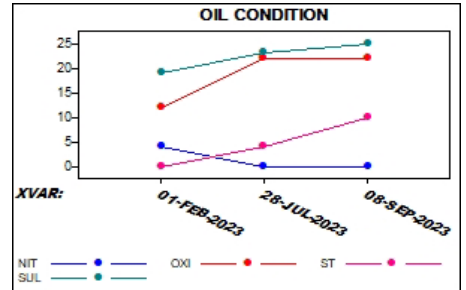
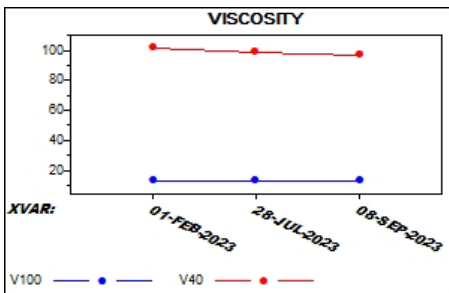
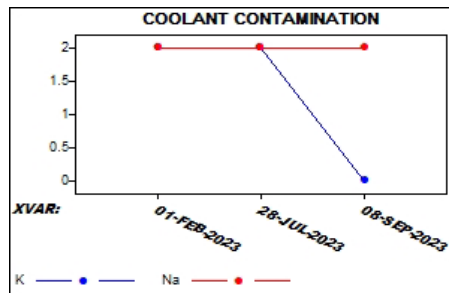
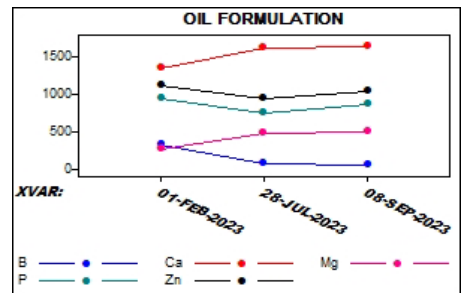
08-Sep-23	28-Jul-23	01-Feb-23
VISCOSITY (CENTISTOKES) ASTM D445				
V100	Viscosity at 100 C	12.93	13.00	13.08
VISCOSITY (CENTISTOKES) ASTM D445				
V40	Viscosity at 40 C	96.31	98.20	101.4

08-Sep-23	28-Jul-23	01-Feb-23
VI	Viscosity Index	131	129	126

08-Sep-23	28-Jul-23	01-Feb-23
ST	Soot	10	4	0
OXI	Oxidation	22	22	12
SUL	Sulfur Products	25	23	19
NIT	Nitration	0	0	4

08-Sep-23	28-Jul-23	01-Feb-23
FERROUS DEBRIS				
PQI	PQ Index	0	0	7
