**Professional Independent Boat Inspection**

# Boat Condition Overview - GRAYS

Raeline 185 Bowrider

10.02.2026

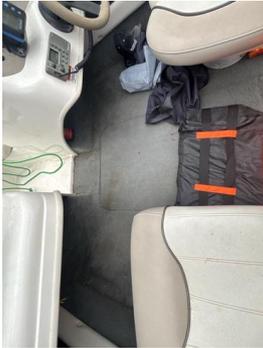
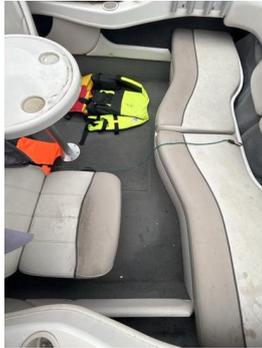
### Main Floor/Deck

Satisfactory

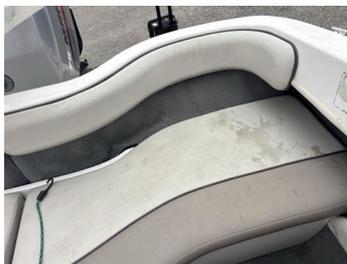
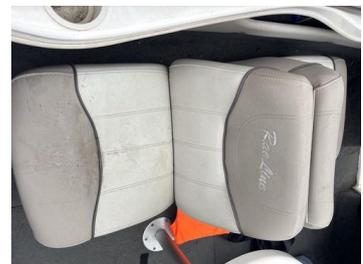
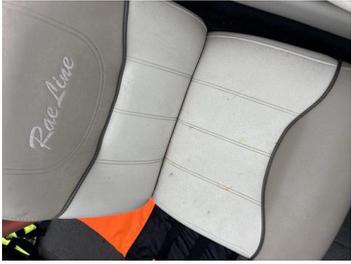
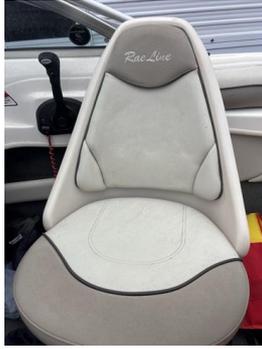
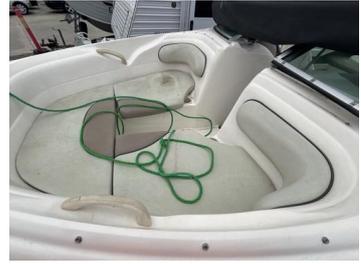
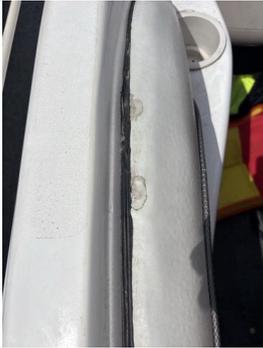
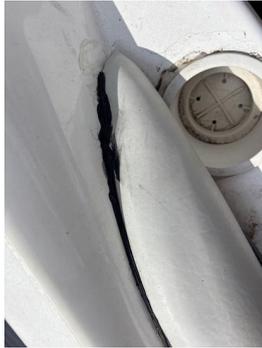
### Seating and Trimming

Nominal wear and tear from UV, aligned with age of vessel

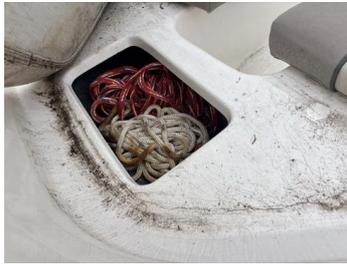
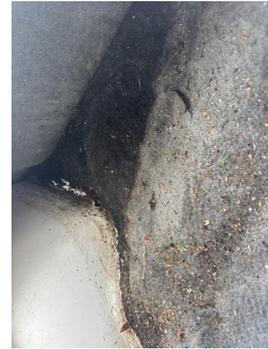
Starboard bow under seat has mud/dirt - would clean now

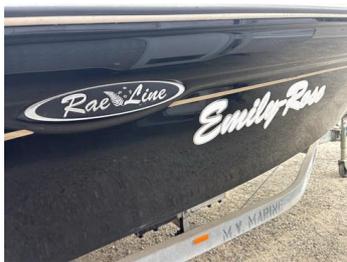
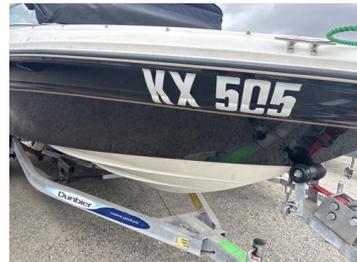
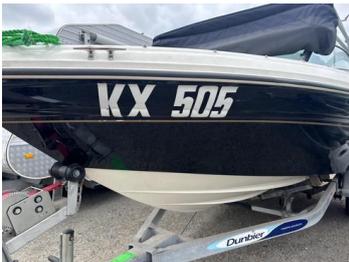
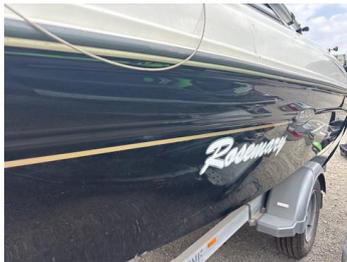
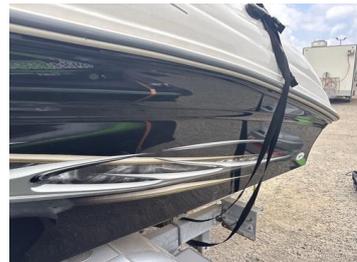
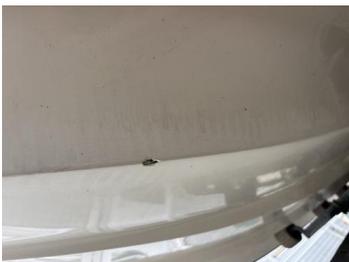
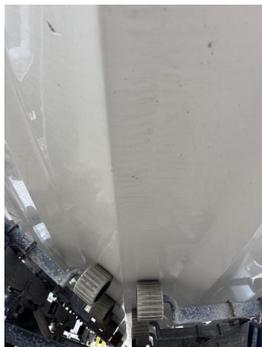
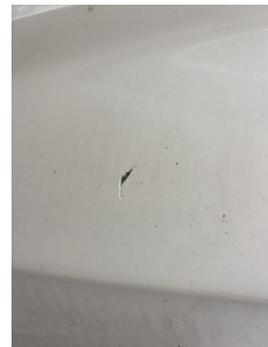
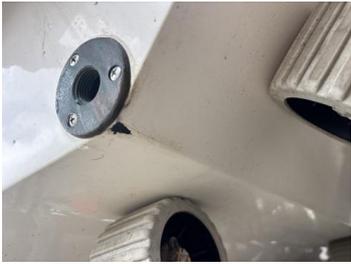
No damage noted, very minor scratches on underside of Boat

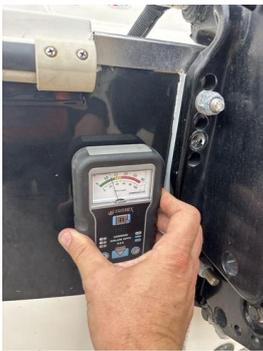
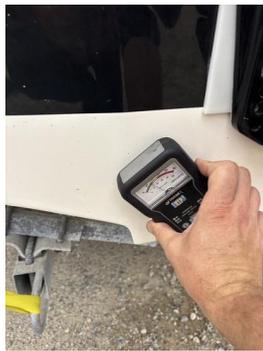
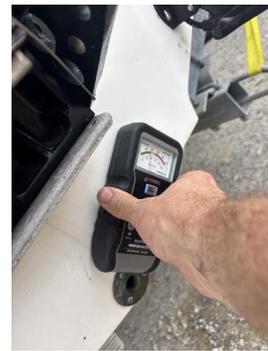
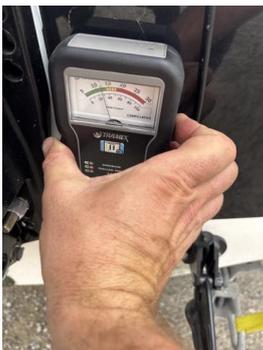
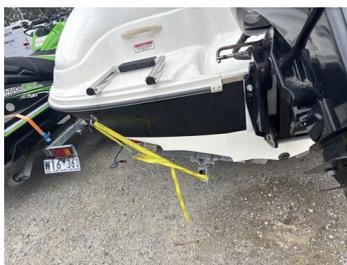
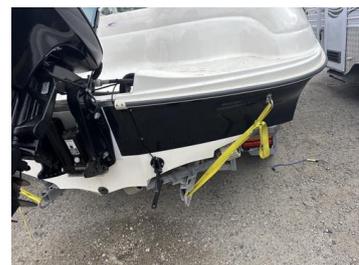
no moisture in transom, no delamination

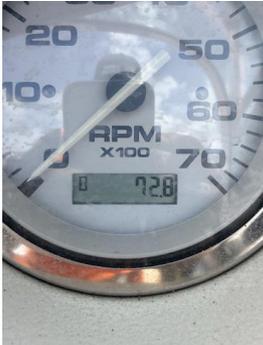
Photo 40

**Port/Main Engine Hours**

72.8

indicated

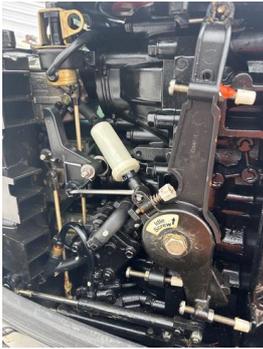
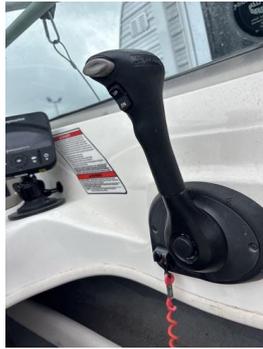
**Engine Controls and Control Cables**

free to move

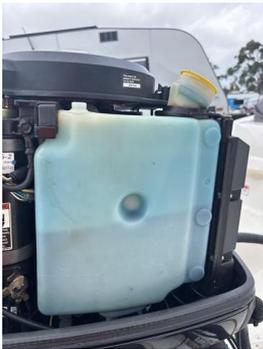
Photo 45

### Engine Oil Visual Inspection

no leaks

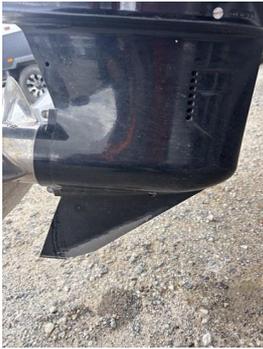
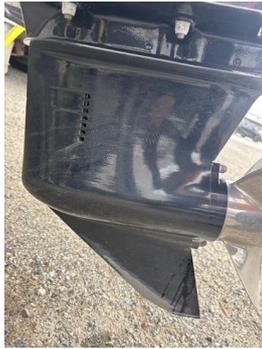
### Gearcase Condition and Gearbox Operation

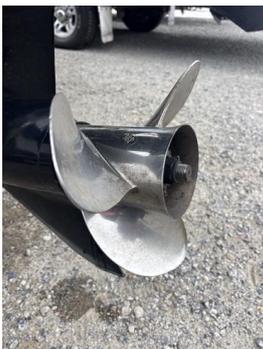
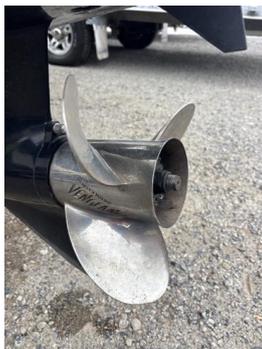
### Propeller

Satisfactory

stainless

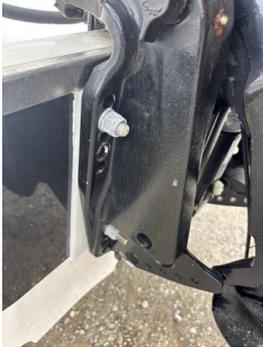
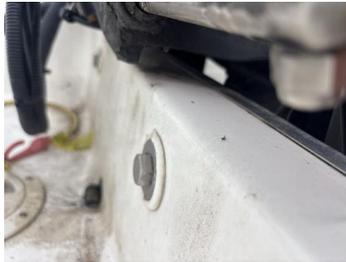
## Engine Mounts

Satisfactory

solid

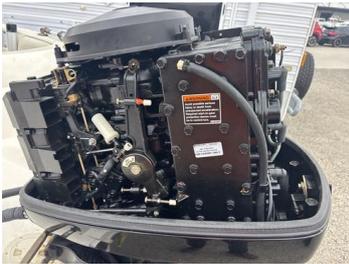
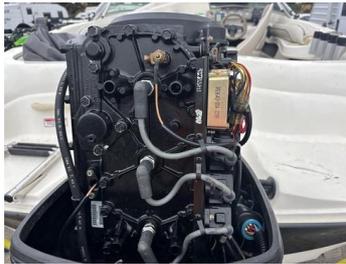
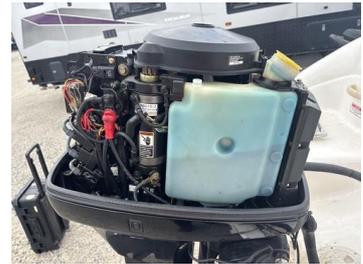
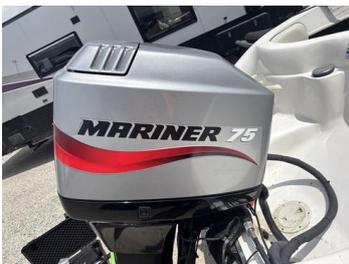
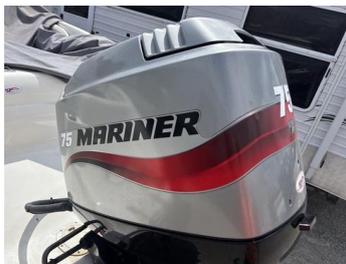
Engine started with Lees.  
Maintained idol.  
Slow to rev up due to age of fuel suspected.  
Gear engaged well  
shut down ok

Whilst the engine low hours and fuel is expected to be aged, the engine inspected well, recommend service.

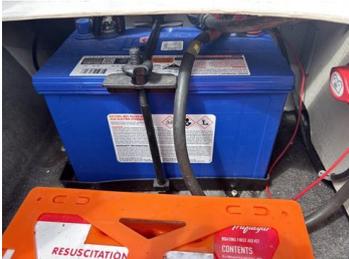
Photo 58

1 x Calcium M27

Reject

Less than 50% life

Accept

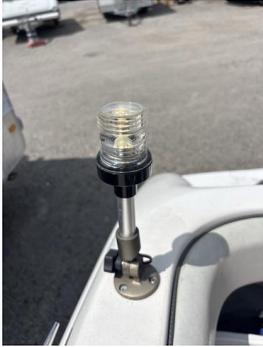
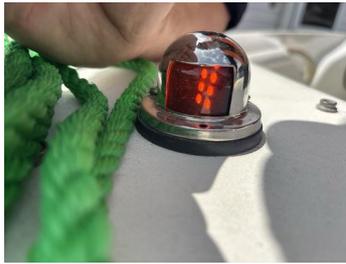
### Navigation Lights

Satisfactory

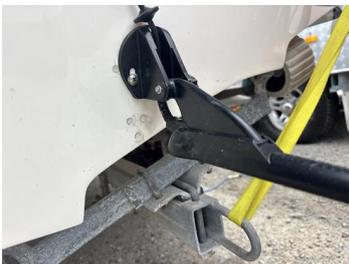
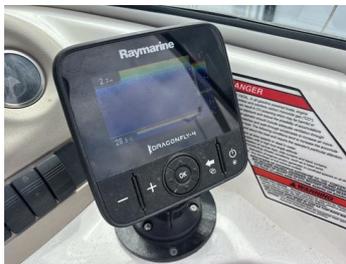
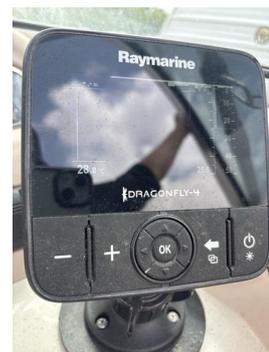
### Navigational Equipment

Satisfactory

Navman GPS also fitted and operating

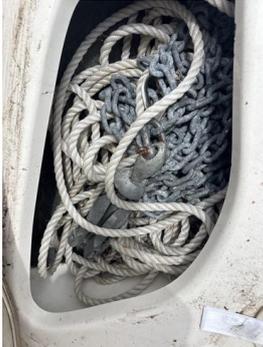
Photo 71

### Anchor / Chain / Rope

Satisfactory

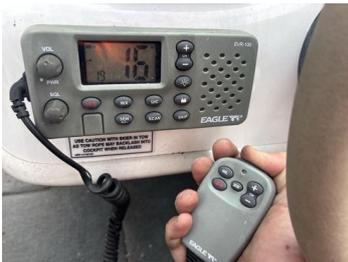
Photo 72

### Marine Radio

Satisfactory

27mhz radio
